THERMO-MECHANICAL CRACKING OF A NEW AND LASER REPAIR WELDED DIE CASTING DIE

D. Klobčar, J. Tušek, M. Pleterski, Faculty of Mechanical Engineering, University of Ljubljana, Ljubljana, Slovenia, M. Muhič, TKC d.o.o., Ljubljana, Slovenia

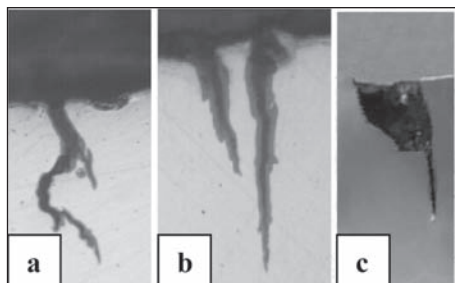
Measurement of the length of thermo-mechanical fatigue cracks on mould surfaces during the actual production run is practically impossible. Approx. measurement of crack length would be possible by sticking thin wires into the crack and measuring the penetration depth [8]. This could not be done without stopping the production. Another more precise way would be by cutting the tool and measuring the crack length on the prepared micro-sections (Figure 3). This is hardly affordable, since the die casting dies are very expensive [9]. Therefore, idea was to measure the defects-fins on the castings [7]. These defects-fins are basically the negatives of the cracks and other surface irregularities on the mould (Figure 1 – 5). The basis for this idea is that in industrial practice the tool fails when the mould starts to produce castings with defects-fins, which are no longer acceptable for the final product. In fact, the size of the casting defect-fin is a bit different from the corresponding mould defect-crack (Figure 3). The cause for this

deviance could be in detection possibility of relatively wide cracks that are filled with melt during die casting. The thinner parts of cracks that can not be filled up are undetectable by this method of monitoring (Figure 3). Nevertheless, our innovative monitoring method can be used to continuously monitor the condition of die casting die in order to estimate and predict the time for changing or repairing the mould.

Figure 3 Typical thermal fatigue cracks.

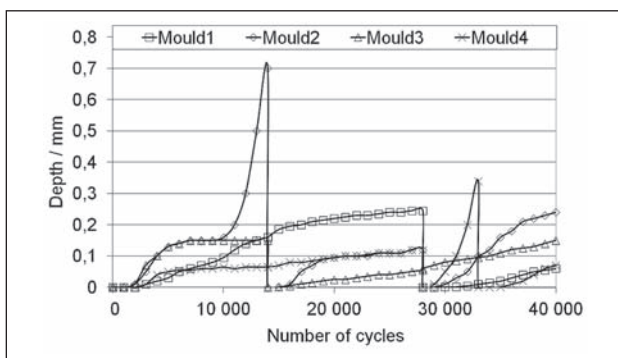
Figure 4 shows a complete history of defect-fin depth over the in-service lifetime of monitored die casting die. The die casting process was stopped there times for laser repair welding during the production of 40 000 cycles. First repair welding was done after completion of 14 000 cycles on moulds two and three. The reason for stopping and repairing the die was because the defect-fin depth (height) exceeded the unacceptable limit by a factor of two. At this time the crack was also repaired on the mould 3, which experienced a fast crack growth i.e. defect-fin growth at the beginning of die casting (Figure 4). A second stop of production was done after completing 28 000 cycles (Figure 4). At this time the moulds one, two and four were subjected to a laser repair. Shortly after that at 34 000 cycles the production stopped and the mould four was refurbished for the second time, after only 5 000 cycles (Figure 4). The reason for that could be in joining of two adjacent cracks, which joined together and produced a surface material in-between to be removed (Figure 3b). This mechanism of tearing of material between the cracks due to closeness is schematically presented on the figure 3b and 3c. Figure 3b shows two adjacent cracks which are growing together. If such surface cracks are subjected to additional thermo-mechanical cycling, the two cracks meet and the material in-between is removed from the surface. This causes tearing of material between the cracks due to closeness, which is causing widening of surface crack (Figure 3c).

Figure 4 The depth of defect-fins throughout the die lifetime.

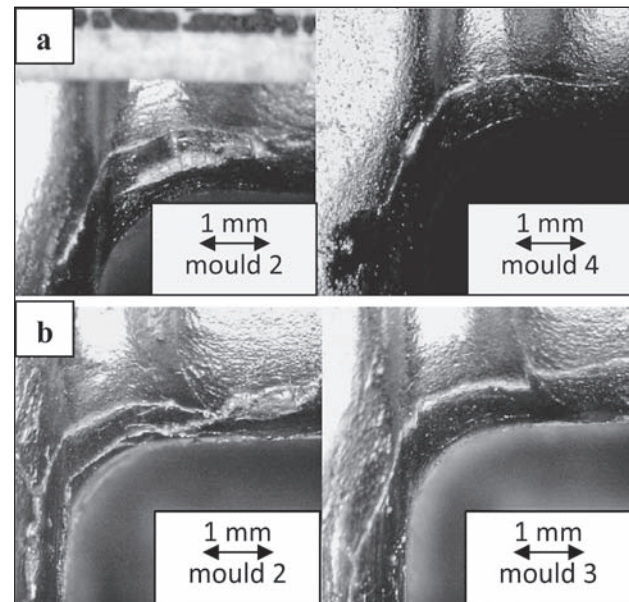
Figure 5 shows defect-fins on castings after a) 9 800 cycles and b) after 22 500 cycles. The observed location on mould 2 experienced fast crack growth shortly after 10 000 cycles (Figure 4 and 5a). The reason for that is in widening of surface crack due to joining of two adjacent cracks seen on Figure 5a. At casting from mould 4 only one small defect-fin is observed (Figure 4 and 5a), whereas at castings from mould 2 two bigger defect-fins are observed at 9 800 cycles (Figure 5a and 4). The moulds 2 and 3 were laser repaired after 14 000 cycles. After 22 500 cycles the cracks on the mould 2 have grown fast at the beginning and then steadily proceeded with growth. On castings from mould 2 two defect fins can be observed (Figure 5b). The laser repair done at mould 3 was very good, since a slow and steady crack growth is observed (Figure 4). Even at casting (Figure 5b, mould 3) a defect-fin is hardly observed.

Figure 5 Defect-fins on observed location on castings after a) 9 800 cycles (mould 2 and 4) and b) after 22 500 cycles (mould 2 and 3).

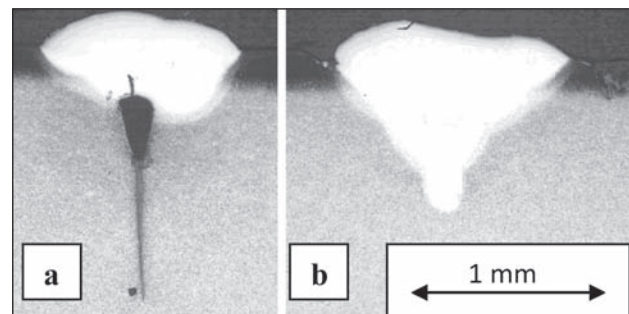
As we mentioned, there are many factors influencing the crack i.e. defect-fin growth and even a few more if we are considering laser repair welding of tools. Usually a fast crack growth is observed when crack widening appears, i.e. when two adjacent cracks joins or meet. On repair welded moulds a faster crack growth could appear due to a) fatigue material or b) faulty repair (Figure 6a). In both cases removing of more material would be beneficial. Faulty repairs could happen if the surface cracks are going zigzag (Figure 3a and 6a) or are long

Figure 6 a) Faulty and b) quality repaired surface crack.

(Figure 3b). In both cases after grinding and before laser repair welding the crack is not visible. If laser repair welding is done on the filthy crack, small cracks or porosity could appear in the weld metal. If this is not observed during the repair, a crack could quickly be opened (Figure 7b, mould 4, 2 welding).

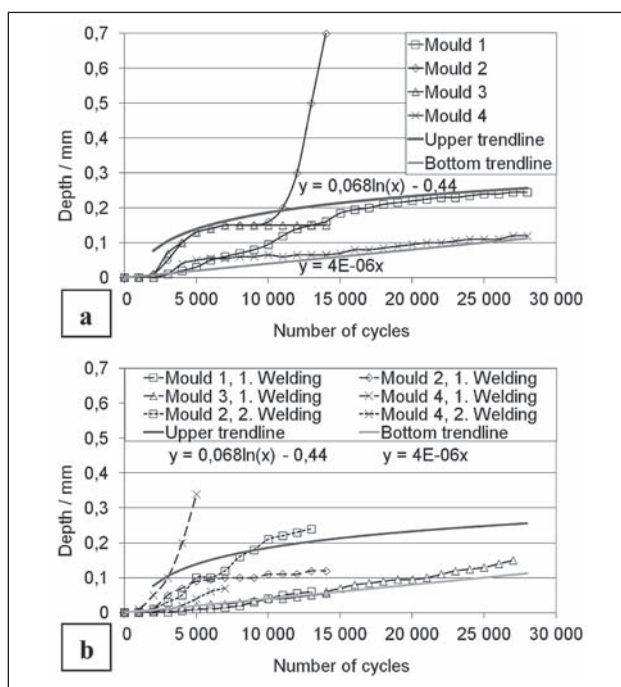
Figure 7 Defect-fin growths vs. number of cycles for a) new and b) repaired die.

Figure 7 shows defect-fin growths vs. number of cycles for a) new and b) repaired welded die casting die. In both plots upper and bottom trend line is drawn and their equations are written. The area between this two trend lines indicates the frame of crack growth rate, where the majority of cracks will appear (for this tool material, heat treatment, die casting parameters, mould design and particular location with notch effect). If the crack growth rate is closer to the bottom trend line, the crack grows slower and the mould lasts longer. If the crack growth rate is faster, it is closer to the upper trend line. If the crack growth rate exceeds the upper trend line (very fast) two adjacent cracks have most probably grown together, which caused crack widening.
