Đeni GOBIĆ-BRAVAR

DVOJNA VRATA, PULA KONZERVATORSKO-RESTAURATORSKI OSVRT

THE DOUBLE GATE AT PULA A CONSERVATION-RESTORATION REVIEW

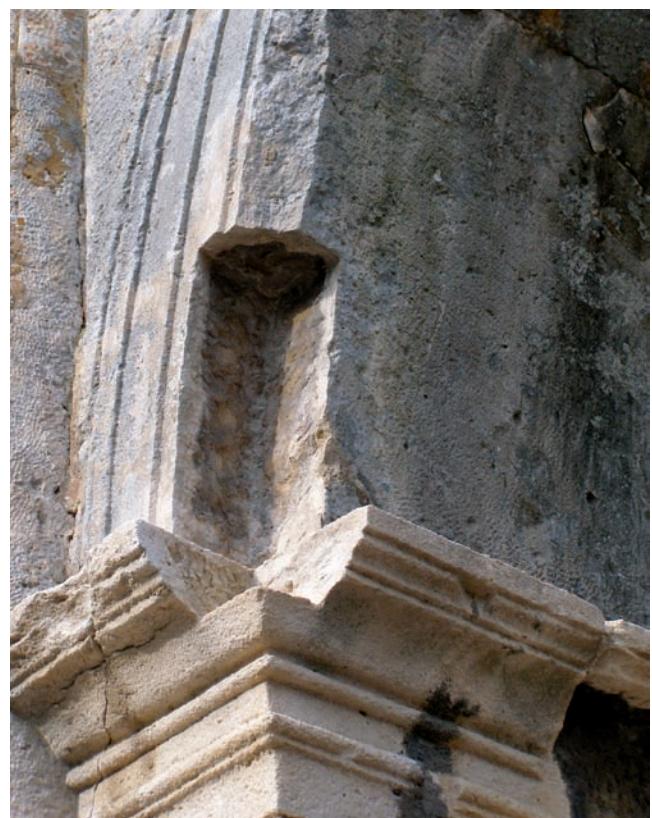
Prije nekoliko godina jedna se takva nadogradnja (iz dva ulomka) gotovo u potpunosti odvojila od spomenika te je iz sigurnosnih razloga odstranjena i pohranjena u Arheološkom muzeju Istre, gdje se i danas nalazi (slika 4). Kod ova je dva ulomka vidljivo da su popravci novim kamenim umecima izvedeni na način da je umetak zalijepljen, najvjerojatnije životinjskim ljepilom, a zatim rubno fugiran mortom. Također, većina je umetnutih dijelova danas smećkaste boje, što bi moglo značiti da su upravo ti dijelovi premazani katranom koji je zatim početkom 20. stoljeća odstranjen.

Sl. 4 Detalj pozicije odstranjenih kamenih nadogradnji.

Fig. 4 A detail showing the position of subsequent stone additions that were removed.

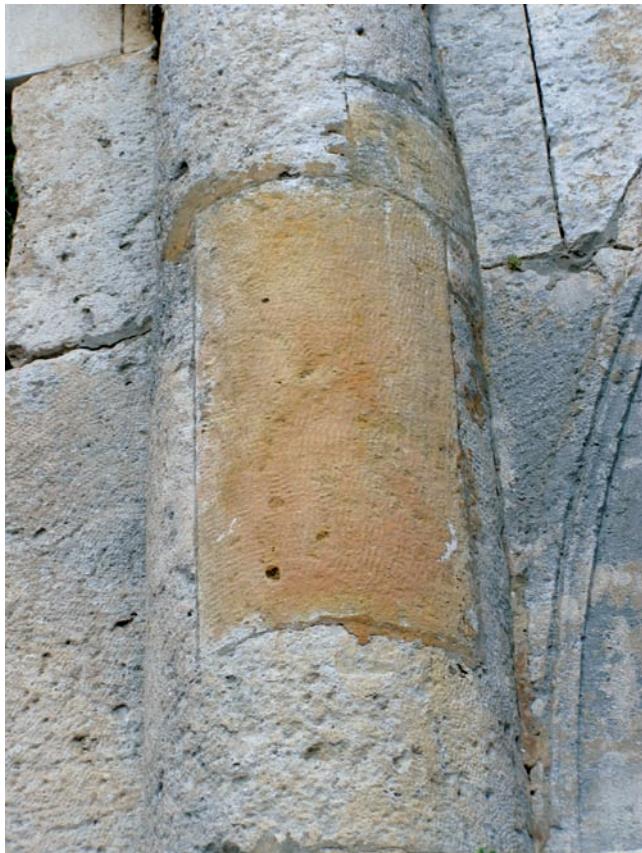
Sl. 5 Primjer mrlje na mjestu s kojeg je odstranjen katranski premaz; lijevi polustup istočnog pogleda

Fig. 5 An example of a stain in a spot from where a layer of tar was removed; the left semi-column as seen from the east.

The stains on the Double Gate were in the vast majority of cases caused by tar, or were left there after the tar coating was removed. Initially it was thought that the fragments were reddish in color because of close contact with red earth; however, by comparing historical photographs, and after the discovery of the data put forth by Pons in Eco di Pola in 1887, it was concluded that these are tar stains. There are also sporadic instances of graffiti.

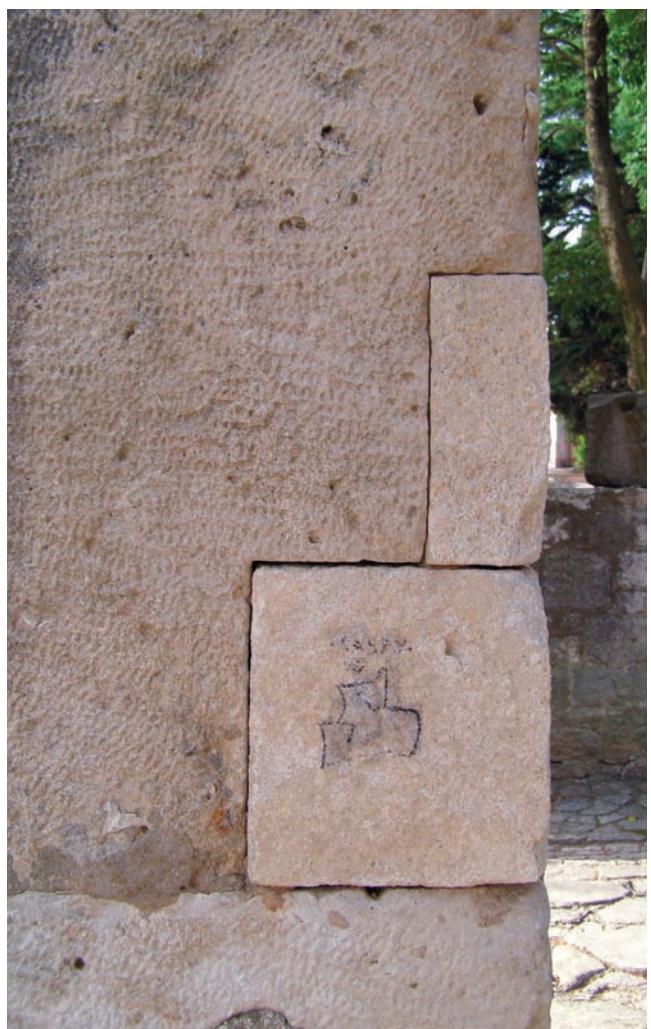
Sl. 6. Primjer graftita

Fig. 6 An example of graffiti.

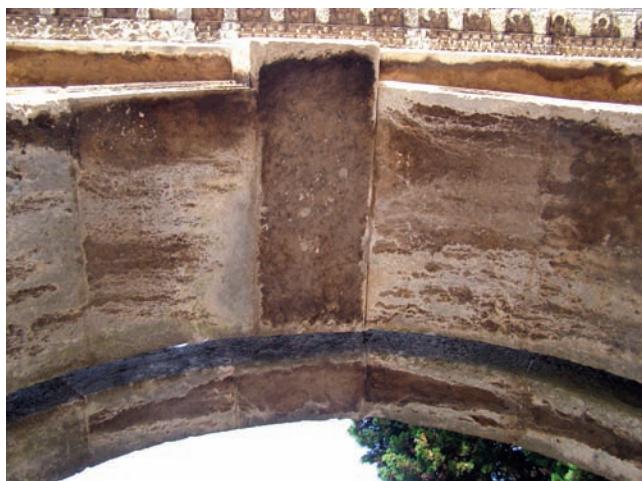
Crne su inkrustacije također prisutne na svim dijelovima spomenika, posebno na onima koji su zaštićeni od kiše, što je i uobičajeno za ovu vrstu degradacije.

Sl. 8 Primjer crnih inkrustacija na Dvojnim vratima
Fig. 8 An example of black incrustations on the Double Gate.

Black incrustations are omnipresent on all parts of a monument, and especially on those that are protected from rain, which is customary for this kind of degradation.

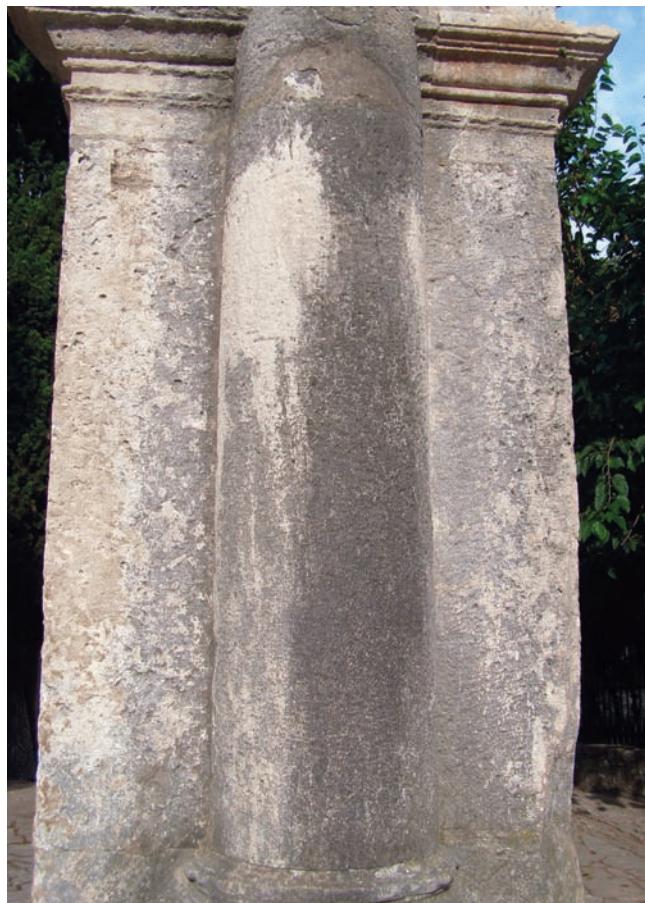
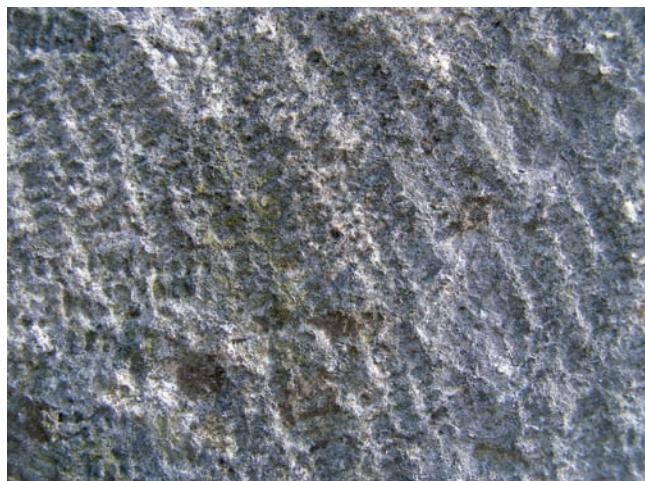
Biological film is represented on large surfaces of the monument. It is a dark grey color caused by colonies of lichen that have died off.

Sl. 7 Primjer biološkog filma i detalj
Fig. 7 An example of biological film and a detail.

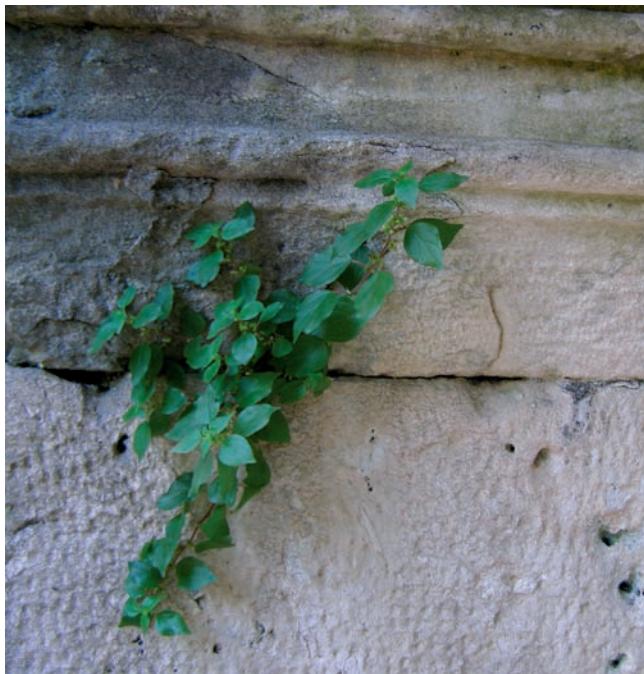
Sl. 9 Primjer tipične vegetacije prisutne na Dvojnim vratima
Fig. 9 An example of typical vegetation present on the Double Gate.

Vegetation is widely spread on the monument. Fortunately, we are talking about smaller plants, but they too have a negative effect on stone. Even though there is no available documentation, the author can confirm the existence of a small fig tree that grew out of a crevice in the posterior section of the central pilaster approximately 3-4 years ago; it was mechanically removed and its remaining roots were chemically treated. Fig tree roots widen in the crevices and they can cause major damage.

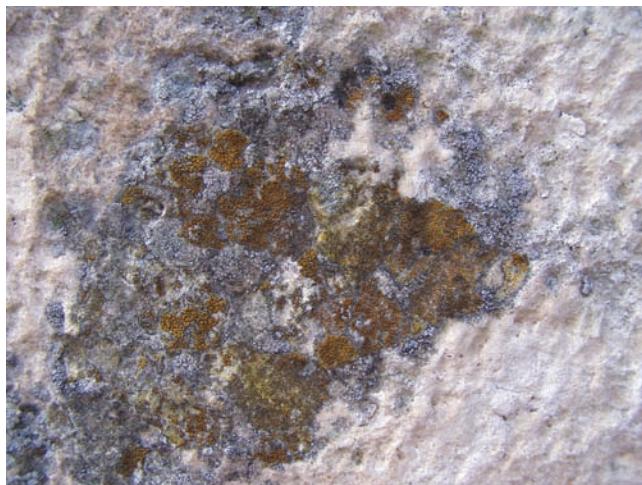
Sl. 10 Primjer lišajeva prisutnih na Dvojnim vratima
Fig. 10 An example of lichens present on the Double Gate.

The active biological patinas present on this monument and on some of its parts cover large surfaces. Although there are also smaller quantities of algae, especially in the lower sections where humidity is constantly present, the active colonies of lichens represent the main problem.

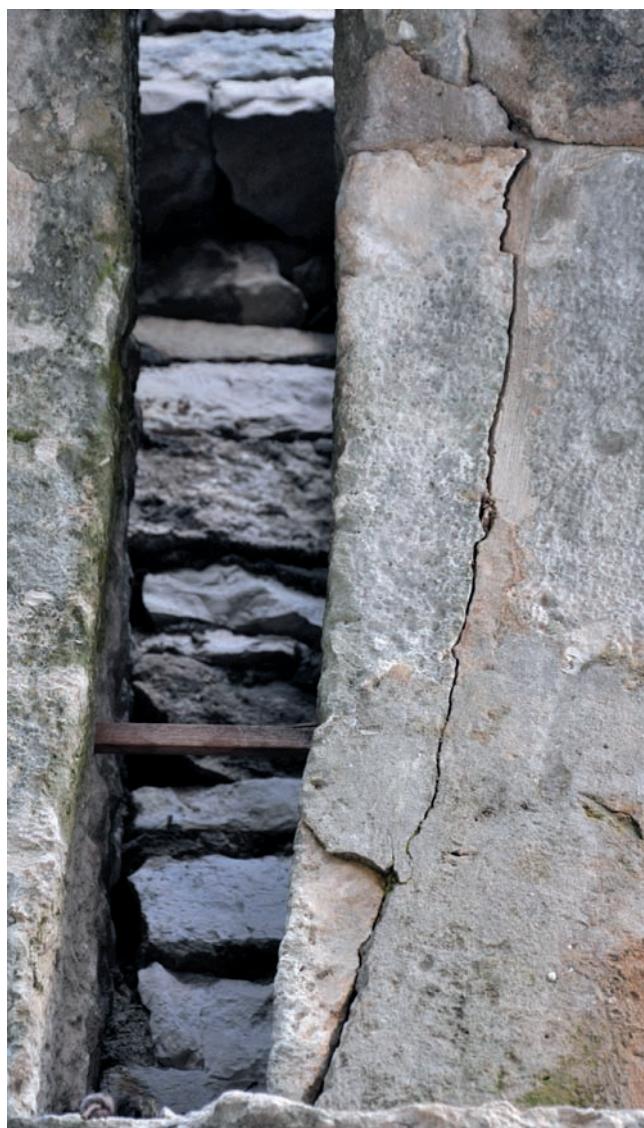
Sl. 13 Primjer pukotine
Fig. 13 An example of a crevice.

Mechanical breakages are often among the degradations found on historical monuments; the Double Gate is no exception because many crevices were recorded there. A visual inspection does not suffice to determine the depth of a crevice, or the danger they pose for the structural stability of the monument. At any rate, crevices represent

a major degradation as they serve as an introduction for major subsequent damages. As was the case with alveolization, they could harbor dust and water which in turn would result in vegetation, or else they could cause the creation of new crevices due to the freezing of water in wintertime.

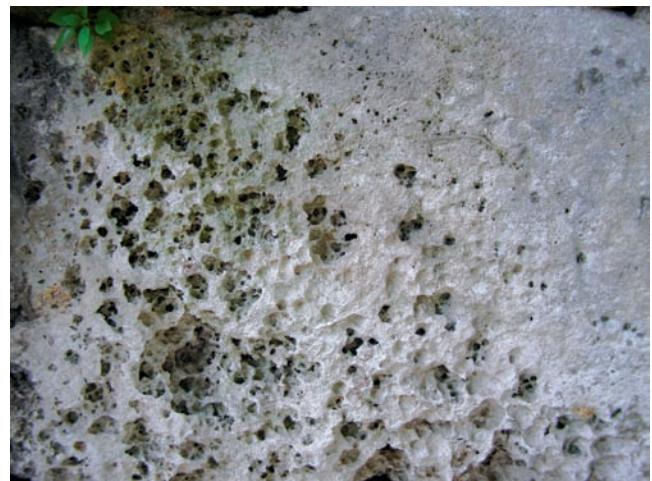
Alveolization has befallen large sections of the monument, and for the most part it has developed even further so that the holes can have a diameter of up to 10 centimeters. Their negative effects for the structure of the monument can be manifold. These holes represent areas for the deposition of earth and water, creating thus ideal conditions for the development of vegetation. And furthermore, water could freeze in them during winter, which would lead to the cracking of stone.

Sl. 11 Primjer alveolizacije, izuzetno raširenog vide degradacije Dvojnih vrata
Fig. 11 An example of alveolization, a very widespread form of degradation on the Double Gate.

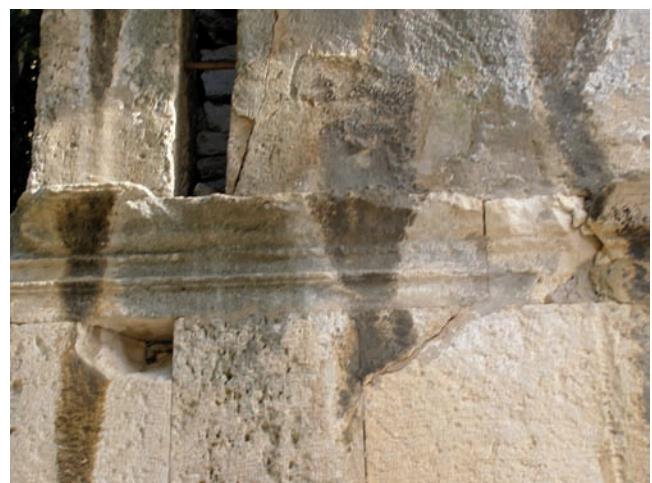
A missing part is one that had been worn out or else it had broken off and is missing. There are quite a few missing parts. As is commonly the case with historical monuments, mostly corners and protuberances in relief are missing; however, on several spots we can observe that the gaps created by the broken off fragments run deep into the structure of the monument.

Sl. 12 Primjer nedostajućih dijelova profilacije i ugaonog dijela kamenog bloka
Fig. 12 An example of missing parts in the form of decorative sections with a steplike profile, and a corner section of a stone block.

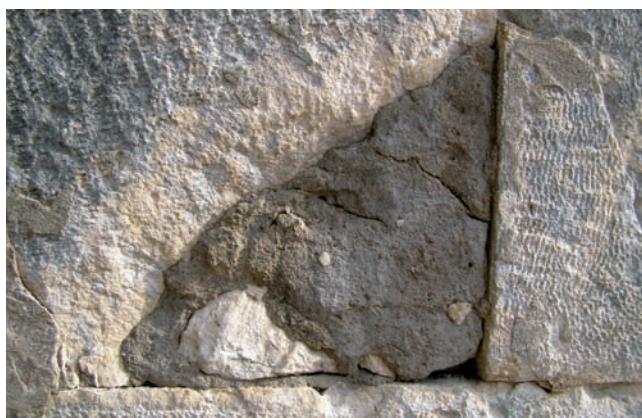
Sl. 14 Primjeri cementnih ispuna na Dvojnim vratima
Fig. 14 Examples of cement fillings on the Double Gate.

In the course of the years, numerous repair works were executed on the Double Gate, and for some of these works a cement mortar was employed. Originally it seemed as if though some of the fillings were done with calcareous mortar that would have been a good choice for use on stone because after it hardens, its technical characteristics are similar to those of stone, and if need arises it is easily removable. However, after a detailed analysis it was established that these are probably cement fillings that have become yellow-orange in color, as a consequence of the coating with tar. The technical characteristics of cement, as regards elasticity and thermal spreading, differ greatly from those of stone. Likewise important, cement adheres exceptionally well to stone. A consequence of this is that after a certain number of years, during which different mechanical shifts of both stone and cement occur, the latter separates itself from the stone surface and falls off, taking with it a superficial layer of stone because of its extraordinary adherence to stone. Even if the cement does not fall off from the stone surface by itself, the problem is that in case of any needed repair works on the monument, it is well-nigh impossible to remove the cement without damaging the surface of the stone. The last but by no means less important problem are the soluble salts (sodium and potassium carbonate) that are present in cement, which over a certain period of time enter into the structure of the stone⁴.

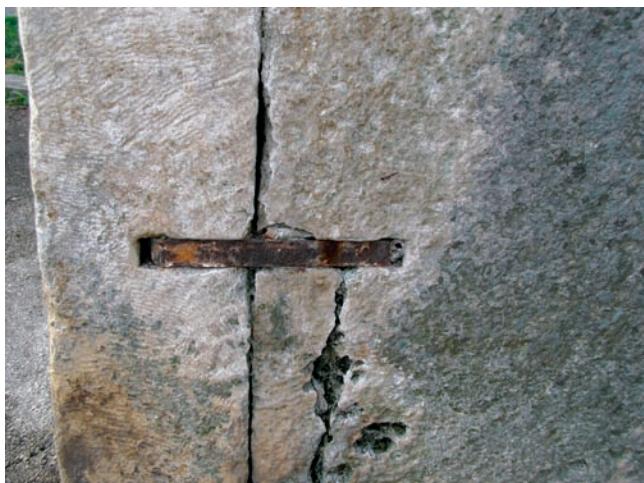
Sl. 16 Primjer (moguće originalne) željezne spojnice
Fig. 16 An example (possibly original) of an iron clamp.

this purpose. If these metal spikes were made of non-corroding materials such as stainless steel, they do not pose any problems. However, if they are made of iron, as is mostly the case, besides the creation of unaesthetic stains of reddish-brown iron oxide, spikes made of this material, under the influence of salt and water, and atmospheric elements, also oxidize and expand, creating thus a lot of pressure that causes the stone to crack.

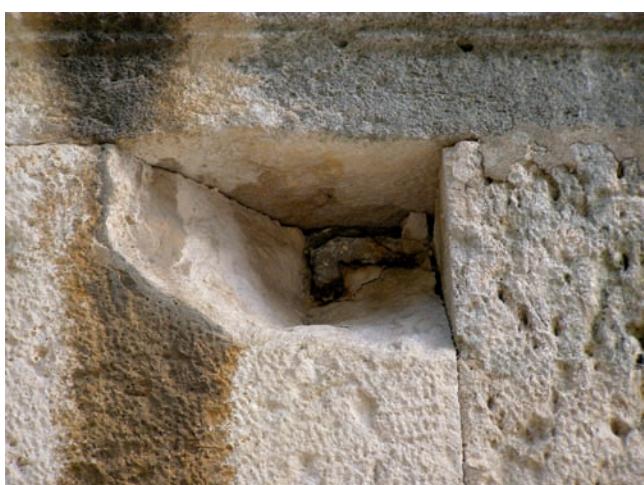
Sl. 17 Primjer željeznog kлина u strukturi spomenika
Fig. 17 An example of an iron spike in the structure of the monument.

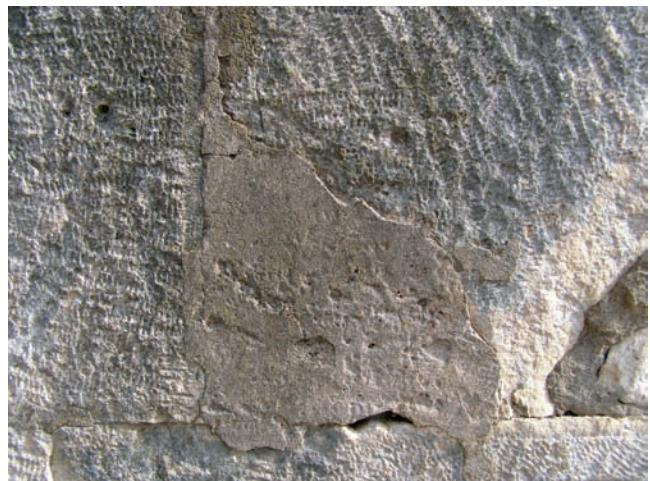
Sl. 15 Primjeri cementnih ispuna na Dvojnim vratima
Fig. 15 Examples of cement fillings on the Double Gate.
