PONOVNA KONZERVATORSKO-RESTAURATORSKA OBRADA PRAPOVIJESNE KACIGE

U članku se opisuje konzervatorsko-restauratorska obrada prapovijesne kacige koja je stigla u Arheološki muzej Zadar kao razmjena s muzejom u Anconi još u vrijeme prije Drugog svjetskog rata. Opisane su sve faze rada s kratkim osvrtom na korozijske promjene koje su se dogodile na kacigu tijekom vremena pohranjivanja. Date su preporuke za njezino čuvanje.

RE-CONSERVATION-RESTORATION TREATMENT OF A PREHISTORIC HELMET

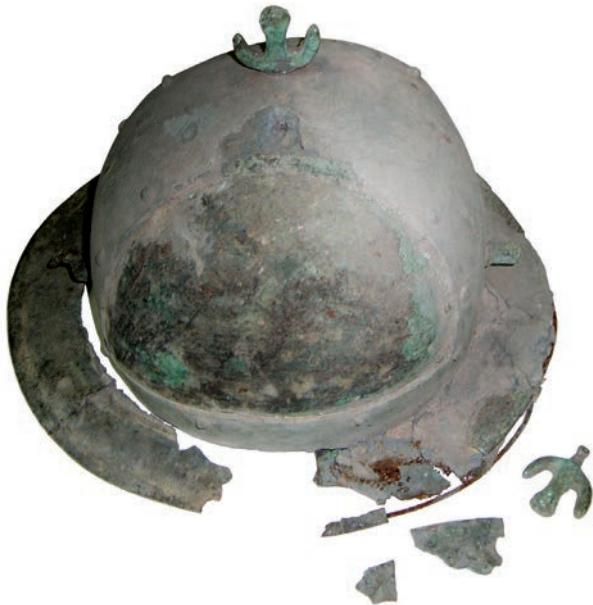
Kaciga je pri dolasku iz Italije bila restaurirana. Poprečne ploče i veći dio oboda je originalan, a ostale ploče su rekonstruirane. Kaciga je na obradu donesena u prilično lošem stanju (Sl. 1). Vidljiva su značajna oštećenja na rekonstruiranim dijelovima, kao i tragovi aktivne kloridne korozije na metalnim dijelovima. Bila je prekrivena debelim slojem prašine. Cijela unutrašnjost kacige bila je obložena čeličnom mrežom, a rub oboda s donje strane pojačan debljom čeličnom žicom koja je bila pričvršćena lemom. Mreža se većim dijelom sjedinila s masom kojom je kaciga rekonstruirana, a dio mreže koji nije bio stopljen s masom je na nekoliko mjesta korodirao. Žica s donje strane

Slika 1. Kaciga prije konzervatorsko-restauratorske obrade

Figure 1. The helmet before conservation and restoration treatment.

The helmet was restored before its arrival from Italy. The transverse plates and larger part of the rim is original, whereas the other panels were reconstructed. The helmet was brought in for restoration in a relatively poor condition (Fig. 1). Significant damage to the reconstructed parts are evident, as well as traces of active chloride corrosion on the metal parts. The helmet was covered with a thick layer of dust. The entire interior section of the helmet was covered with a steel mesh while the rim edge on the bottom side was reinforced with a thick steel wire fastened with a solders. The mesh is largely connected to the main section of which the helmet is reconstructed, and part of a mesh that was not blended with main section has corroded in several places. The wire from the underside of the rim was corroded, cracked and warped. The reconstructed part of the rim was also cracked, with the original section completely separated from the dome. One part is missing.

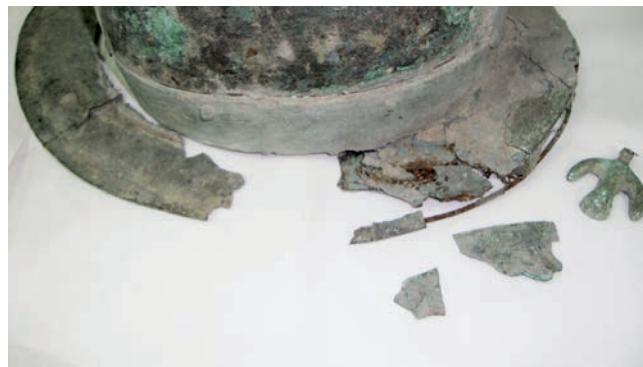
Slika 2. Tragovi aktivne kloridne korozije na kacigi

Figure 2. Traces of active chloride corrosion on the helmet.

Kaciga je aktivno stabilizirana srebrnim oksidom zbog vidljivih znakova aktivne kloridne korozije. Mesta zahvaćena aktivnom kloridnom korozijom su sondirana i u sondirana mjesta je špatulom nanesen srebrni oksid ovlažen etanolom. Kaciga je izložena utjecaju vlage na način da je stavljena u hermetički zatvorenu posudu (eksikator) u kojoj su uvjeti visoke vlažnosti postignuti zasićenom otopinom natrij-tiosulfata-pentahidrata. Nantokit (kupro-klorid) reagira sa srebrnim oksidom i stvara stabilne soli kupro-oksida i srebrni klorid koji nepropusno zatvara od vlage ostale kupro-kloride. Postupak se ponavlja dokle god se na površini uočavaju zelene mrlje.⁷

The helmet was actively stabilized using silver oxide due to the visible signs of active chloride corrosion. Places affected by active chloride corrosion were probed and the probed places had silver oxide moistened with ethanol applied to them with a spatula. The helmet was exposed to moisture by placing it in an airtight container (desiccator) in which high humidity conditions were attained using a saturated solution of sodium thiosulfate pentahydrate. Nantokite (cuprous chloride) reacted with the silver oxide and formed a stable salt containing cuprous oxide and silver chloride, sealing against the moisture content of other cuprous chloride. The procedure was repeated until green spots were observed on the surface.⁷

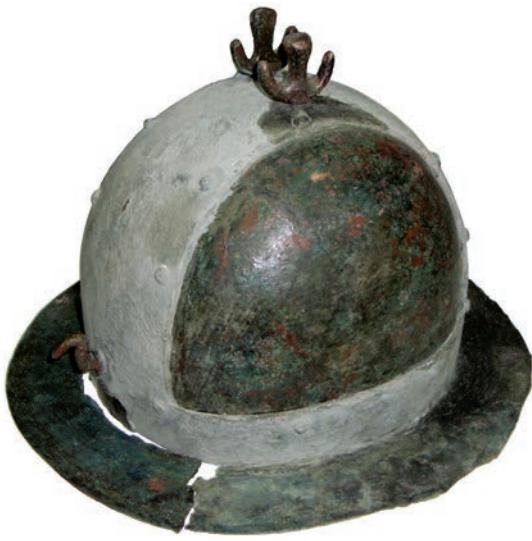
Slika 3. Kaciga u postupku lijepljenja i rekonstrukcije

Figure 3. The helmet in the sealing and reconstruction process.

Smaller fragments from the helmet rim were glued using a cyanoacrylate instant adhesive, where the heavier cast bronze element was attached to the top of the helmet with a two-component epoxy adhesive. The missing parts were reconstructed using a two-component epoxy resin Araldite 427 and green pigment was added (Fig 3). After drying, the surface was grinded into the appropriate shape. Earlier reconstructed parts were coated using an acrylic paint with the addition of a copper pigment for consolidating the area. The metal helmet parts were polished with brushes made of synthetic materials.

epoksidnim ljepljivom. Nedostajući dijelovi su rekonstruirani dvokomponentnom epoksidnom smolom Araldit 427 uz dodatak zelenog pigmenta (Sl. 3). Nakon sušenja površina je oblikovana brušenjem. Ranije rekonstruirani dijelovi su premazani akrilnom bojom uz dodatak bakrenog pigmenta radi konsolidacije površine. Metalni dijelovi kacige su polirani četkicama od umjetnih materijala.

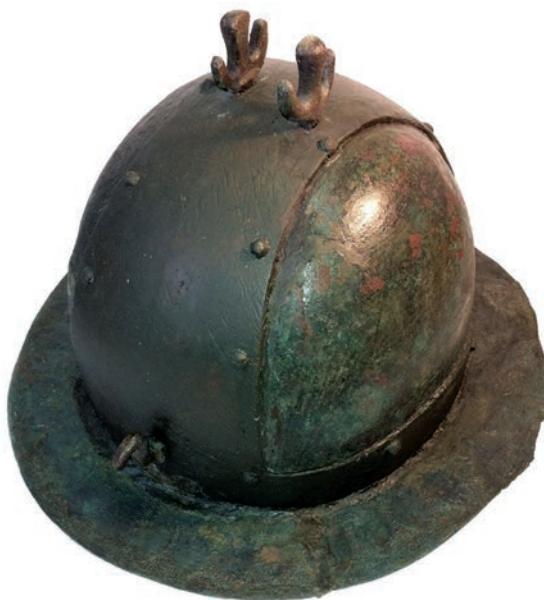
Slika 4. Kaciga nakon konzervatorsko-restauratorskog zahvata

Figure 4. The helmet after conservation and restoration work.

The helmet was impregnated with a 2% solution of Paraloid 72B in ethyl acetate. Paraloid 72B is a thermoplastic acrylic

Kaciga je impregnirana 2%-tom otopinom Paraloida 72B u etil-acetatu. Paraloid 72B je termoplastičana akrilna smola koja se široko upotrebljava u restauratorskoj struci za premazivanje, učvršćivanje i kao ljepljivo. Kod pripreme otopine važno je pripremiti otopinu odgovarajuće koncentracije, jer se u radu s visokim koncentracijama površina metala može zasjajiti. Takav sjajan izgled metala nije nam poželjan.
