CRACKS IN A ROLLER-BEARING

Bearings are among the most important components of electromotors, pumps, compressors and other processing equipment. After 30 years of work some non-destructive and metallographic examinations were carried out on a single-row cylindrical roller-bearing. A non-destructive liquid-penetrant testing revealed crack indications on an inner ring groove. When a sample of the roller-bearing outer ring was cut out for metallographic examination, new cracks were discovered that were not detected by the non-destructive testing. However, with the examination of the non-failed bearing it is possible to obtain useful information that can help us to decide how much of the remaining population of bearings with the same geometry and loading should be examined.

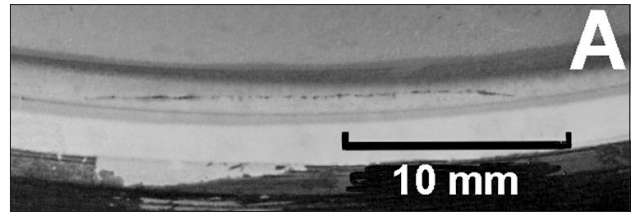
Figure 2. Indications of an inner-ring crack no. 1

All the surfaces of the inner and outer rings were examined with a red-dye liquid penetrant. On the outer ring no indications of defects were found. Three linear indications of cracks were found in the groove between the side rib and the raceway (location C in Figure 6). Figure 2 shows indication no. 1 with length of 22 mm. The lengths of indications no. 2 and no. 3 were of 25 mm and 60 mm, respectively.

On the side faces of all the cylindrical rollers traces of spalling were detected. This is due to a lack of lubricant between the side face of the roller and the ribs of the inner and outer rings or retainer. The spalling shown in Figure 1b is minimal and in its initial stage. The contrast of the indications in Figure 2 is very poor because:

- of the very narrow crack opening, which is on the very limit of detection for the liquid-penetrant system applied,
- the lubricant penetrated into the crack during roller-bearing operation and was impossible to remove it with the applied cleaning and degreasing procedure.

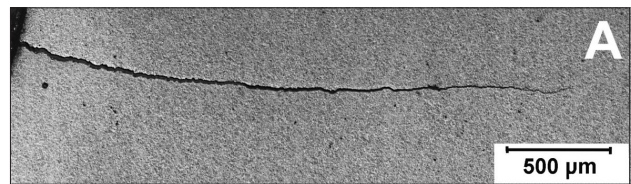
Figure 3. Crack no. 1

On the inner ring cross-section samples were cut out on the crack indications no. 1 and no. 2. Figure 3 shows cross-section of the crack indicated in Figure 2.

The depth of crack no. 1 is approximately 3 mm. Also, a sample cross-section was cut out at random from the outer ring. Rather unexpectedly, crack no. 4 (spot A in Figure 6) was discovered. The crack opening in Figure 4 is so narrow that the applied liquid-penetrant technique was not sufficiently sensitive to detect the crack.

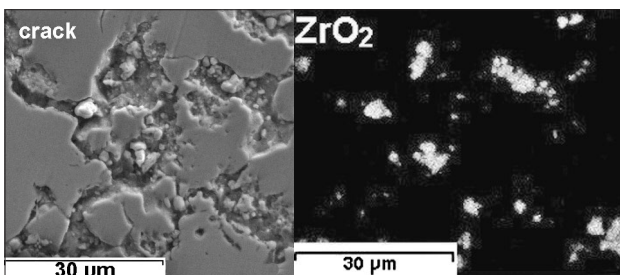
Figure 8. Crack no. 4 with the distribution of the ZrO_2

An EDS analysis on crack no. 4 was carried out, and the presence of zirconium oxide (ZrO_2) was detected. Figure 8 shows a picture of the crack with the distribution of ZrO_2 .

Crack no. 4 was probably formed at the outer ring forging due to the crashing of hard non-metallic inclusions [5]. It appears that the crack itself did not propagate during the operation of the roller-bearing. The zirconium oxide inclusion probably originates from the steel casting process as a fragment of the pouring ladle, for which ZrO_2 is often used. In the other cracks there were no deposits found (scale, sulphide, oxide); only in the area near the crack opening were the remains of a lubricant detected.
