CRACKING OF AN AIRCRAFT WHEEL RIM MADE FROM AL-ALLOY 2014-T6

Received – Prispjelo: 2009-11-06
Accepted – Prihvaćeno: 2009-12-20
Professional Paper – Strukovni rad

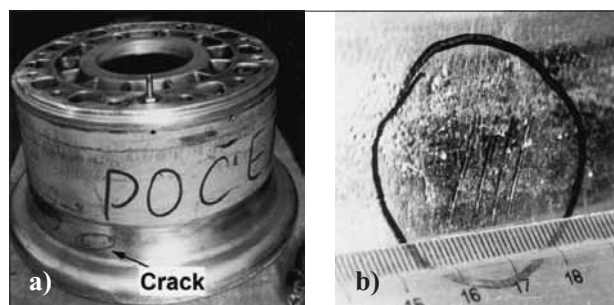
The crack (Figure 1) was revealed in a regular check up by the method of eddy currents. The crack was approximately 38 mm long and had propagated through the rim wall. Small pits over the entire rim/tire contact surface were revealed. A small number of corrosion pits were also observed by the naked eye. In the manufacture of tires a strong textile fabric net is incorporated. In worn-out tires the net is in direct contact with the rim surface. Therefore, high pressures result in pits on the rim surface.

Figure 1 An investigated aircraft wheel with a crack (a), and the detail of crack in the rim (b).
