ANALYSIS OF LACK OF FUSION IN WELDS AT WATER HEATERS

The paper treats a weld discontinuity called lack of fusion, which is frequently a cause of leakage of a water heater. The heater was produced by MAG welding using two wires (twin arc welding). The paper states some reasons for the occurrence of lack of fusion, i.e. the arc blow effect, an inappropriate gun position, uncontrolled movement of the weld pool, too low energy input, an improper joint preparation. The defect is illustrated in a macrograph of a weld produced at the water heater with twin wires in a shielding gas. Welding with twin wires is schematically represented with a circumferential welded joint between the end and shell of the water heater.

J. Tušek, Faculty of Mechanical Engineering University of Ljubljana, Ljubljana, Slovenia, B. Bajcer, Gorenje Tiki d.o.o., Ljubljana, Slovenia, B. Taljat, M. Hrženjak, TKC d.o.o., Ljubljana, Slovenia

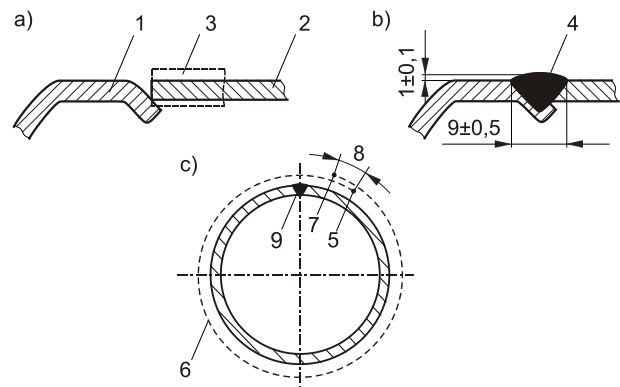
Figure 3.a shows a joint assembly between the end and the shell where 1 is the end, 2 the shell, and 3 is the longitudinal weld at the shell. It is this longitudinal weld that represents a disturbance when the circumferential weld is being made. At the moment the circumferential weld is crossing the longitudinal weld at the shell, a disturbance

will occur, which results in incomplete root fusion. This phenomenon can be explained by several physical principles such as welding-arc deflection, stronger removal of heat due to a higher mass, impurities, oxides present at the spot, and insufficient energy input at the welding area.

Figure 3. Schematic representation of making circumferential weld: a) joint assembly between end and shell, b) cross section of circumferential weld between end and shell, c) schematic representation of circumferential welding, 1 - end, 2 - shell, 3 - longitudinal weld at shell, 4 - circumferential weld, 5 - beginning of welding circumferential weld, 6 - circumferential welding, 7 - end of welding circumferential weld, 8 - size of overlapping of circumferential weld, 9 - location of longitudinal weld at shell

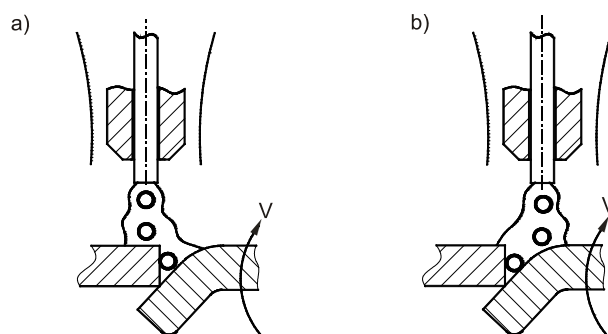
In Figure 5. two different types of imperfection, which very often appear during shielding gas welding of the

Figure 5. Two cases of an improper gun position by MAG welding with two wires by making of the circumferential weld between end and shell of the water heater

water heater, are shown. In both cases the position of the gun is not correct and the arc does not burn in the welding groove. Consequently, the molten droplets detaching from the wire remain cold and unmelted. The weld root will not melt. The molten drops fall into the groove but they do not mix with the parent metal. Consequently, lack of fusion occurs.

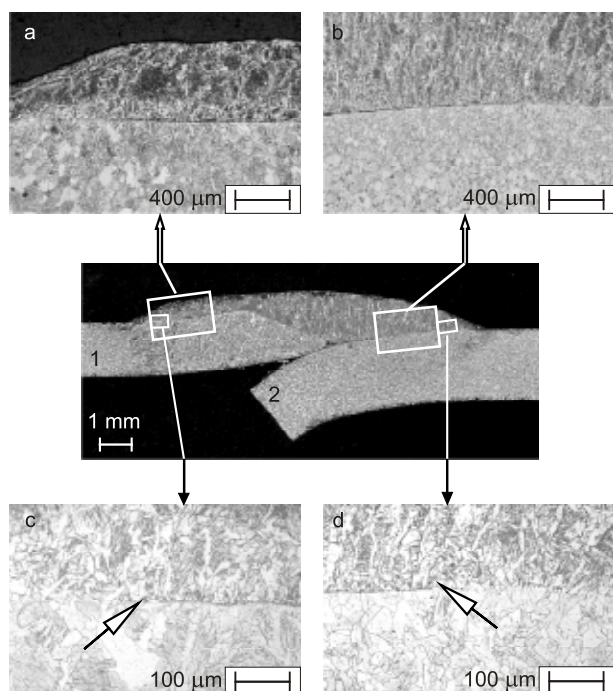
Figure 8. shows a macrosection of the welded joint between the end (2) and shell (1) of the water heater. The

weld shape is very nice and without imperfections. This is a cross section at the very intersection of the longitudinal weld of the shell and the circumferential weld between the shell and the end of the water heater (Figure 3.). The external appearance of the weld is nice and shows no undercuts or any other imperfections.

Figure 8. Macrosection of welded joint between the end (2) and shell (1) of the water heater; a), b) part of the welded joint with lack of fusion (50 ×); c), d) part of the welded joint with beginning of the lack of fusion (200 ×); $I_1 = 244 \text{ A}$, $I_2 = 224 \text{ A}$, $U = 31 \text{ V}$, $b = 11,5 \text{ mm}$, $L = 20,5 \text{ mm}$, $v = 2,1 \text{ m/min}$

The weld was produced with two wire electrodes in the shielding gas mixture (82 % CO_2 + 18 % Ar). The wires were positioned one after another in the welding direction (Figure 7.). The distance between the two wires was equal to 11,5 mm and the wire extension length to 20,5 mm. Welding speed was 2,1 m/min. During welding the wires had different feed speeds. The current at the first wire amounted to 244 A and at the second to 224 A. The arc voltage was 30,5 V, which was too high.

An accurate analysis of the macro specimen, however, showed that there was lack of fusion in the weld since the dilution between the parent metal and the filler material was not sufficient due to insufficient heating of the parent metal. At several locations in the weld lack of fusion defects can be noticed. Figure “a” shows a lack of fusion defect on the left side of the macro specimen magnified 50

times. With the same magnification a lack of fusion defect is shown in Figure “b”. This one is even more distinct than that in Figure “a”. The end of the water heater was made of a thicker plate than the shell; therefore, the removal of heat was stronger and the energy available for heating and fusion of the parent metal was lacking. With Figures “c” and “d” a magnification of 200 times was used. The arrows in the two figures show the beginning of the lack-of-fusion defects. In Figure “c” the weld on the left to the arrow is sound. There are coalesced grains between the parent metal and the filler material. To the right of the arrow there is the boundary between the grains of the parent metal and those of the filler material. Almost the same is true of Figure “d”. To the left of the arrow there is a lack-of-fusion defect and to the right of it the weld is sound.

There seem to be two causes of lack of fusion, the first being an improper positions of the burner and the second an arc voltage too high, i.e., an arc too long. To our mind the long arcs in welding with the two wires are the reason for the occurrence of lack of fusion. This statement can be substantiated by the high arc voltage and a very wide weld face. This indicates that the arc energy of the two arcs is distributed over a large area, the energy density is small, and the energy supplied is not sufficient to melt the parent metal.

To improve the weld quality the arc length and, consequently, the arc voltage should be reduced and welding parameters should be recorded and stored [2].
