Static and dynamic analysis of the old stone bridge in Mostar

Professional paper

1. Introduction

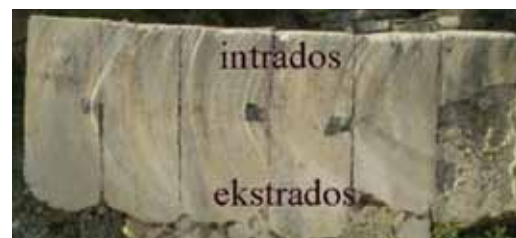
At the original bridge, the arch thickening at the spring was realized using a hard crushed limestone bound with a special mortar (mixture of quicklime, terra rossa, sand, gravel, and water). At that, some blocks situated in between external frontal walls were more than 0.8 m in thickness, and were rounded or slit at the top, with very rough extrados surface (Figure 4). In case of the renovated bridge, a lower strength mortar was used for arch thickening at the spring level, and stone blocks are of similar thickness (0.8 m), with a relatively flat extrados surface. Thus the initial shear bearing capacity, at the connection between the arch extrados and arch thickening at spring, was reduced, i.e. the resistance of the composite structure was reduced.

Figure 4. A remaining part of the original bridge's stone arch at spring, with a thickening above extrados

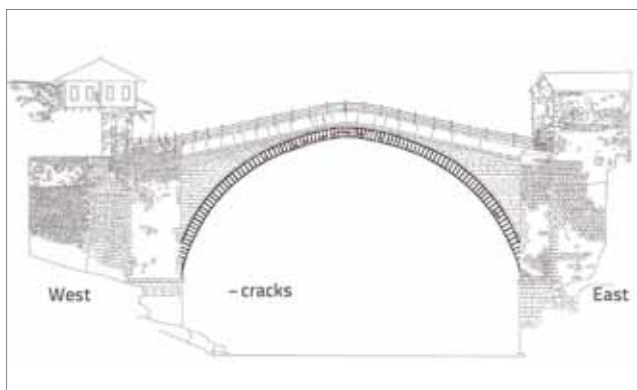
Figure 5. Cracks at the south face of the Old Bridge prior to collapse [3]

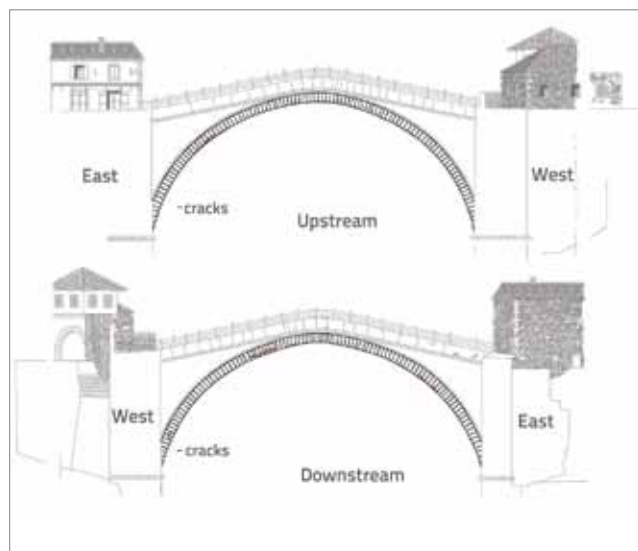
The cracking was first noted on the renovated Old Bridge in 2007 [8]. The cracking registered at arch faces is shown in Figure 7. The greatest crack width amounted to 8 mm. In addition, a smaller number of cracks were registered at the arch intrados next to the left-side (east) bank of the river. Cracks revealed at the arch intrados in 2010 are shown in Figure 8 [9]. Besides cracks in stone blocks, the transverse horizontal detachment of blocks, perpendicular to the bridge plane, was also registered. It was noticed during bridge inspection conducted in November 2011 that crack zones previously registered on arch face [8] have extended along the length of the arch. The disposition of cracks is shown in Figure 9. The greatest crack width amounted to about 10 mm. Cracks were also registered at the arch intrados, as presented in paper [9], and as shown in Figure 8. No cracking or damage was registered at other parts of the superstructure.

Figure 7. Cracks at arch faces of the renovated bridge, registered in 2007 [8]

It can be seen that cracks at arch faces are almost parallel to the arch axis, and that they are close to the arch intrados. The cracking depth in the transverse direction of the arch is not known. It is assumed that cracks locally reach deep into the interior of external stone blocks, and that some have probably spread along the entire width of such blocks. It can also be noted that the cracking zone on the south face of the arch is greater than the one at the north face.

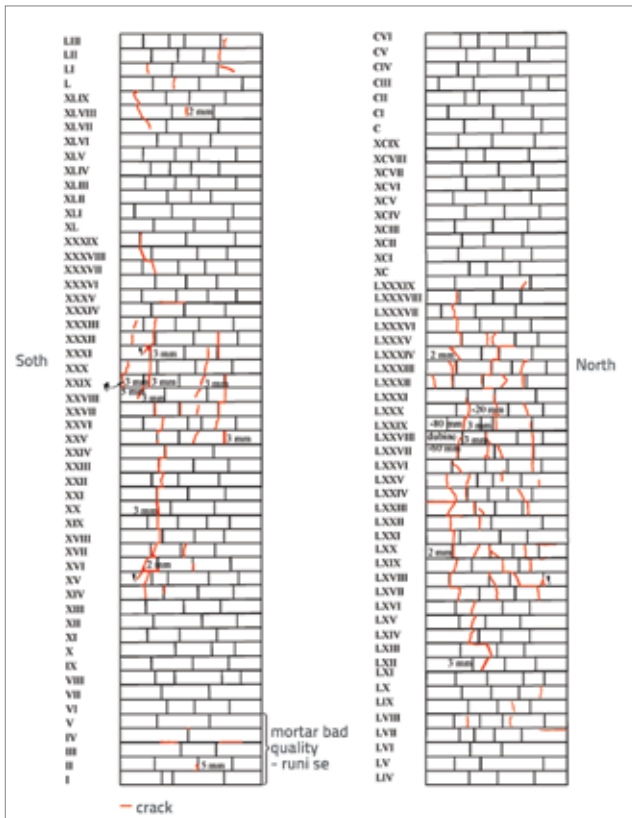
Figure 8. Cracking at the intrados of the renovated arch, registered in 2010 [9]

The cracks at arch intrados are also oriented in the direction of the arch axis, and are disposed in several vertical planes along the bridge width. It can be seen that the greatest intrados damage is concentrated at the south face of the arch. Here also, it is not known what is the depth attained by the cracks. It is however assumed that they locally extend over the entire arch thickness. The above mentioned cracks in stone arch are due to the fact that tensile strengths (limit tensile deformations) of stone blocks in the direction perpendicular to the plane of these cracks have been exceeded. Tensile stresses (deformations) perpendicular to arch axis in two planes perpendicular to one another, i.e. these cracks, result from compressive stresses (deformations) in the direction of the arch axis.

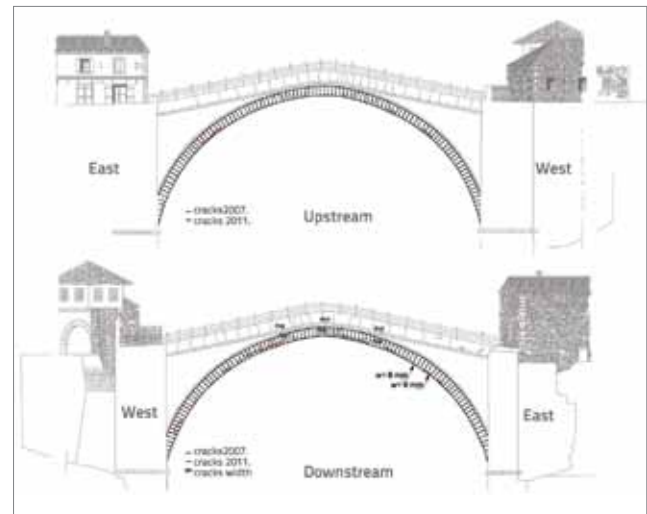
vertical loads, by temperature changes. The possibility that the extent of damage has been influenced by weak earthquakes that occurred after renovation has been ruled out, as additionally confirmed in the paper [8]. Small tensile strength of tenelija stone, out of which both the original arch and the renovated arch were built, is the main cause of cracking.

Figure 9. Cracks registered in 2011 at the faces of the renovated arch

Therefore, the cracking in both the original arch and the renovated arch was most probably caused the same load actions, probably of similar intensity. Greater damage to the renovated arch, when compared to the original one, is probably due to one or several of the following influences:

The extent of arch damage at the renovated bridge is such that its original mechanical resistance and safety have been reduced. It is probable that the situation will continue to deteriorate over time. Already at this time, there is a real danger that the pieces of damaged stone blocks might fall out. The repair of arch damage is urgently needed, which should include preparation of the study that is to propose appropriate solutions for the avoidance or reduction of further arch damage, and define the need for its durable successive repairs, in the ways similar to the original arch.
