THE "VRLA" HE PLANT ENTRY STRUCTURE CONCRETE RESTORATION

Professional paper

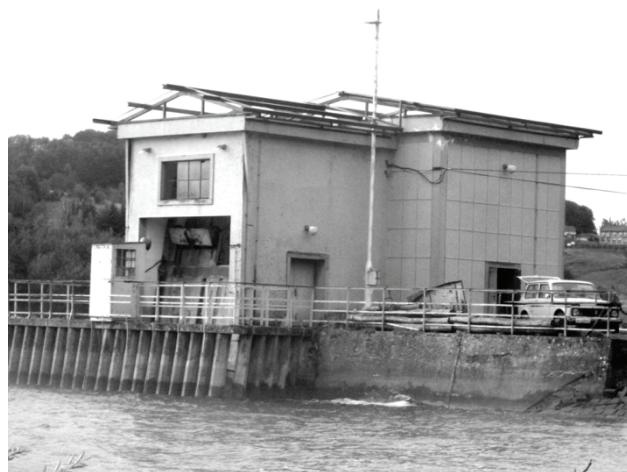
Figure 1 Appearance of the entry structure of "Vrla" HE

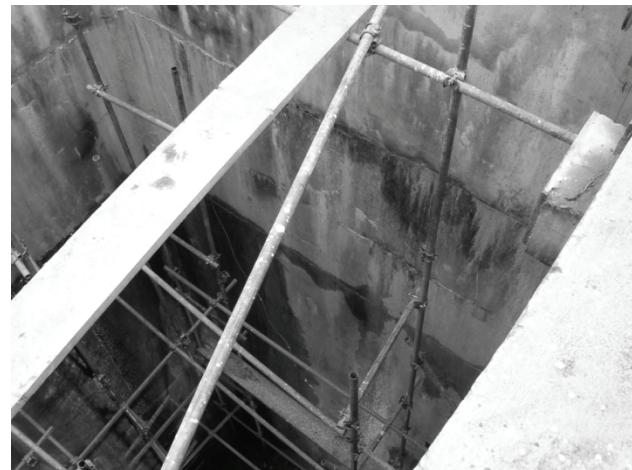
Figure 2 Concrete shaft within the structure

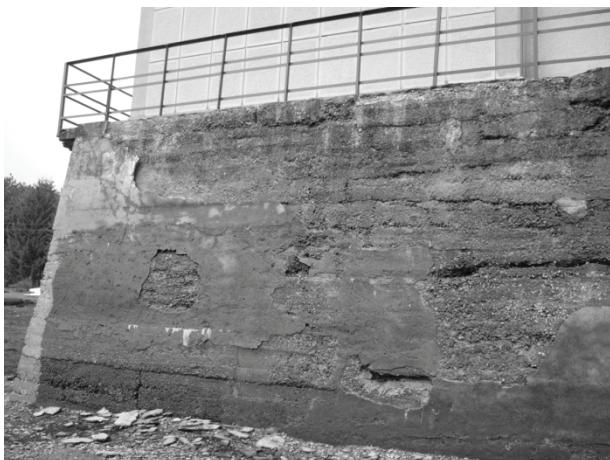
The exterior surface of concrete is exposed to direct action of lake water whose level varies throughout the year. Winter season on Vlasina is very long and cold, so the effects of alternate freezing and thawing are evident on concrete.

In Fig. 3, there is the appearance of the external surface of concrete at the moment when the level of water in the lake was lowered so that the restoration could be performed.

Figure 3 Appearance of concrete on the exterior of the shaft

Restoration of the external surface of concrete was performed by the multi-layered protection system, consisting of: primary layer – cement restoration mortar, with added latex and polypropylene fibres, then coating of three-component epoxy cement mortar and finally waterproofing coating intended for the potable water reservoirs.

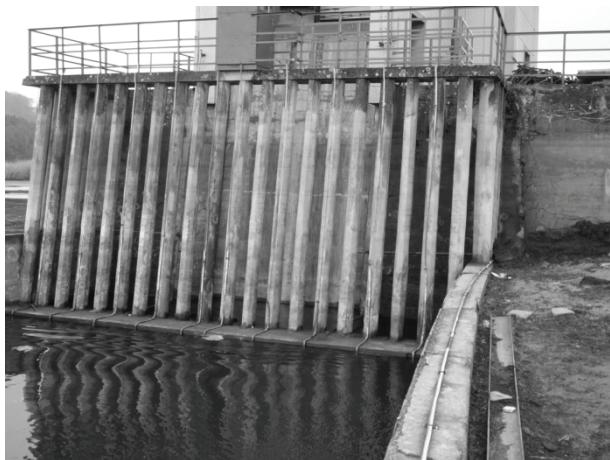
Figure 4 Appearance of protective grille

In Fig. 4 there is a protective concrete grille preventing passage of large objects (tree trunks, limbs and branches, etc.) into the lake water intake pipe. The damage due to the frost action is also visible on these slender concrete elements.

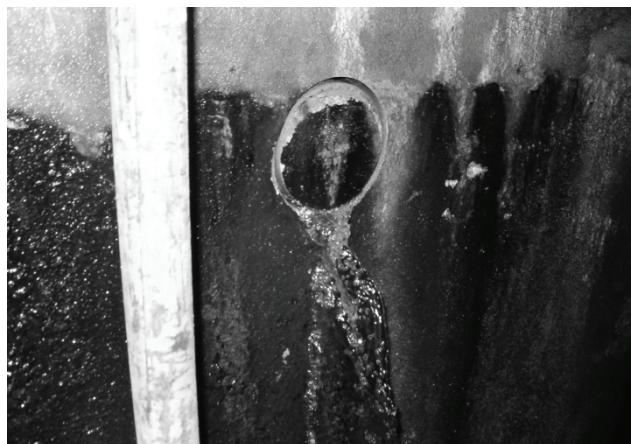
On the basis of the explicit request of the examination commissioner, a sample of one cylinder was taken precisely on one of the concreting joint locations, Fig. 5. Those locations are always critical for the concrete exposed to the action of water under pressure. It is known that due to the difference in shrinking of old and new concrete at their joint, even if the difference is only one day, there occurs a crack through which water may penetrate. After extraction of the drill from the concrete, a considerable amount of water started to penetrate inside, so after extraction of the sample cylinder, the measures to seal the cavity in concrete with adequate means were taken.

Figure 5 Water penetration at the concreting joint

On the basis of the extent of determined damage, its cause, physical and mechanical characteristics of concrete, materials for restoration of the facility were selected [21]. For grouting of horizontal cracks at the locations of concreting joints on the internal surfaces of the walls, a two-component injection plastic material based on epoxy resin was used. The epoxy was injected under pressure through the tubes which were previously inserted in concrete from which all the loose parts were removed.

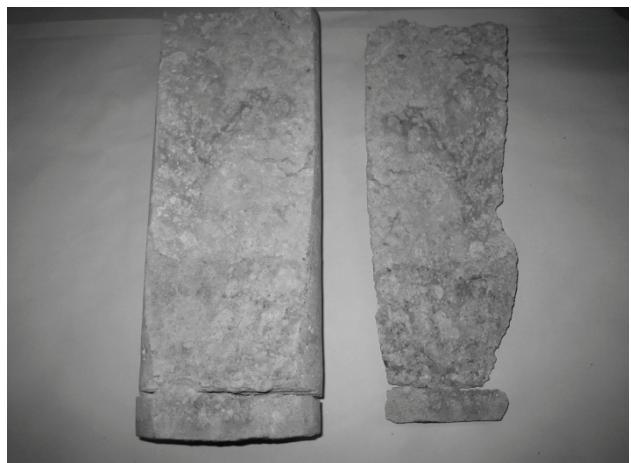
In Fig. 6 the appearance of the cylinder sample taken from this location is presented. As it can be seen, it is virtually separated along its height by the salt deposits, primarily carbonation products.

Figure 6 Appearance of the cylinder sample taken at the location of concreting joint

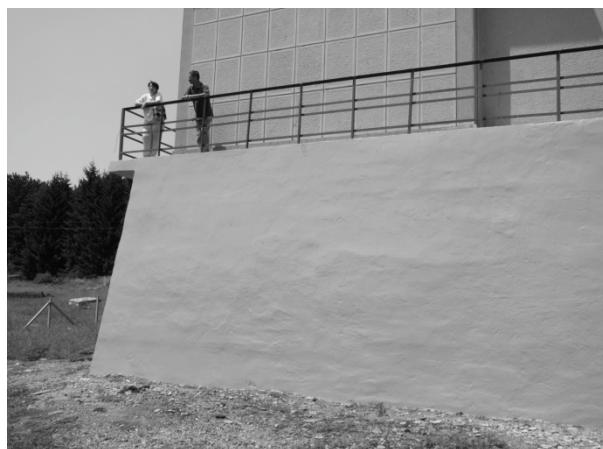
Figure 7 Appearance of the exterior concrete surface after restoration

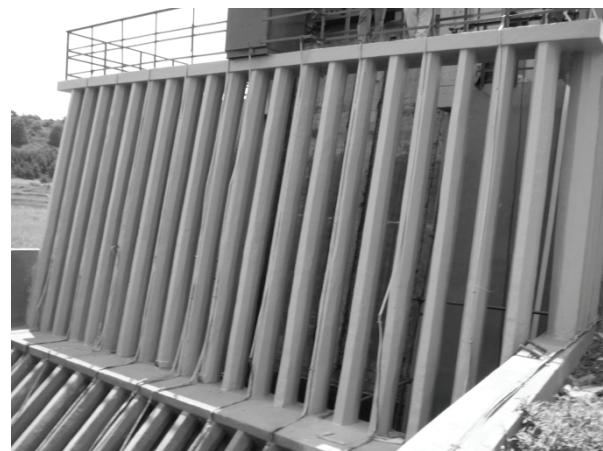
Figure 8 Appearance of protective grille after restoration
