HERKULOVA VRATA U PULI KONZERVATORSKO-RESTAURATORSKI OSVRT HERCULES' GATE AT PULA A CONSERVATION-RESTORATION REVIEW

UDC 725.941.025.3/.4(497.5 Pula)
Professional paper
Received: July 2, 2012
Approved: September 3, 2012

KEY WORDS: Hercules' Gate, degradations, graphical documentation, restoration-conservation proposals

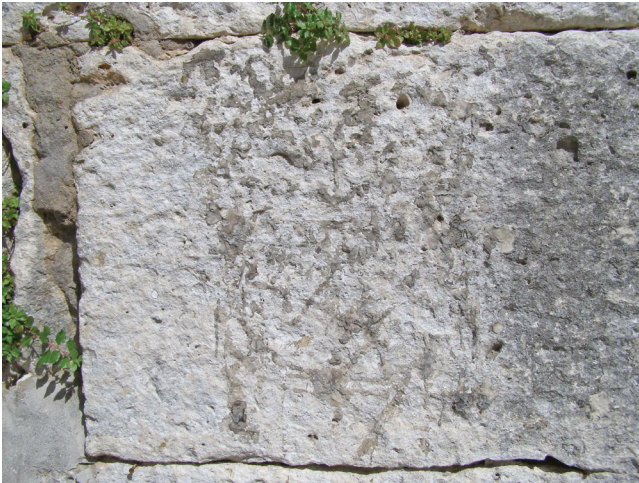
The stains found on Hercules' Gate were in the great majority of cases caused by human activities. At one such spot we have the remains of a color that was probably used to paint a nearby wall. On several other spots there are remnants of a silicone sealant that leaves stains on stone, and there are also remains of a plastic substance, presumably epoxy glue, which likewise stains stone. It is assumed that both the sealant and the glue were used to fasten a sign or inscription on the stone blocks of the monument. The selection of these means of fastening is not such a bad one, as it does not entail the drilling of the stone blocks in order to affix the signs; however, it would be desirable to give the stone surface a protective coating before the use of such substances, and to clean these surfaces once the signs are removed.

Sl. 7 Primjer mrlja
Fig. 7 An example of stains.

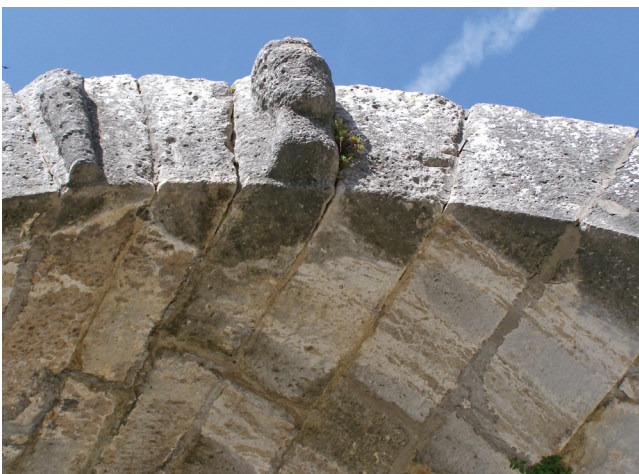
Generally speaking, black incrustations represent one of the most widely spread types of degradation on stone monuments located out in the open. However, black incrustations on Hercules' Gate managed to spread in a very limited area and are only present in thin layers on the inner edge of the arch roof.

Sl. 8 Crne inkrustacije ispod reljefa glave Herkula
Fig. 8 Black incrustations underneath Hercules' head in relief.

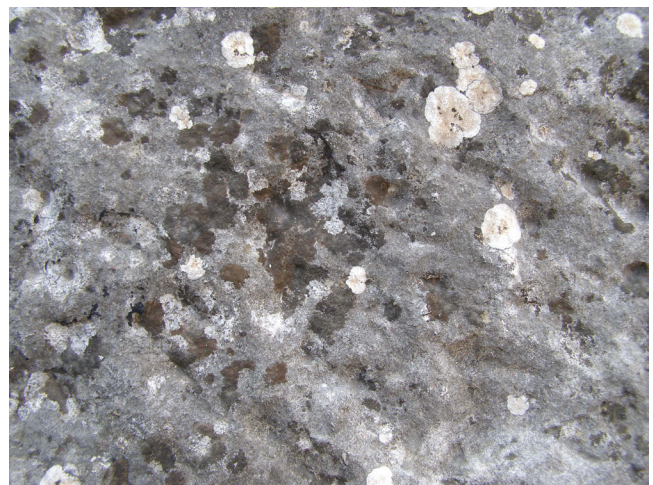
Active biological patinas on Hercules' Gate are present mainly on its high sections where they cover broad surfaces of the monument. If we compare Hercules' Gate with the Double Gate or the Amphitheater, it is interesting to note the different colors, i.e., types of lichens present. Whereas on the Double Gate and Amphitheater we encounter mainly yellow-brown lichens, on Hercules' Gate it is possible to discern at least three different colors that stand presumably for three different kinds of lichens: white, yellow-brown and black.

Sl. 9 Fotografija detalja lišajeva prisutnih s gornje strane luka
Fig. 9 A detail showing lichens present on the upper side of the arch.

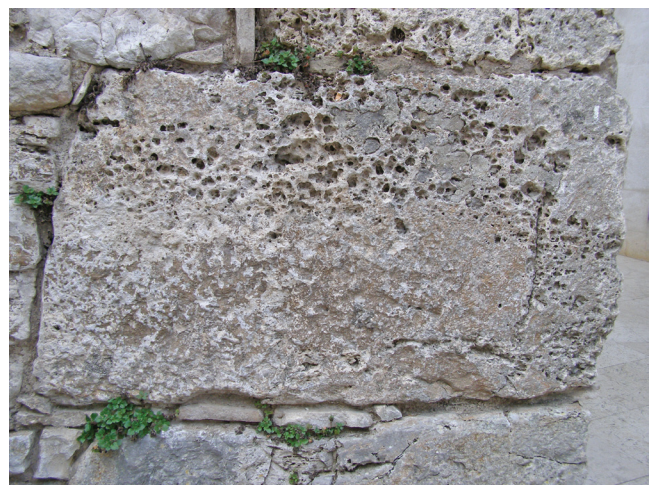
On Hercules' Gate, alveolization covers almost the entire surface of the façade. The most conspicuous aspect of alveolization is marked on the degradation tables, where alveoli are extremely dense and/or large and deep. This aspect of degradation is present on the majority of Pula's monuments on a large scale. Moreover,

There can be multiple negative effects that alveolization can cause on the structure of a monument. The small cavities (alveoli) represent spaces where earth and water can accumulate, facilitating thus the creation of vegetation. Likewise, in winter the water in them can freeze, causing the stone to burst.

Sl. 10 Kameni blok zahvaćen alveolizacijom
Fig. 10 A block of stone beset with alveolization.

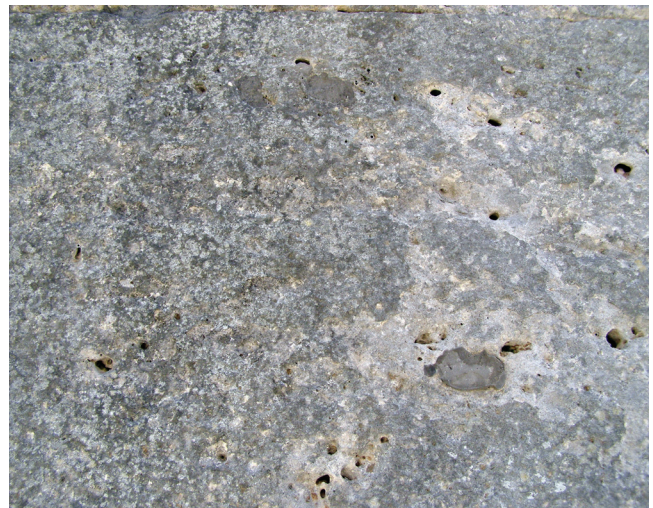
In the course of the years, numerous repair works were executed on Hercules' Gate, and for some of these works a cement mortar was employed. Cement was used for three main kinds of repair work: as fill for the large cavities created as a result of alveolization, to grout the joints of the stone blocks on the arch, which was probably done in order to strengthen it and to prevent the penetration of water, its flow through the blocks and creation of calcite crusts, as well as to coat a whole block of stone that was probably beset with a large number of crevices and threatened with flaking. The technical characteristics of cement, as regards elasticity and thermal spreading, differ greatly from those of stone. Furthermore, cement adheres exceptionally well to stone. A consequence of this is that after a certain number of years, during which different mechanical shifts of both stone and cement occur, the latter separates itself from the stone surface and falls off, taking with it a superficial layer of stone because of its extraordinary adherence to it. Even if the cement does not fall off from the stone surface by itself, the problem is that in case of any needed repair works on a monument, it is well-nigh impossible to remove it without damaging the stone surface. The last but by no means less important problem is the presence of soluble salts in cement, which with time enter into the structure of the stone (Malinar, 1996, pp. 37-40).

Sl. 11 Primjer velikih alveola zapunjenih cementnim mortom
Fig. 11 An example of large alveoli filled with cement mortar.

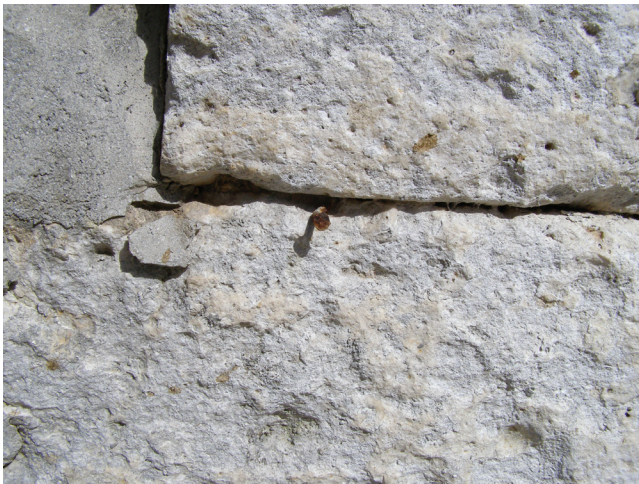
Sl. 12 Primjer željeznog čavla između dva kamena bloka
Fig. 12 An example of an iron nail between two blocks of stone.

An inspection of Hercules' Gate revealed no metal parts on this monument, which does not mean that they don't exist in the interior of the monument itself. The metal elements shown on the degradation charts represent mostly iron nails that were (except in one instance) driven into the joints between the blocks of stone.

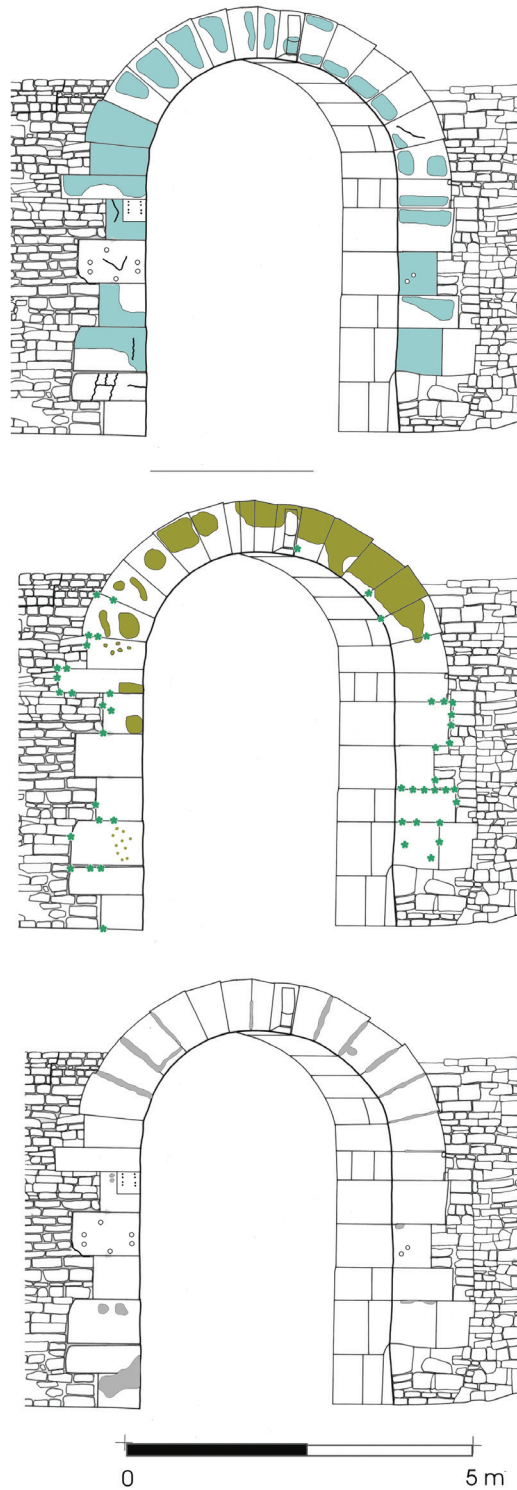
Tabla 1 Pogledi na pročelje Herkulovih vrata - alveolizacija, biološki film i vegetacija, cementne ispune
Table 1 Views of the façade of Hercules' Gate - alveolization, biological film and vegetation, cement fillings.

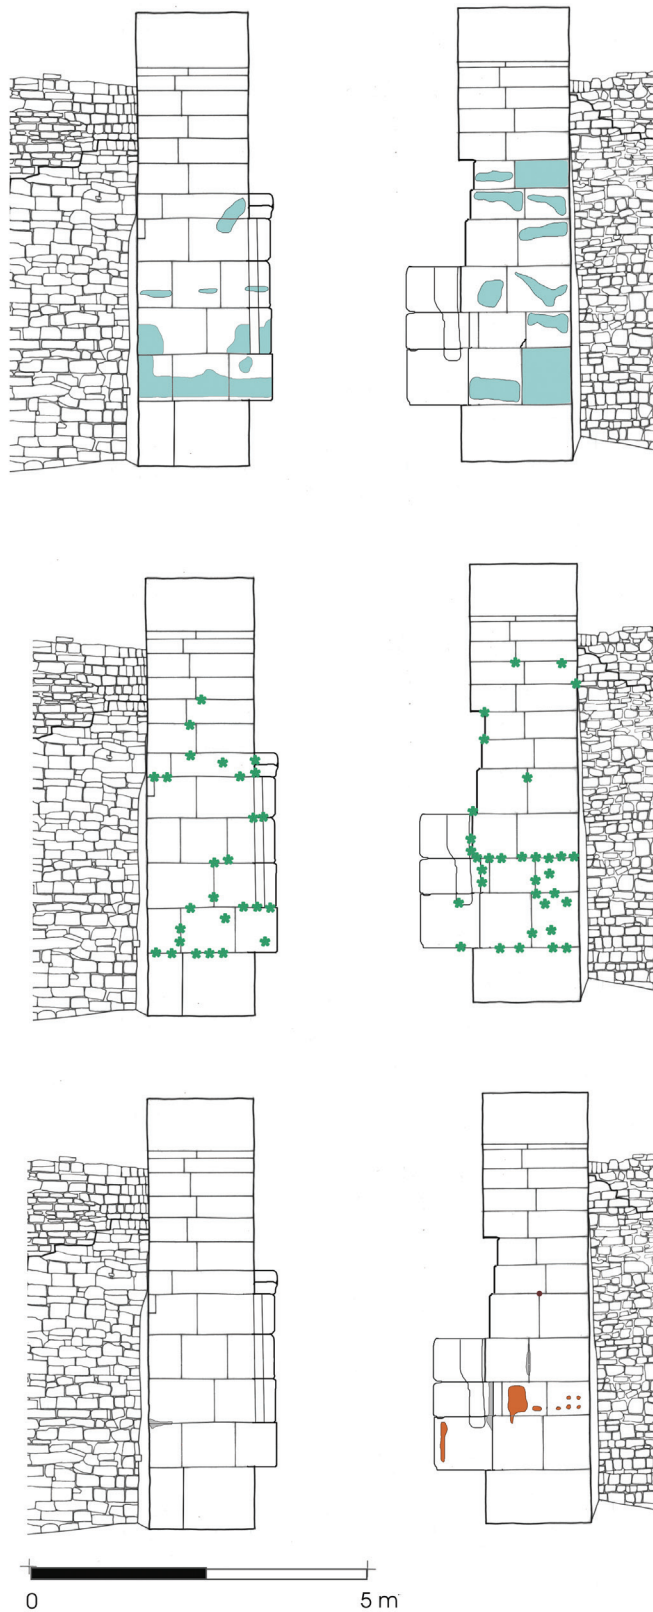
Tabla 2 Presjeci s pogledima na Herculova vrata - alveolizacija, biološki film i vegetacija, cementne ispune i mrlje
Table 2 Cross-sections with views of Hercules' Gate - alveolization, biological film and vegetation, cement fillings and stains.

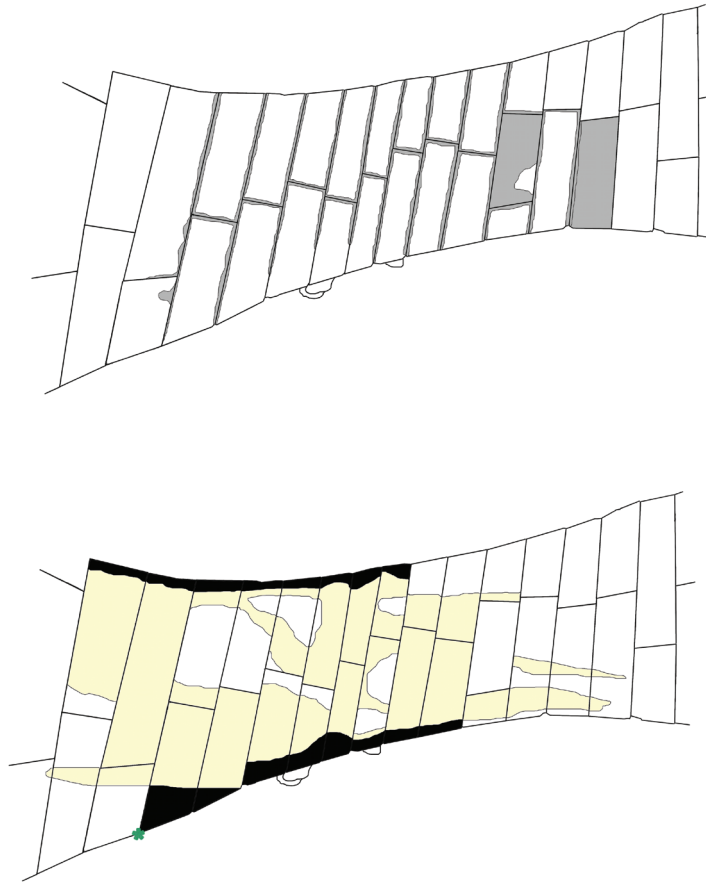
Tabla 3 Pogled na unutrašnji svod luka Herkulovih vrata - cementne ispune, crne inkrustacije i kalcifikacije
 Table 3 A view of the interior arch roof of Hercules' Gate - cement fillings, black incrustations and calcifications.
