Analysis of building damage caused by earthquakes in Eastern Turkey

Cumhuri Cosgun, MSc. CE
Istanbul Kultur University
Department of Civil Engineering
cumhurcosgun@gmail.com

Professional paper

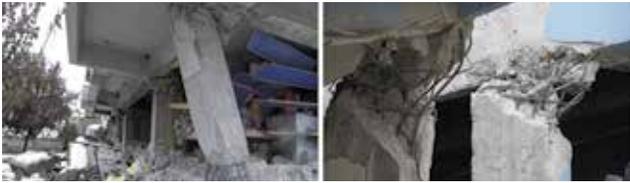
Structural elements are designed to withstand static and dynamic forces under various circumstances such as excessive gravity loads and earthquakes. It would be desirable for permanent damage to occur at the end of the beams, while the columns should remain elastically intact. In this way, the total collapse of the buildings would be prevented and people inside the building could be evacuated without any loss. However, the observations regarding earthquakes that hit the city of Van and the town of Erciř have revealed that most of the heavily damaged buildings have the RC beams which are stronger than the columns, contrary to the above mentioned principle. This proves that acceptable structural behaviour has not been provided for in the design and construction of buildings in this area.

Figure 9. Examples of plastic rotations at the end of columns instead of beams in Erciş

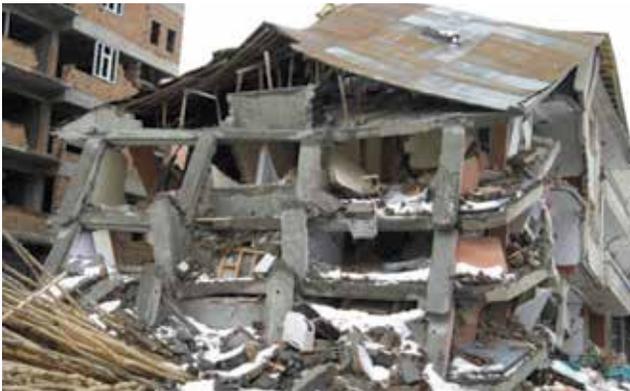
Figure 10. Total collapse of a building in Erciş due to sway mechanism after plastic rotation at the end of each column of individual storeys

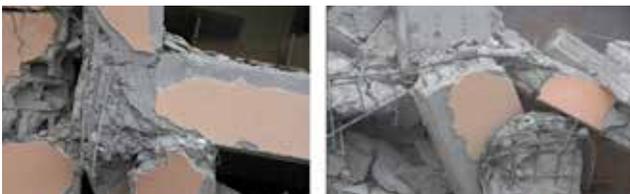
The beam-column joints are the most vulnerable parts of the structural system when the latter is subjected to lateral loading actions, such as those occurring during earthquakes. To provide for an adequate rotation and shear capacity, the detailing of the reinforcement is of highest significance. In particular, the lateral reinforcement of longitudinal rebars of the columns must be continued throughout the height of the joint. However, this reinforcement was not done in almost every damaged building, Figure 11.

Figure 11. Typical failure at the joints of a multistorey building in Erciş

Mostly owing to the difficulty in placing longitudinal rebars of beams on the top of the columns, the stirrups were usually not installed along the height of the beams at the joints. This defect is unfortunately one of the main reasons for failure of structural systems, even though the beam and columns remain intact after the quake.

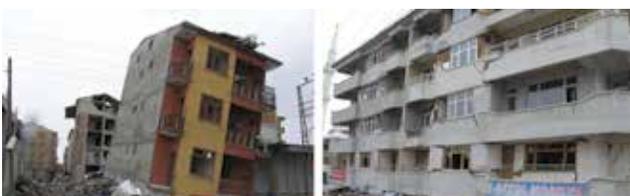
Figure 12. Collapse of two buildings due to soft storey effect at the ground floor level in Erciş

Buildings adjacent to streets are usually used for both commercial and residential purposes. To provide enough space at the ground floor, the storey height is generally higher than that of the upper floors and also, there are no infill walls at the street side of the ground floor, because of the need to provide for better visibility of the commercial area. However, this fact causes a soft storey effect in case of multi-storey buildings. Due to the lack of lateral stability at the ground floor level, the building sways up to the limit of the lateral deformation capacity of the columns at the ground floor, resulting in collapse of the entire soft storey, Figure 12.

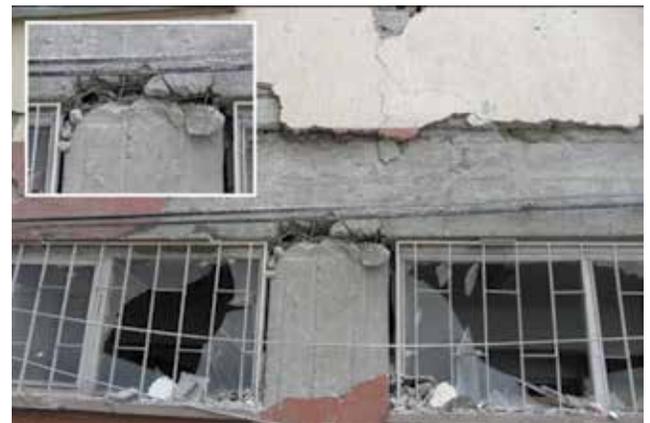
Modern seismic design codes prevent shear failure of columns by prescribing a certain amount of confinement around longitudinal rebars. However, if the shear span of flexural elements is shortened for some construction related reasons, the structural element is prone to excessive shear forces rather than flexural forces. As a result, during the quakes, the diagonal shear cracks occur along the free height of the flexural element, Figure 13. Such damage could create undesirable mechanisms at the building's floors.

Figure 13. Shear failure at the top of the column due to short shear span in Van

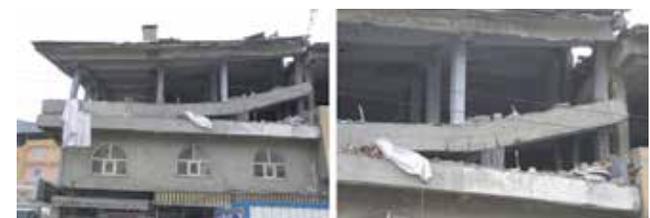
The buildings constructed in the downtown of Van and Erciş are row house style buildings situated along both sides of the streets. Unfortunately, the lack of regulations on the height of buildings creates a practical problem of having different story heights, as shown in Figure 14. Hence, during ground shaking, the rigid floor of one building may hammer at the middle of the columns of the adjacent building. Such lateral forces acting on the columns lead to disastrous drop of the column stability and, accordingly, to the collapse of the entire slab above.

Figure 14. Partial collapse of the slab due to pounding in Erciş

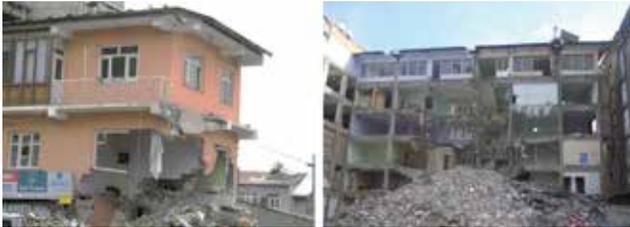
In medium to high density housing areas of Van and Erciř, many more buildings are affected by the impact of collapsing buildings, Figure 15. Buildings of low construction quality or buildings built contrary to relevant regulations are subjected to heavy damage during a strong ground shaking activity. In case of partial or total collapse of such buildings, it is quite possible that they will fall on neighbouring buildings that may have survived the quake. Unfortunately, no precautions can be taken to prevent such an event, except for effective inspections during the design and construction of buildings.

Figure 15. Damage due to the impact of the collapsed building on the neighbouring building in Erciř and Van

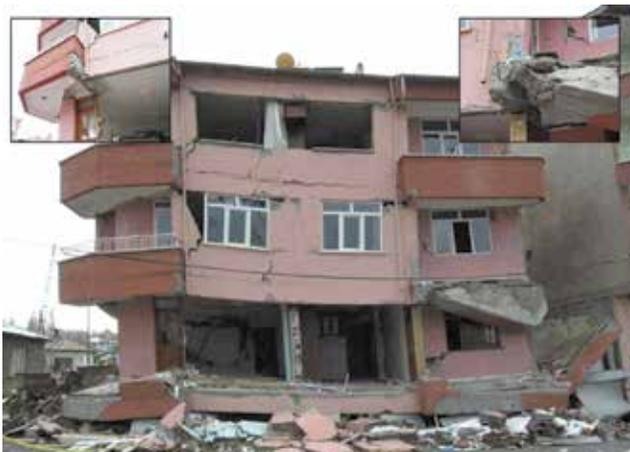
Selection of the structural system and elements is a crucial engineering decision in earthquake prone areas. Therefore, the practicing engineer must have experience in the earthquake resistant design of structures. Even if service loads do not inflict any damage on a poorly designed building, the earthquake load may exceed the bearing capacity of the element, and ultimately lead to catastrophic results, Figure 16.

Figure 16. Damage due to selection of an improper structural system in Erciř

- In areas where considerable seismic activities are likely to occur, mixed load bearing systems (shear wall and frame) must be preferred to frame structures.

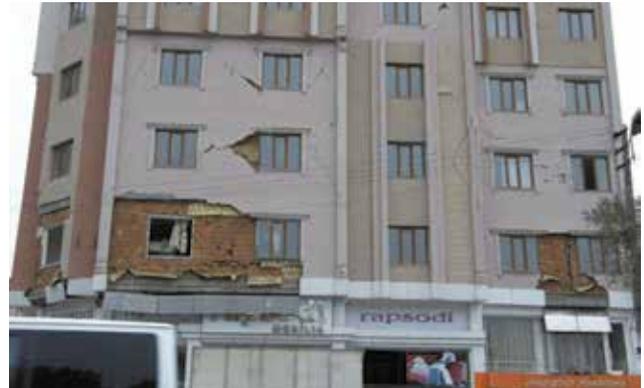
Figure 17. Although structural systems of buildings were not damaged during the first earthquake in the city of Van, almost every building had diagonal cracks and out of plane deformations on outer walls, which is due to the total lack of mechanical bond between the double brick layers.

Figure 17. Diagonal damage patterns occurred at the infill sandwich walls in city of Van

- External infill walls should preferably not be made of two-layer brick walls. If such layered walls are used, they must be mechanically connected with ties.

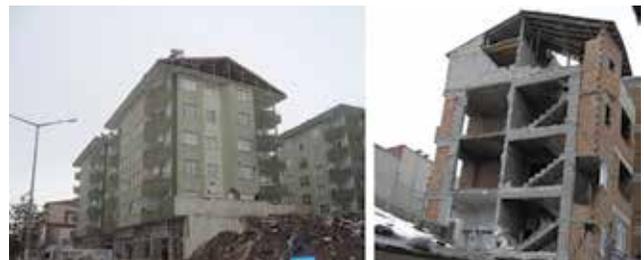
Due to the severe winter conditions, or in order to enable the use of attic space, the roofs are significantly elevated and inclined. Therefore, the walls under gable roofs are accordingly high, which causes out-of-plane stability problems. In addition to that, the lack of tie beams at the top of gable walls is yet another reason for an insufficient stability, Figure 18. Such construction defects have been observed at almost every building in Van and Erciř.

Figure 18. Out-of-plane deformation damage of the gable walls

- Gable walls under high roofs must be framed with tie beams to achieve required stability.

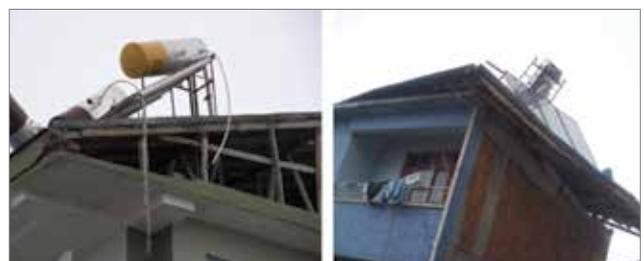
Structural systems supporting the roof do not usually provide an appropriate lateral stiffness. This situation has additionally deteriorated when water tanks (each about 10 kN) with solar panels were installed on the top of the roof consequently causing additional seismic mass on the roof structural system. During the earthquakes, the majority of the roofs swayed or fall down from the top of the buildings, Figure 19.

Figure 19. Swayed roofs due to low stiffness and additional seismic masses in Erciř

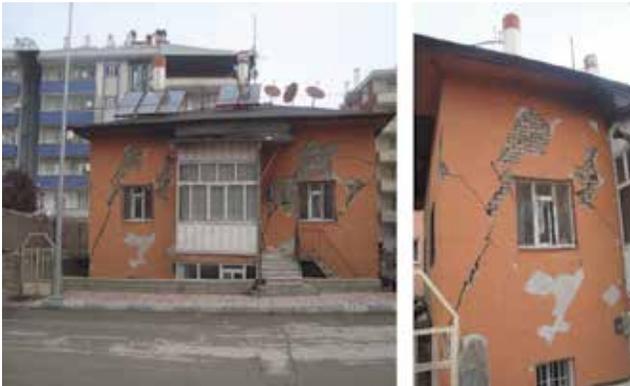
In masonry buildings, the lateral stiffness is provided by strong adobe walls and slabs on the walls. In case one of them is insufficiently constructed, a severe damage to masonry buildings during a strong ground motion is unavoidable. The typical damage observed in masonry buildings are diagonal shear cracks and openings on walls, Figure 20.

Figure 20. Typical shear damage observed on structural walls of a masonry building in Van

- Adobe buildings are prone to shear deformations unless beams are provided. Thus, horizontal and vertical tie-beams and reinforcement should be provided to masonry walls in high seismic areas.

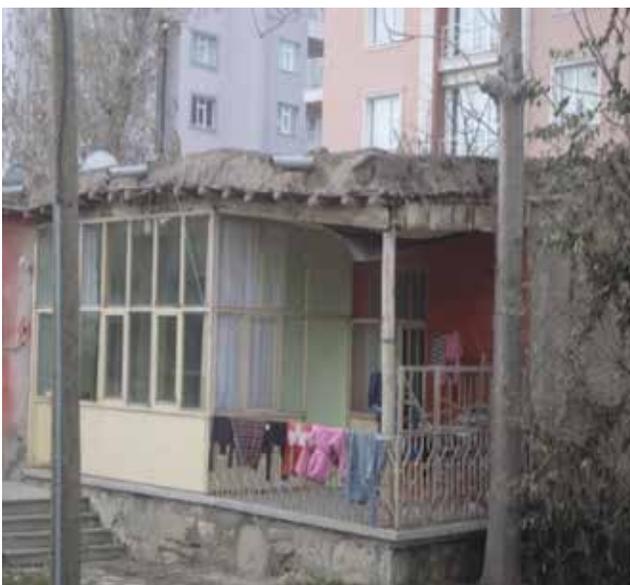
Slabs resting on masonry walls are usually made of earth material filling on wooden beams. The higher the earth material filled, the more lateral force is exerted on the walls, which causes shear openings. This phenomenon was observed at most of the old masonry houses in Van and Erciş. The thickness of the earth fill on the roof reaches up to 40 cm, Figure 21. The lack of an appropriate connection detail between intersecting walls and roof-wall intersections, and the absence of mortar, lead to an out-of-plane instability of masonry buildings made of natural stones, Figure 22.

Figure 21. Excessive earthfill on the roof of a masonry building.

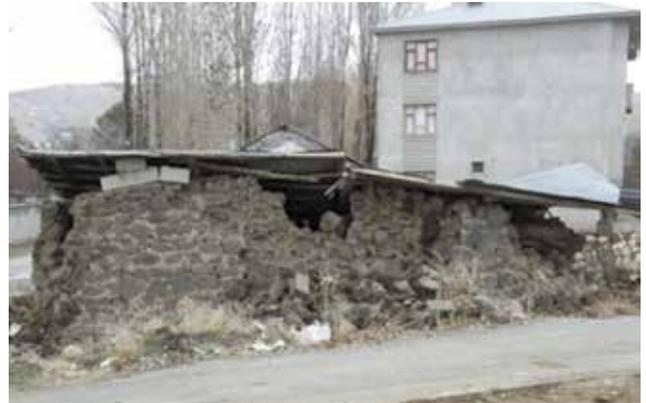
Figure 22. Collapsed masonry building due to the lack of connection and mortar on the walls and roof in Erciş

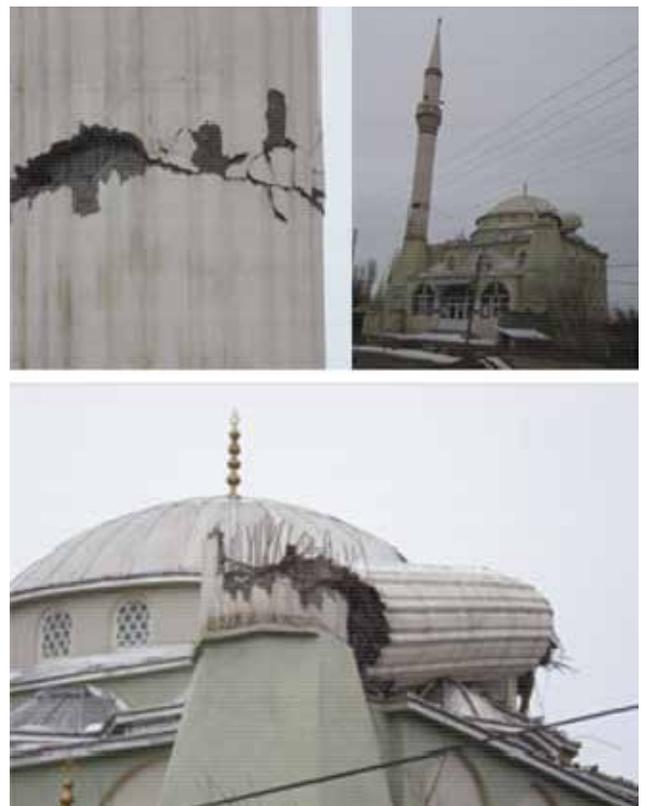
Minarets built near mosques are exceptionally slender structures. They are made of either block stones or reinforced concrete (RC). The inspection of minaret damage has revealed that the block stone minarets of poor mortar quality lost their stiffness and stability, and totally collapsed. On the other hand, the RC minarets have suffered damage at the parts where there is a change in section geometry or material property, Figures 23 and 24.

Figure 23. Local damage and two totally collapsed minarets of a mosque in Erciş

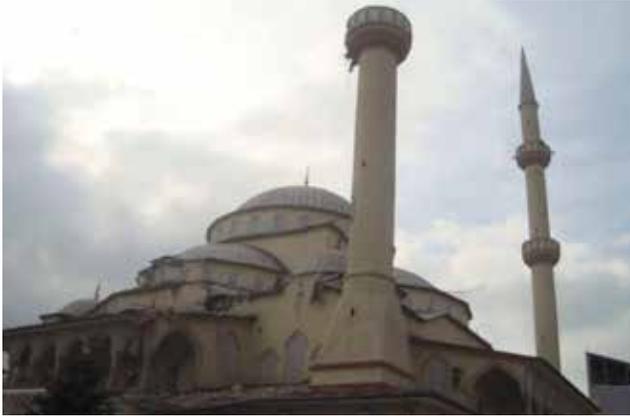
Figure 24. Intact and damaged minarets of a mosque in Van

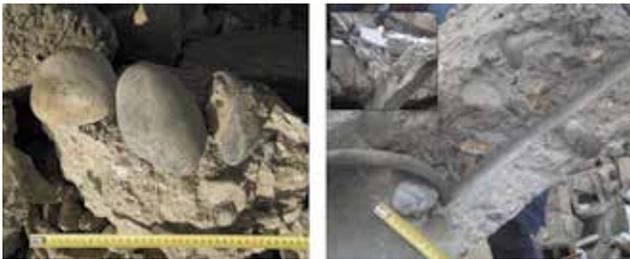
The concrete at the damaged or collapsed buildings displayed a poor quality of the concrete mixture. Aggregates used in the mixture are far from acceptable diameters as stated in Turkish Standards [12], Figure 25. It is obvious that the aggregates were derived from river beds instead of stone pits. In addition, the cohesion of the cement with the aggregate is almost nonexistent, Figure 26.

Figure 25. Inappropriate aggregates used in Reinforced concrete buildings

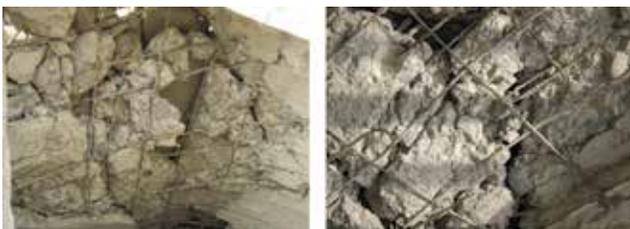
Figure 26. Poor cohesion between cement and aggregate

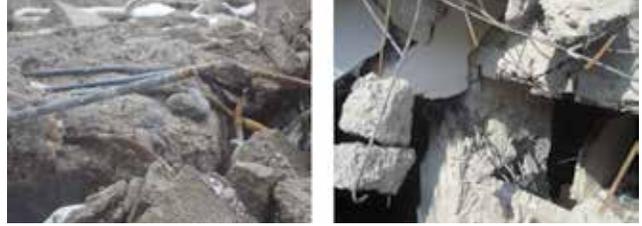
The study of the damaged or collapsed buildings has revealed that both the longitudinal and lateral reinforcement details at structural elements are not consistent with the code based regulations. For example, the Turkish Earthquake Code (TEC2007) strictly forbids the use of plain rebars as longitudinal reinforcement in earthquake-prone areas. However, most of the multistorey RC buildings that collapsed in Van and Erciş suffered from the poor-bonding problem, Figure 27.

Figure 27. The use of plain reinforcement as longitudinal rebars in RC beams and columns

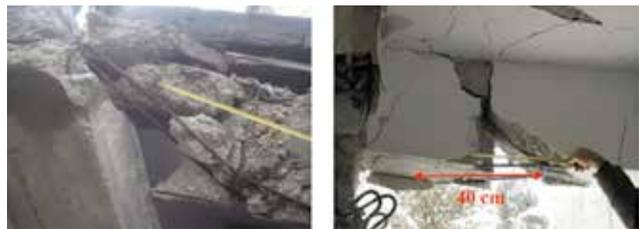
In case of reversed cyclic deformations, the confinement of the RC beams and columns is very crucial for maintaining adequate resistance of longitudinal rebars to shear forces. Therefore, lateral reinforcement intervals along RC elements are limited to 10-20 cm and 15 cm for the columns and beams, respectively, [10], Figure 28. In the majority of the damaged or collapsed buildings, structural elements did not have a sufficient quantity of lateral reinforcement. In addition, the hooks at the end of the rebars were also either missing or were not arranged at 135 degrees as required by the codes, Figure 29.

Figure 28. Inadequate lateral reinforcement intervals

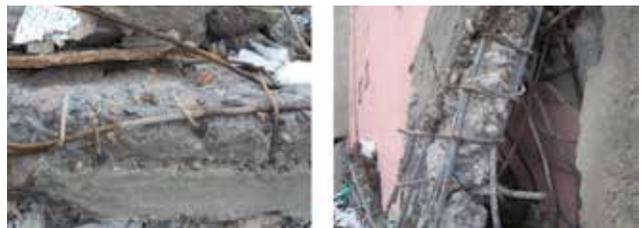
Figure 29. Poor hook arrangements at the end of lateral confinement bars

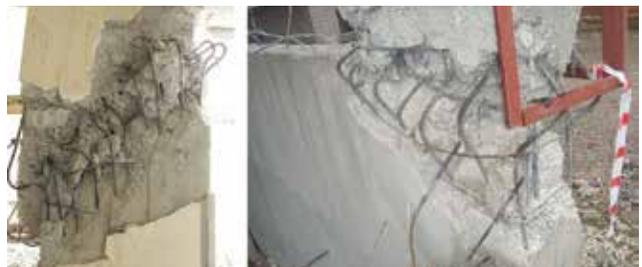
In case of structural elements with insufficient lateral rebar intervals, the buckling of longitudinal rebars may occur when such elements are subjected to severe shear forces, Figure 30.

Figure 30. Shear damage and buckling of longitudinal reinforcement due to insufficient lateral rebar interval
