RAIL DEFECTS HEAD CHECKING ON THE SERBIAN RAILWAYS

Zdenka Popović, Ljiljana Brajović, Luka Lazarević, Leposava Milosavljević

Preliminary notes

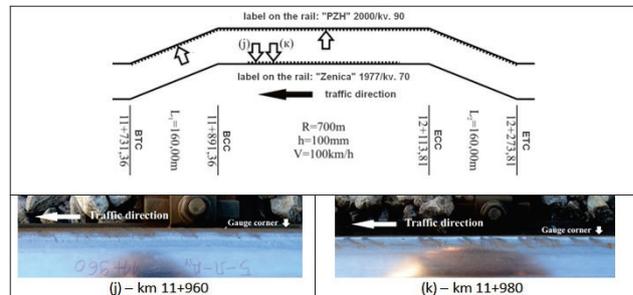
Figure 6 HC defects on the outer and inner rail in a curve

HC defect was observed on both rails (Fig. 6), on the railway section Zemun – Zemunsko polje, in the curve with radius $R = 700$ m (the left track, km 11+731,36 – 12+273,81). This line was designed for maximum speed of 120 km/h, in 1978. The cant of outer rail amounted to 145 mm. Speed was reduced for a long time at 40 km/h due to poor track geometry. Speed was increased to 100 km/h, and the rail cant was reduced to 100 mm in 2011. New outer rail was installed in October 2004. The defect is observed along outer rail in the curve. The defect is medium severe: 4 ÷ 5 cracks/1 cm, crack length of 10 ÷ 20 mm. The defect is observed on most parts of inner rail in the circular curve: 1 ÷ 2 cracks / 1 cm, crack length of 5 ÷ 20 mm. Figure 6 shows PZH rails made by the Chinese producer PZC Steel that are known to be susceptible to corrugation and occurrence of cracks at the driving surface [22].

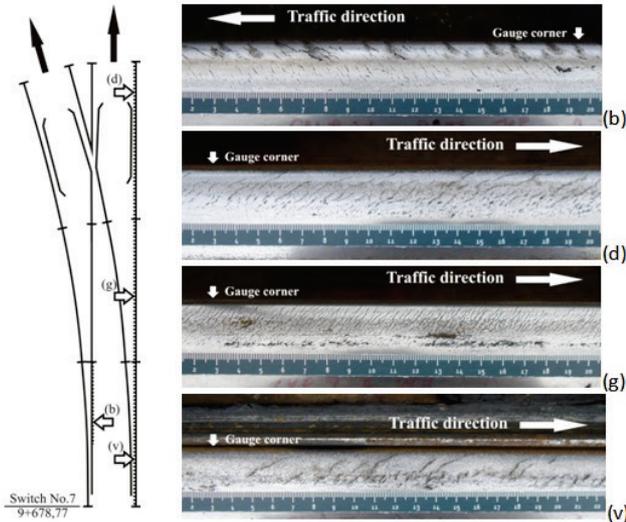
HC defect was also noted in some rail switches in stations "New Belgrade" and "Zemun". The reason for this can be found in irregular track geometry and worn out

elements of switches [21]. The appearance of defects in Fig. 7 is untypical because the HC appeared on the right stock rail and on the right switch rail. A switch was incorporated into the track in 1993. All rails in the switch have the steel quality 700. The severe defects are observed: crack lengths from 5 mm to 35 mm and 2 ÷ 5 cracks/1 cm.

Figure 7 Untypical HC defects in the rail switch number 7 in station "Zemun", km 9+678,77

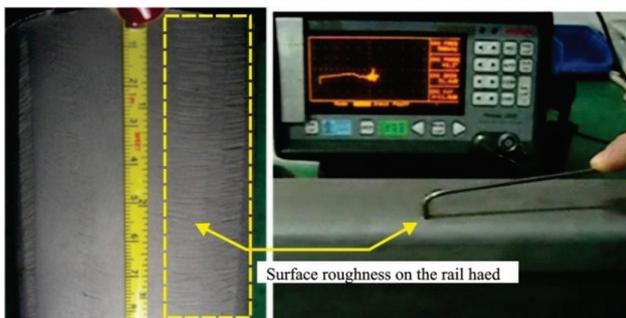
Figure 8 The surface roughness detection using the EC and the rail sample for testing

The rail surface roughness becomes visible after the rail sample treatment by sandblasting in the laboratory (Fig. 8, left). The device for EC testing detects roughness that cannot be detected by visual inspection (Fig. 8, right). EC testing of surface and subsurface defects that cannot be detected by visual inspection is shown in Fig. 9. This proves the importance of grinding of new rails and cyclic grinding.

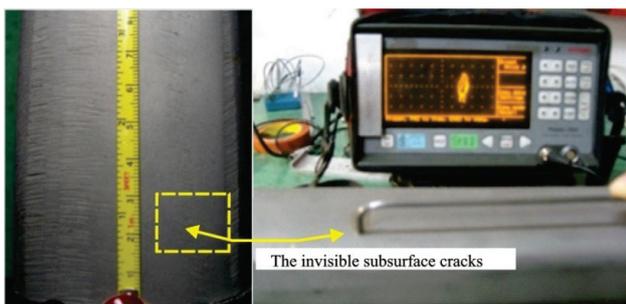
Figure 9 The subsurface cracks detection using the EC and the rail sample for testing
