ASSESSMENT AND REPAIR OF THE BEARING STRUCTURE OF THE GRADISKA CULTURAL CENTRE AFTER FIRE

Vlastimir Radonjanin, Mirjana Malešev, Radomir Folić, Ivan Lukić

The paper briefly presents the specificity of evaluation and repair of fire-damaged reinforced concrete structures through one case study. Analysed building is the "Čubrilović" Cultural Center in Gradiška, Bosnia and Herzegovina, that was severely damaged by fire in 2005. Reinforced concrete structure as a classic skeletal structure stiffened with RC walls for seismic actions, was built with many defects which contributed to progressive appearance and spreading of damage characteristic for fire. Real condition of the structure was assessed on the basis of analyses of all field and laboratory test results. On the basis of control design of structure with increased imposed load and decreased concrete strength class it was identified that in certain structure elements there is a lack of built-in reinforcement and that the cross-sections of elements are insufficient. Repair solutions for the damaged structure elements due to the fire are briefly described and only characteristic repair details and a few original solutions for the s

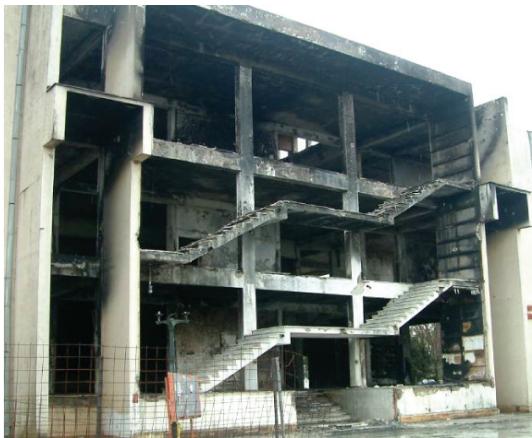
Figure 1 View of the front facade of the building after fire

In 2005, a fire broke out at the "Cubrilovic" Cultural Centre in Gradiska. The fire caught all floors and was extinguished after 4,5 hours. During the fire, installations and the interior of the building as well as the timber roof structure were completely destroyed, while the bearing reinforced concrete structure was partially damaged (Figs. 1 and 2).

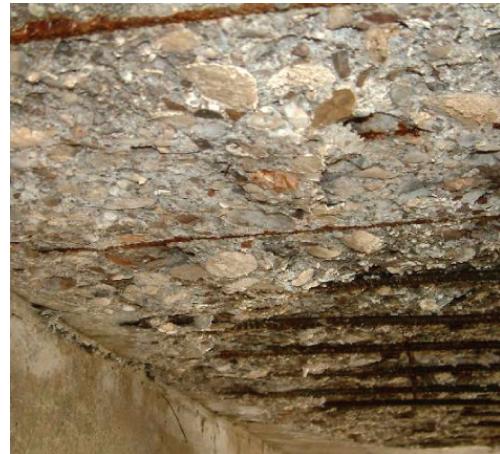
Figure 2 Severely damaged RC slab after fire

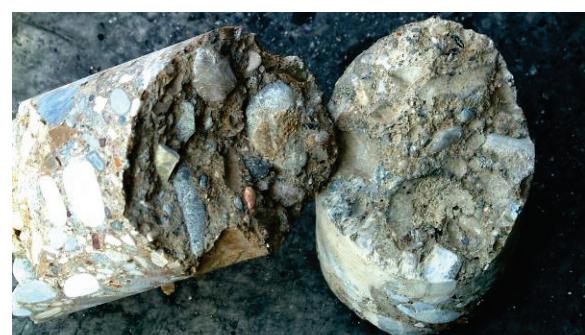
Figure 9 View of a plane fracture of concrete core

After the analysis of the appearance of the concrete cores that were taken out, and the character of their failure mode, it was concluded that some columns contain fissures in the concrete mass, the consequence of mass defects in the concrete structure and local exceeding of concrete tensile strength. This local damage in the

concrete mass occurred due to poor adhesion between the cement stone and the large grains of aggregate, which was additionally damaged by concrete stress caused by the fire. Poor adhesion is primarily the consequence of using quarry aggregate with clay film on the grain surface. The characteristic view of RC columns after the fire is shown in Figs. 10 and 11.

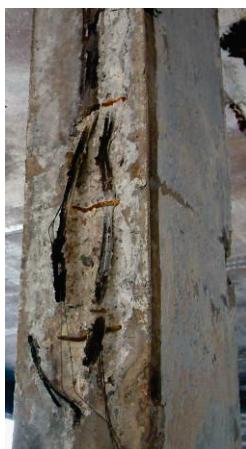
Figure 10 RC column M/3
(ground floor)

- On 8 columns no visible damage from the destructive influence of the fire was recorded.
- A change in colour in the surface layer of the concrete was recorded on about 40 % of the total number of columns. The pink colour of the concrete shows that the temperature of that layer was above 300 °C. The thickness of this layer is about 1 cm.

- Thin net-like fissures in the surface layer of concrete are recorded on about 30 % of the total number of columns. It is presumed that the percentage is greater due to the decorative layer which made it more difficult to examine the surface of some columns.

- Vertical fissures and cracks near the edges of the columns (along the main reinforcement) are recorded on about 20 % of the total number of columns. The main reason for this damage is impaired adhesion between the concrete and the reinforcement due to the two-sided effect of high temperatures. The cracks are located 10 cm from the edge of the column and the cracked part of the concrete is easily removed from the rest of the concrete (Fig. 11).

As a basic repair method, after removing the crumbly and cracked parts of the concrete, "confinement" of the RC columns with additional stirrups $\varnothing 8/25$ cm and local

reprofiling with fibre reinforced repair mortar (to the designed cross-section), was chosen (Figs. 17 and 18).

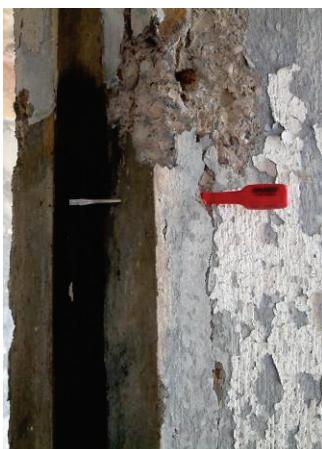
Figure 11 RC column K/2
(first floor)

- Cracking, separation and falling of concrete along the edges of columns was recorded on about 20 % of all columns. The cause of this is the same as for the vertical cracks (usually on the same columns).

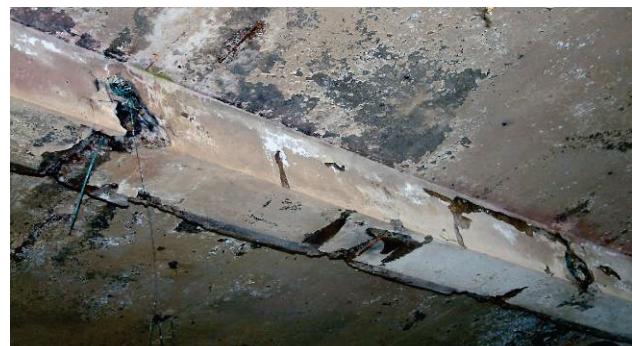
Figure 12 RC beam above the first floor (J-K/2)

In beams spanning 5 and 2,5 m, there are numerous wirings, the heating and burning of which caused the surrounding concrete to burn through, and the local deformations of reinforcement (Fig. 12). At the places where anchors for partition walls were placed, local mechanical damage showed up during removal of the load bearing structure of partition walls. This kind of damage is most noticeable at five places on the longitudinal edge of the beam.

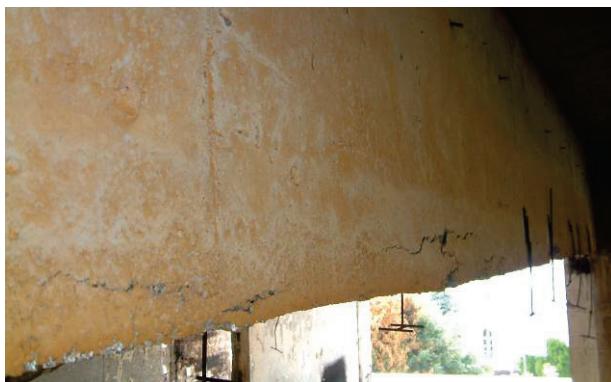
Figure 13 RC beam above the first floor (K/3-5, span of beam 15 m)

- Cracking, separation and falling of concrete along the free longitudinal edges (along the main reinforcement) was recorded on about 30 % of the

total number of beams. This damage is characteristic for the beams with 15m span, where the lower edges are dilapidated and cracked in the layer as high as 10cm along the entire length of the beam. The cracked part of the concrete is easily separated from the rest of the concrete (Fig. 13).

Strengthening of the RC beams with 15 m span was done by adding new reinforcement and a new concrete on the bottom side of the beams (Fig. 23).

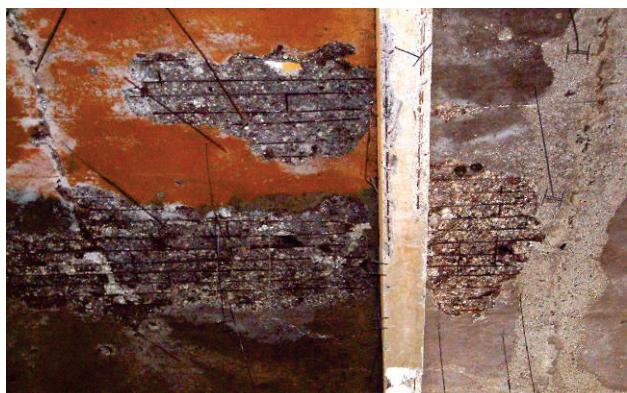
Figure 14 RC slab above the first floor (K-L-M/3-5)

- Surface layer of concrete that is burnt through, dilapidated or fallen off was recorded in about 60 % of the total number of slabs. The thickness of this layer is 1 ÷ 5 cm. At the places where wiring is set, the concrete has burned through deeper. The described damage is also more pronounced at the places of defects, especially at concrete honeycombing and breaking of concreting. On slabs with smaller span this damage is local and exists in several places. On slabs with the span of 15 m (J-M/3-5) the described damage has caught most of the downside surface of the slab, and white, broken grains of the aggregate were recorded, apart from the change in colour of the concrete. For these slabs, falling off of concrete up to and behind the reinforcement is characteristic.

- Longitudinal, transverse and slanting fissures and cracks were recorded in about 60 % of the total number of slabs. On most recorded fissures, marks and products of water leaking are noticeable. A number of fissures are located at the area of wiring in the slab. On cantilever slabs (1-1' and 7-7') transverse fissures are characteristic, probably located at places where there was a break in applying of the concrete layer. On square slabs, spanning 5 m, fissures appear in both ways, and on some there are also diagonal fissures. On slabs spanning 15 m, longitudinal fissures are characteristic (at the third and in the middle of the span). They are located at places of badly performed breaking and continuations of concreting. The width of the fissures is from 0,1 to 0,3 mm.

- A small protection layer (bared – visible reinforcement) was recorded on about 35 % of the total number of slabs.
- Surface reinforcement corrosion was recorded on about 10 % of slabs.

Poor adhesion between the aggregate and the cement stone is characteristic for the concrete built-in in reinforced concrete slabs, as well as the concrete built-in in other elements of the structure. Characteristic

appearance of the bottom side of RC slabs after the fire can be seen in Figs. 14 and 15.

Strengthening of the continuous RC slabs was done by adding new reinforcement and a new protective layer of concrete on the bottom side of the slab, (Figs. 24 and 25). The new concrete layer was done as a shotcrete. Strengthening in supporting zones was also done by adding new reinforcement and a new protective layer of concrete on the upper side of the slab. It refers only to the slabs for which it was established by calculation that they lack reinforcement due to bending moments.

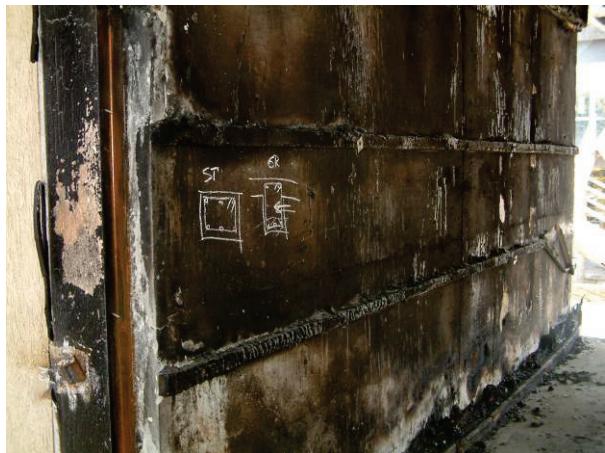
Figure 16 RC wall N/6-7 (ground floor)

RC walls are 30 cm thick and have two types of finishing. RC walls in axis N had the "sandwich" layer of combustible materials (wood-based panels on a wooden substructure with thermo isolation). This finishing of RC walls was mostly damaged during the fire (Fig. 16). The rest of the RC walls only had the finishing decorative coat. At the places of electric wiring local burning-through of the adjacent concrete was recorded.

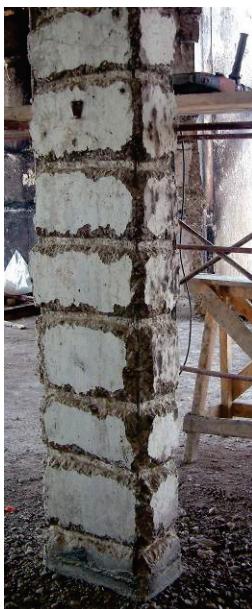
Figure 17 Preparing of RC columns for confinement

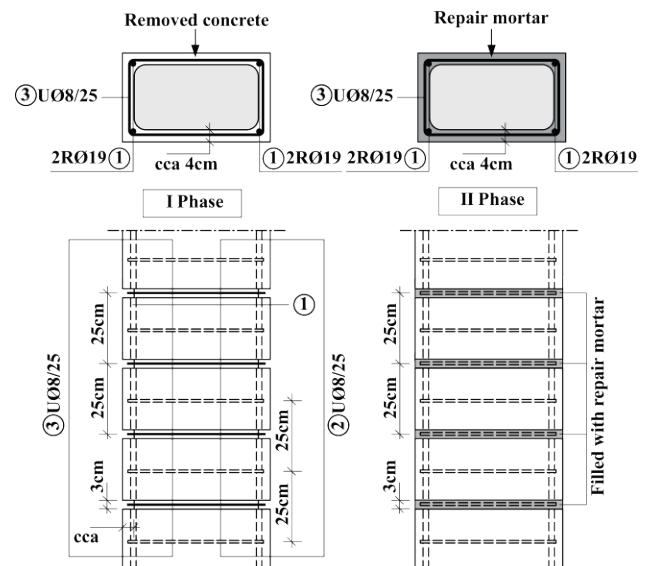
Figure 18 Procedure and details of repair of RC columns

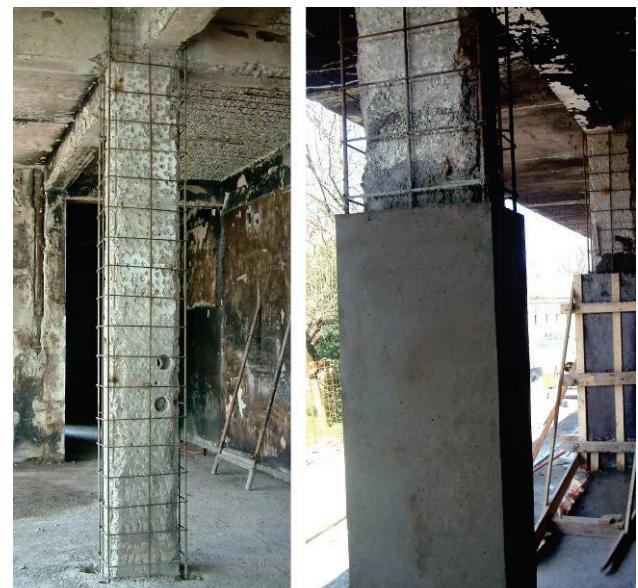
Figure 19 Classic way of repair of RC columns, by jacketing

During the preparation of the RC columns for repair, it was observed that, while cutting grips for the new stirrups, bigger bits of the surrounding concrete were falling off as well. For that reason, the authors of this paper decided at the site, to do a classic repair of the columns by jacketing (additional vertical bars and stirrups and applying an additional concrete layer (Fig. 19).

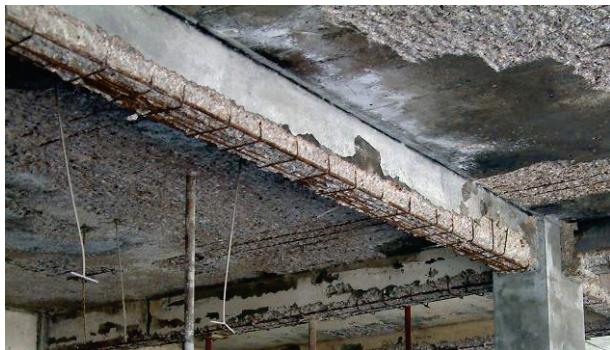
Figure 20 RC beam prepared for repair

Local surface repair with fibre reinforced repair mortar, after removing the crumbly and cracked parts of the concrete, was supposed for the less damaged beams (5 m and 2,5 m span) (Figs. 20 and 21).

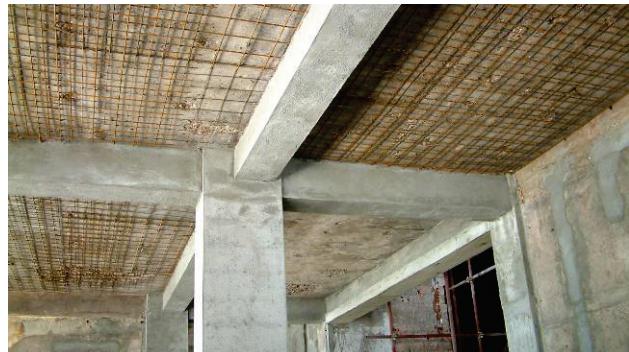
Figure 21 View of columns and beams after repair

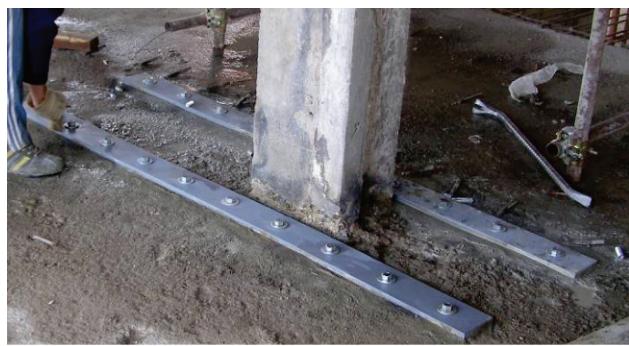
Figure 22 Detail of strengthening of RC beams supporting zones

Strengthening of support zones of RC beams (5 m and 2,5 m span), for which it was determined by calculation that they lack reinforcement to sustain a hogging bending moment (due to the lack of reinforcement in the upper area, steel plates are added, 12

× 200 cm, 15 mm thick, which are connected to the existing construction with M16 bolts).

This solution was proposed due to the impossibility of achieving continuity of additional reinforcement in the upper area at place of the column or RC wall, which goes through two floors (Fig. 22).

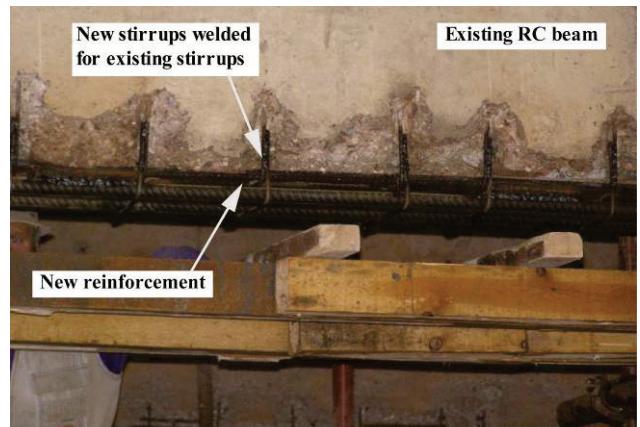
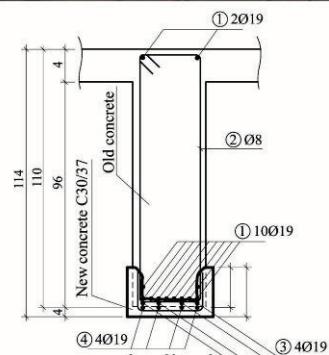
Figure 23 Strengthening of RC beams ($L=15$ m)

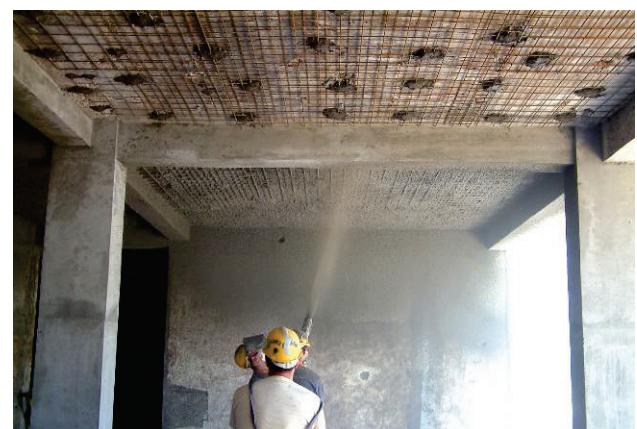
Figure 24 Repair of RC slab
(additional reinforcement and executing of new concrete layer)

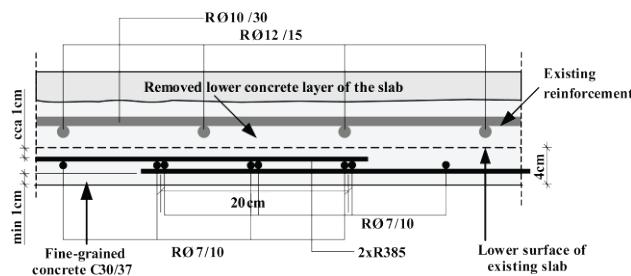
Figure 25 A detail of strengthening of RC slabs (additional reinforcement and new concrete layer)

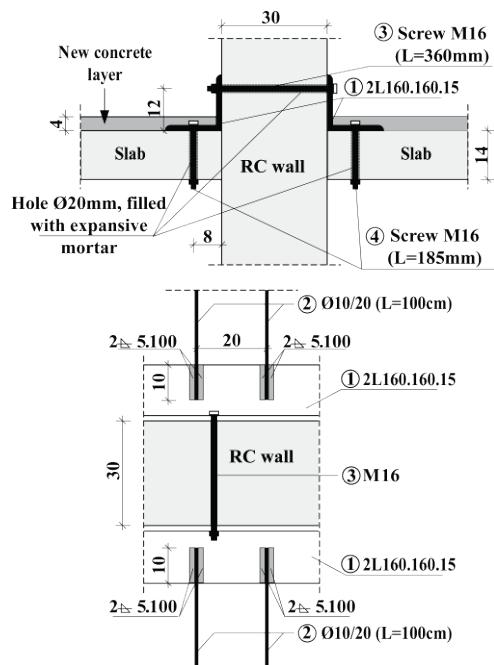
Figure 26 Details of strengthening of RC slabs in the zone of existing RC wall

Fig. 26 shows a characteristic detail which served to solve the anchorage problem of the additional reinforcement in RC wall zone, and Fig. 27 execution of the strengthening.

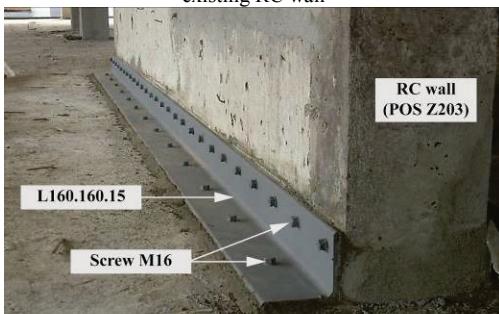
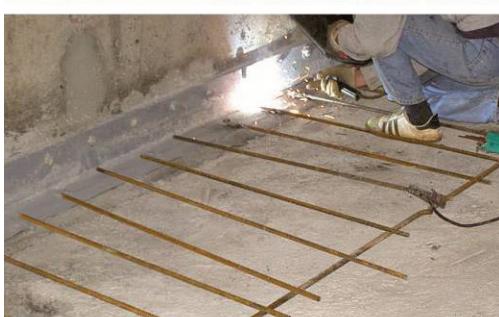
Figure 27 Execution of strengthening of RC slabs in the zone of existing RC wall

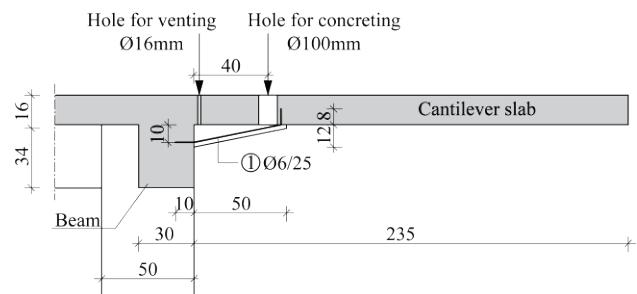
Figure 28 Detail of strengthening of RC cantilever slabs

Strengthening of cantilever slabs was executed by increasing the critical cross-section, i.e. by adding new concrete in supporting zones (Figs. 28 and 29).

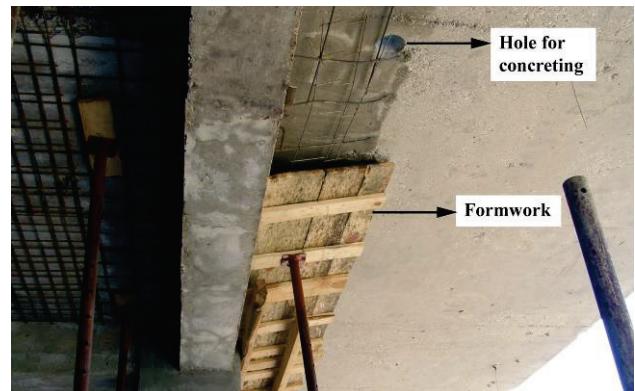
Figure 29 Execution of strengthening of RC cantilever slabs

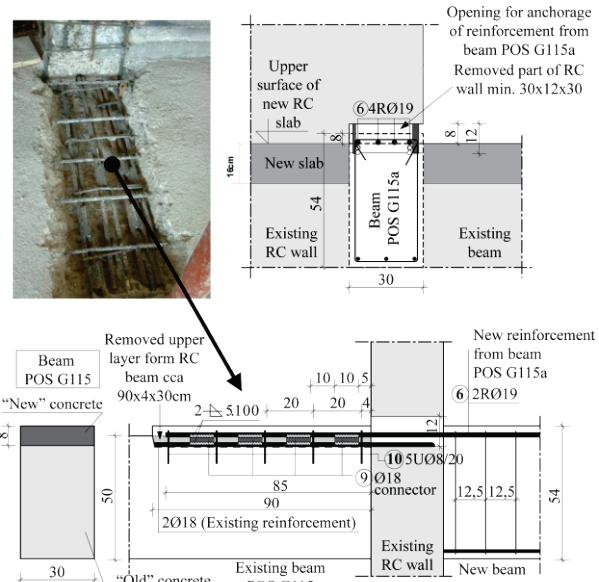
Figure 30 Detail of connection of a new RC cantilever beam with existing structure.

- Reinforced concrete cantilever beam (POS G115a and POS G116a, $b/d=30/54$ cm), which supports the slabs of the small galleries. Fig. 30 shows the solution of connection between the newly-designed cantilever beam – POS G115a and the existing structure (beam POS G115 and RC wall Z104).
 - Reinforced concrete slab of the large gallery (POS P101, $d=16$ cm), by extending and transforming the existing cantilever slab to one-way slab (Fig. 31),
 - Reinforced concrete slabs of the small galleries (POS P116 and POS P117, $d=16$ cm).

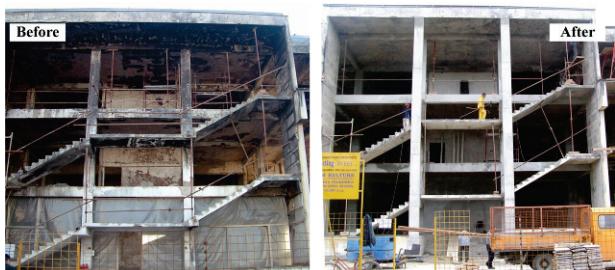
Figure 32 Changed static system of existing cantilever staircase (new RC columns and strengthened beams)

Apart from that, the repair project entails the demolition and removal of the main cantilever staircase on the ground and first floor. During execution of the repair works, this idea was transformed to changing of cantilever system of the existing staircase by adding new columns and strengthening existing beams (Fig. 32).
