Structural damage caused to RC buildings by tunnelling work

Professional paper

Baris Yildizlar, Baris Sayin, Ahmet Sertac Karakas, Cemil Akcay

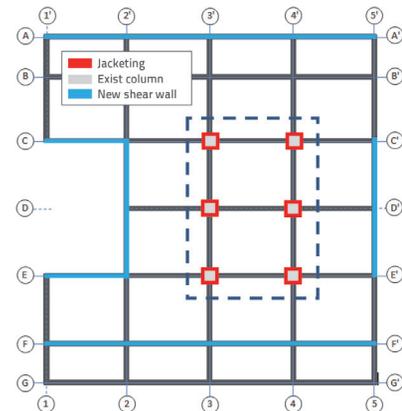
Figure 4. E-1 block basement floor plan: strengthened columns and new shear walls

was a RC shear wall along the x-axis only, and at four spaces along the same axis. As a result, when the cross sections and positions of the existing structural items are examined, it can be concluded that centres of gravity and rigidity are very far from each other. During previous strengthening works carried out at E1 block, a RC shear wall was constructed at five spaces along the x-axis, and at four spaces along the y-axis. The integration of reinforced concrete walls into the present structure was attempted using the minimum 0.2m thick jacketing of the columns in these spaces. The plan of the E1 block basement floor, where the strengthening work was conducted, is presented in Figure 4.

At the basement floor plan of E1 block, U-shaped structural items present at the left side of the plan, items positioned along the y-axis seen at the right side, and structural items presented along three spaces of the x-axis on F-F' axis, are all RC shear walls added by strengthening works. The RC shear walls seen through four spaces along the x-axis on A-A' axis are the first shear walls which existed initially [18].

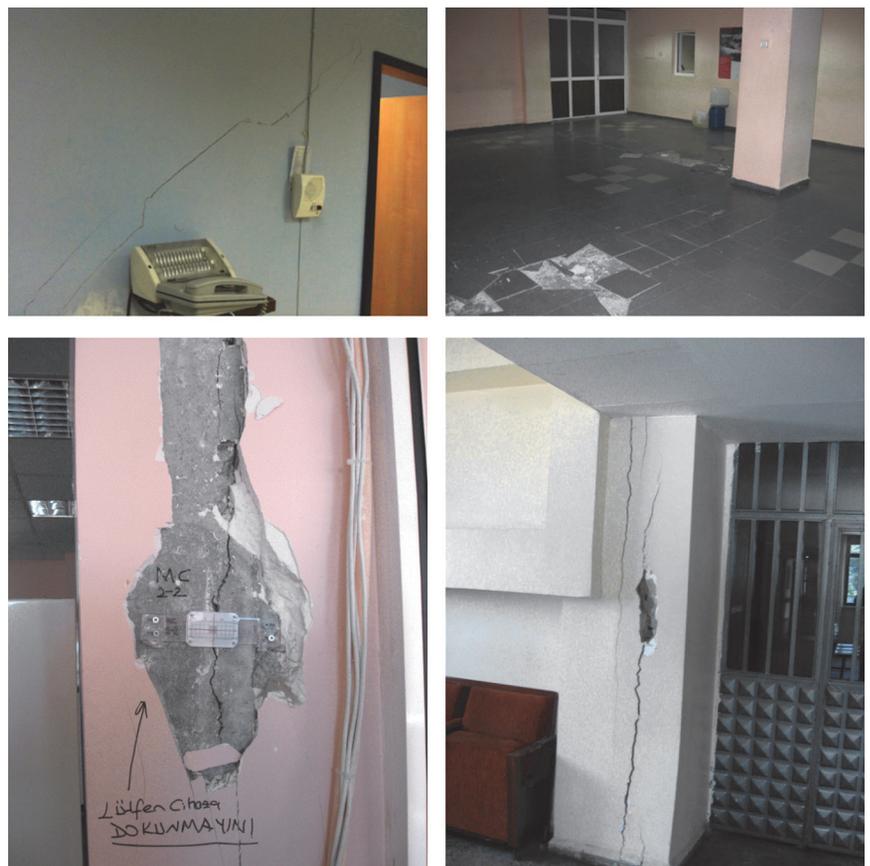
According to the personnel working at the E1 and E2 blocks, a sudden noise was heard in the building at midnight [19]. It is assumed that the cracks on the partition walls formed after this noise. It was established that the cracks are characterized by diagonal geometry. By considering the cracking geometry, it was suspected that an abnormal movement of soil beneath the structure occurred. It was also

speculated that the wall cracking might have been caused by previous strengthening works on the structure and by the use of an inadequate strengthening method. This is why possible reasons for the abnormal ground movement were studied. Meanwhile, by considering diagonal cracks at partition walls, and their spreading with respect to the position of walls, it became clear that the structure was affected by settlement along the vertical axis. It was detected that cracks on the walls, especially the ones on the ground floor and the 1st floor, reached disturbing sizes. The structure was closed to the use by patients for security reasons, i.e. due to cracks of unidentified origin and concern for the personnel. Diagonal cracks 5mm in size, cracks on beam supports due to tension and bending, and shearing cracks, were identified on the walls of the sterilization unit, located at the basement floor, which is vitally important for the hospital building. Tensile cracks that formed due to bending were identified under the flooring of the basement level (Figure 6) [18].

It was observed that the relative displacement on the beams amounts to more than 1/250, and more than 1/250 of settlement was observed at the columns. Due to such relatively extreme settlement, the crushing due to bending at the upper part, and destruction of tiles, were observed at the floor level of the upper floor. All these findings point to the fact that the soil settled under the buildings in question. On the plan shown

Figure 6. Cracking observed on structural and non-structural elements

in Figure 4, the area enclosed by dashed lines represents the region where the relative settlements are concentrated within the building under study. The walls with cracks are division walls made of bricks, aerated concrete and gypsum boards.

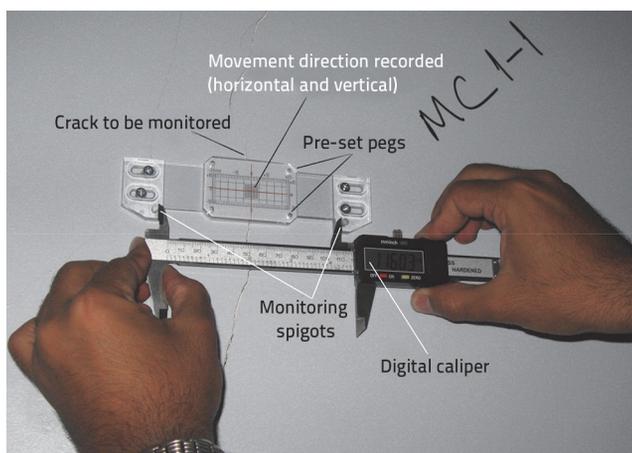
While placing emphasis on possible causes of cracks at a specified level of the structure, and in order to observe the movement of the structure, the total of 30 mechanical crack measurement devices were placed as appropriate on the walls, beams and columns (7 items; MC-2:1-7 for the sterilization unit-E1 block, and 23 items; MC-1:1-23 for the operating rooms-E2 block). Crack variations were observed for 30 days, and data were recorded every day (Figure 7) [18].

Figure 7. Mechanical crack measurement device

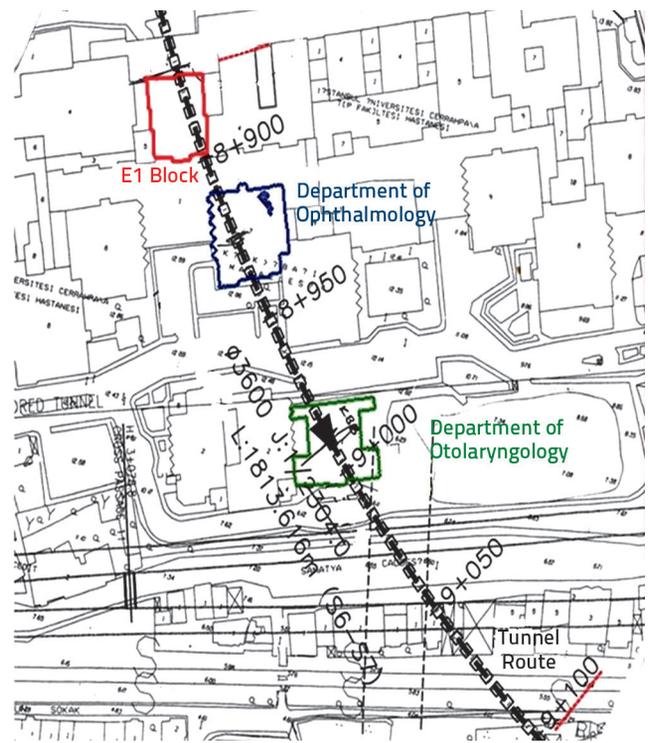
Figure 8. Route of the ISKI Project (Sewage Tunnel), and blocks of I.U. Cerrahpaşa Medical Faculty situated along the same route [20]

After various studies were conducted on the public structures and blocks in the vicinity of the faculty, it was established that cracks and different settlements occurred at some buildings almost 15 days before the damage to the monoblock. In addition, cracks were seen at the department of ophthalmology, in a different hospital block, four or five days before the event. According to interviews conducted by people residing in the public buildings, sounds were occasionally heard from the underground. The collected information suggests that there is an ongoing work under the ground. Officials stated that the excavation work for the construction of ISKI (Sewage Tunnel) has been progressing 15 m per day and, recently, the tunnel excavation work was carried out at the depth of 22 m. As can be seen in Figure 8, the position of E1 block corresponds to

the KM 8+873 of the route, which passes just under a densely populated area of the building. It is emphasized in the study that the work under the privately owned buildings was carried out fifteen days ago. These public buildings, however, are at KM 9 + 100 of the route. In the light of this information, and considering relevant parameters (distance and daily rate of tunnel excavation), it can be concluded that the value of $(9100-8873) \text{ (m)} / 15 \text{ (m/day)} = 15 \text{ (day)}$ fits the collected information quite well. The departments of ophthalmology and otolaryngology lie at KM 8 + 930 and KM 9 + 000, respectively, along the route. The collected information was confirmed by measurements subsequently conducted at these buildings, using the same parameters.

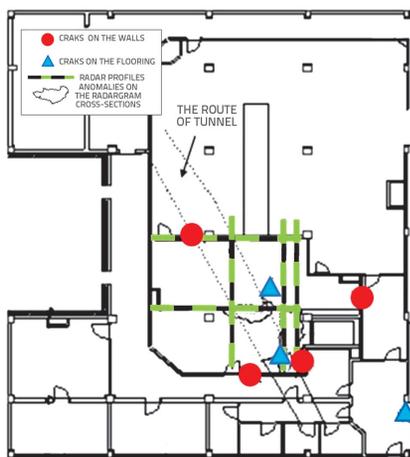
Figure 9. Georadar profiles, radargram anomalies, observed cracks / deformations, and location of tunnel route

As can be seen in Figure 9, an anomaly was also detected by georadar measurements in the region where ground movements were identified by the observed deformations. The georadar findings exactly coincide with the observation results. Interestingly, the initiation point of the anomaly, and the location of the TBM mirror, are the same.

Studies conducted along the route show that there are two fault planes in the part of the sewerage tunnel passing through the zone of the I.U. Cerrahpaşa Medical Faculty. One of the fault planes cuts the tunnel route (Figure 9) and is located under the most heavily damaged parts of the building under study. The crushed fault zone, approximately 7-8 m in width, contains water and is known to have a disturbed porous structure. On the other hand, the other fault plane is 8-10 m in width and it widens conically from the tunnel level at a close distance from the examined structure to the upper levels, at nearly 45°, depending on the thickness of the upper layers.

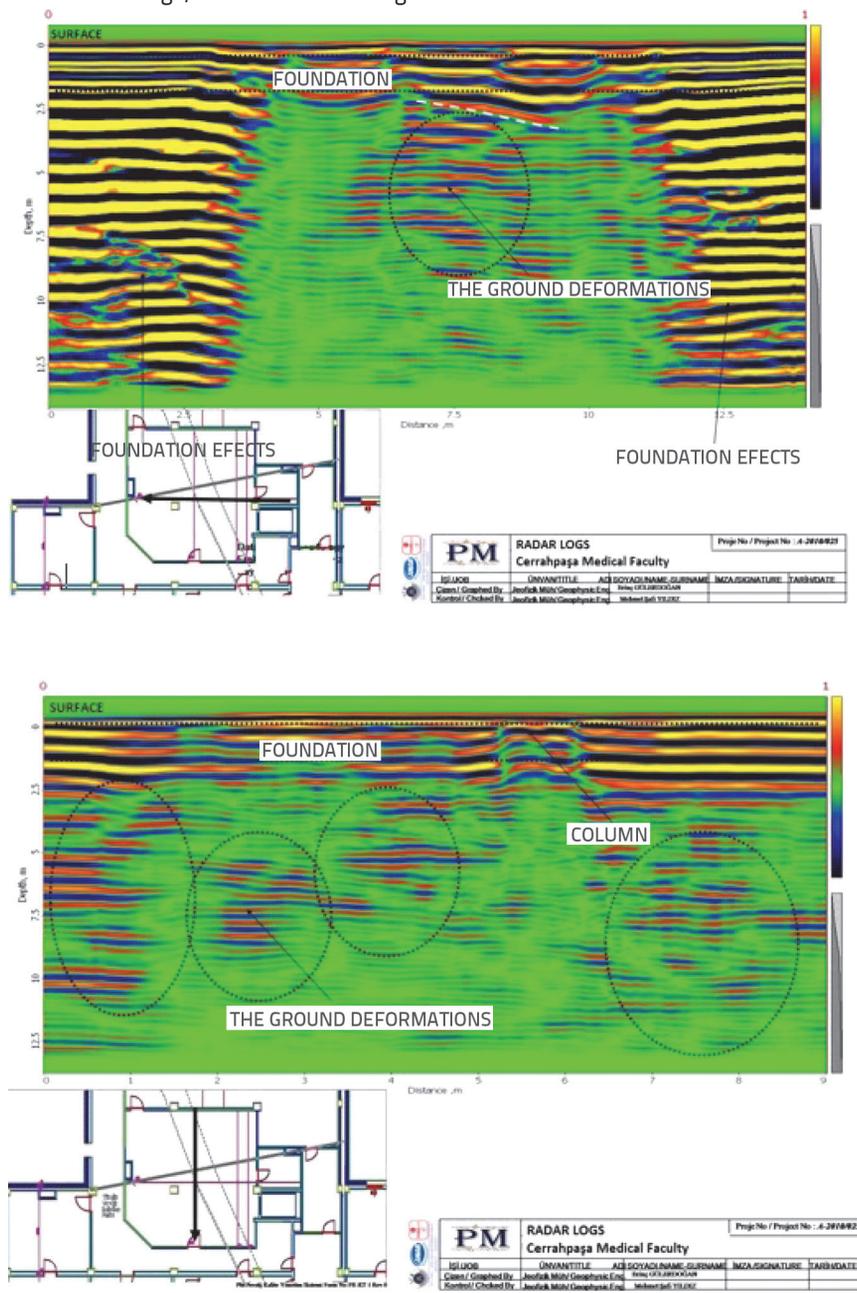
At the operating room level of the structure under study, two dimensional radargram cross sections, obtained from the direction parallel to the x and y-axis in regions of concentrated relative settlements and ground deformations, are shown in Figure 10.

Figure 10. 2-D radargram cross-section and ground deformations [21]

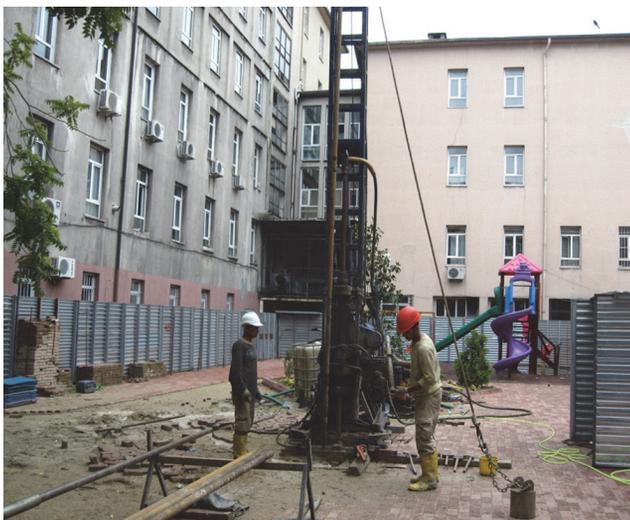
Figure 11. Cement grouting for ground strengthening

Approximately 80 tons of cement grout were injected into the ground during studies conducted under the structure damaged by sudden ground migration. In addition, nearly 80 tons of cement grout was injected into the ground of the structure located above the other fault plane. Although the addition of cement grout was performed as a "ground strengthening" activity, no studies have been made and no data exist about actual effects of this grouting. A view of the cement grouting in progress is given in Figure 11.

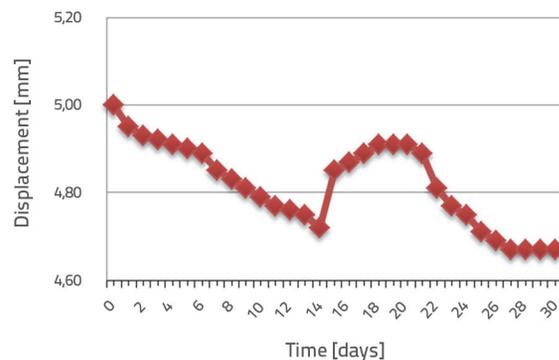
Crack measurement data were obtained over 30-days via 30-mechanical measurement devices mounted in the sterilization (E1 block) and operating rooms (E2 block). The crack regression on mm scale was detected and observed by the crack measurement device in the first two weeks. After the cement grouting, at the end of the third week, the crack size increased compared to the original size. During the last 7-days, cracks reached their reference sizes, and the width of the cracks remained constant (Figure 12). This shows that ground strengthening plays a significant role in the prevention of displacement of the structure.

Figure 12. The sample of MC-1:13: Crack width changes along 30-days
