Structural assessment of traditional stone-timber houses in Turkey

Subject review

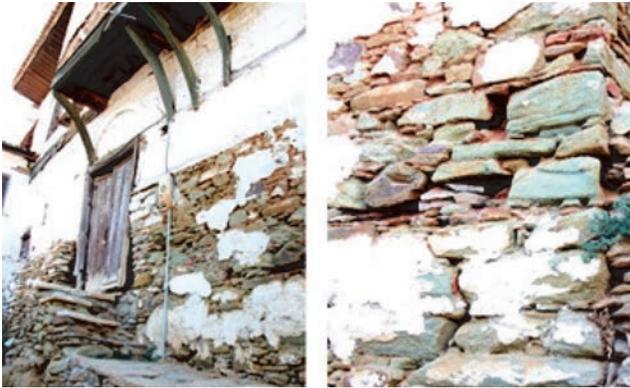
The damage to traditional Şirince houses is mostly due to degradation of structural elements and decay of structural materials. The main forms of degradation are the damage to structural elements, loss of material, and decrease in structural strength [21]. The structural condition of external load-bearing rubble stone masonry walls on the ground floor of these houses is generally poor. Some significant cracks were also discovered at external surfaces of these walls. These cracks are considered to be visual signs of structural deformations. In fact, cracks may occur due to several factors such as the soil settlement, temperature variations, excessive loads, and seismic effects. It was observed at these heritage houses that the cracks are located close to corners of rubble stone masonry walls, and that their orientation is generally vertical (Figure 8.). These cracks often appear at the top of the rubble stone masonry wall (or under the timber floor beam) and they propagate vertically towards the bottom of the wall. Rubble stone masonry walls at the ground floor have been extensively exposed to material degradation (Figure 9.). Moreover, as illustrated in Figure

Figure 8. Vertical cracks at the corners and at external surfaces of the rubble stone masonry walls

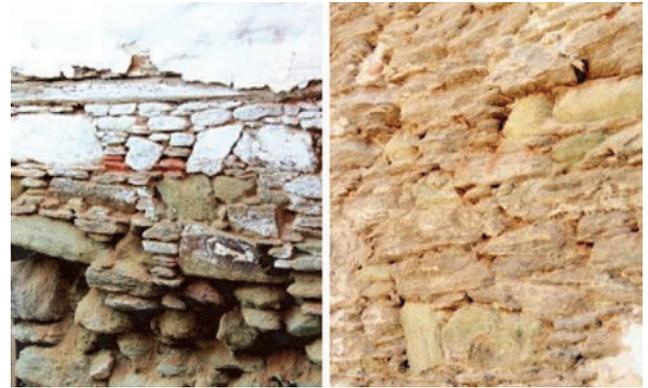
Figure 9. Material degradation in rubble stone masonry walls of the ground floor of traditional Şirince houses

9., the flaking, powdering, swelling, dampness, and stains have been observed at external surfaces of these walls. The mortar between rubble stone units is partially eroded. The loss of this binding material caused the decrease of structural resistance of these walls. The greatest damage to these stone walls is concentrated near the bottom of the wall. In some cases, the effects of abrasion have also been observed on rubble stone units of these masonry walls.

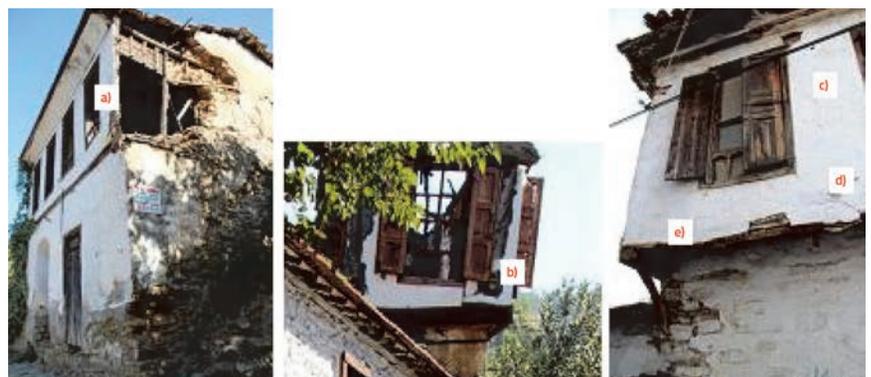
One of façade walls of the timber-framed structure was partly demolished at the timber framed upper floor (Figure 10.). This partial collapse of the structure is not common and can only be seen in cases of the most severe damage to traditional Şirince houses (Figures 10.a and 10.b). This type of structural damage might stem from the out-of-plane behaviour of timber-framed walls, and from the sole use of nailed connections between timber elements of timber-framed walls at the upper floor. As shown in Figure 10.c, there are many irregular micro cracks in the plaster of timber-framed walls at the upper floor of these houses. Besides, diagonal cracks have also been observed (Figure 10.d). These diagonal cracks generally start at the bottom corners of the window openings and extend downward diagonally to the timber floor level. This type of cracking may result from shear stresses caused by lateral forces. Another important structural damage is the deterioration of horizontal timber beams (timber sole plates) placed on top of the rubble stone masonry walls. In some cases, structural damage in form of horizontal sliding has been registered, as illustrated in Figure 10.e.

Figure 10. Examples of the most severe structural damage observed in the upper-floor timber framed structure of traditional Şirince houses: a) partial collapse at one of lateral timber framed walls; b) out-of-plane behaviour of timber framed walls; c) many irregular cracks on the surface of the plaster between openings in the upper floor; d) diagonal cracks under the bottom corner of a window opening; e) horizontal sliding damage at the floor level

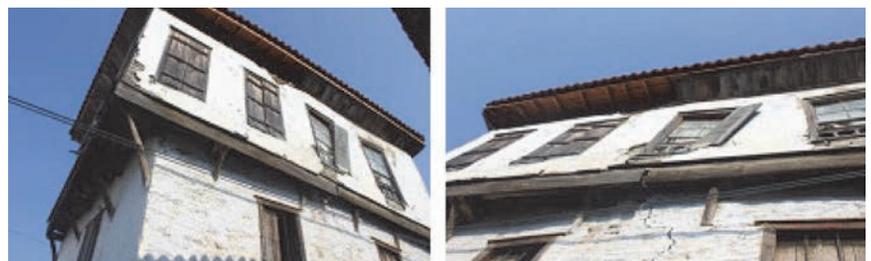
Figure 11. Example of structural damage to a typical traditional Şirince house (August 2013)

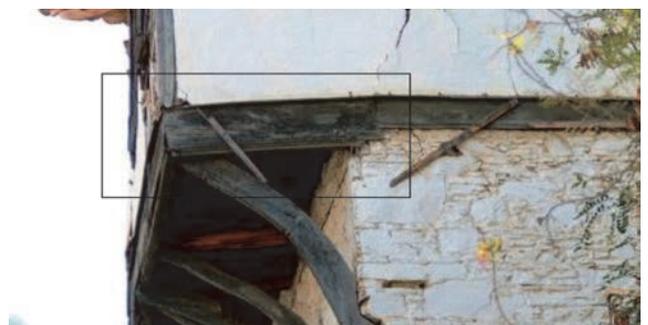
Figure 12. Distortion of horizontal timber element

beams, which are placed along the top of stone masonry walls in traditional Şirince houses. In some cases, it causes disintegration of structural elements at the floor level even in case of very small displacements (Figure 11.). The detachment was observed between the horizontal timber element and the stone masonry wall. In addition, some cracks were observed along the entire length of stone masonry walls under horizontal timber beams. Also, distorted timber elements are rarely observed at the end of timber floor beams under the projections (Figure 12.).

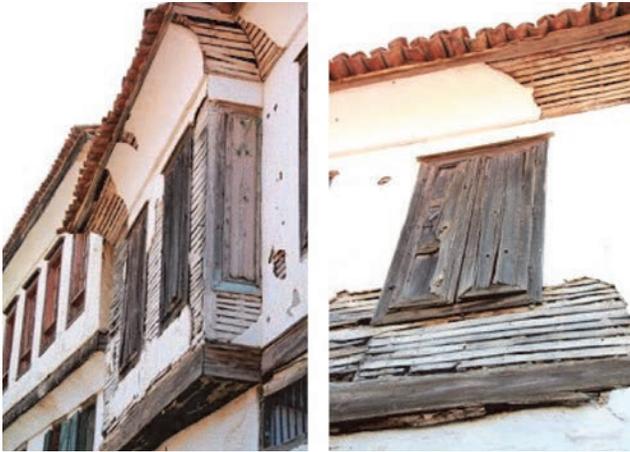
Figure 13. Plaster damage on the surfaces of timber framed walls in the upper floors of traditional Şirince houses (August 2013)

After comparison of types of deterioration registered in these houses, it was established that the most common cause of deterioration is the loss of plaster (Figure 13.). Major plaster damage was mostly observed on the wooden laths in timber framed walls, and underneath the eaves. Lime plaster has partly detached from exterior surfaces of wooden laths.

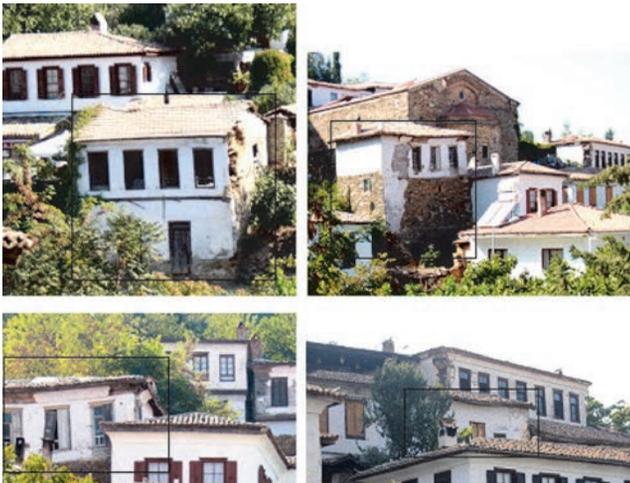
Figure 14. Examples of roof deterioration in traditional Şirince houses

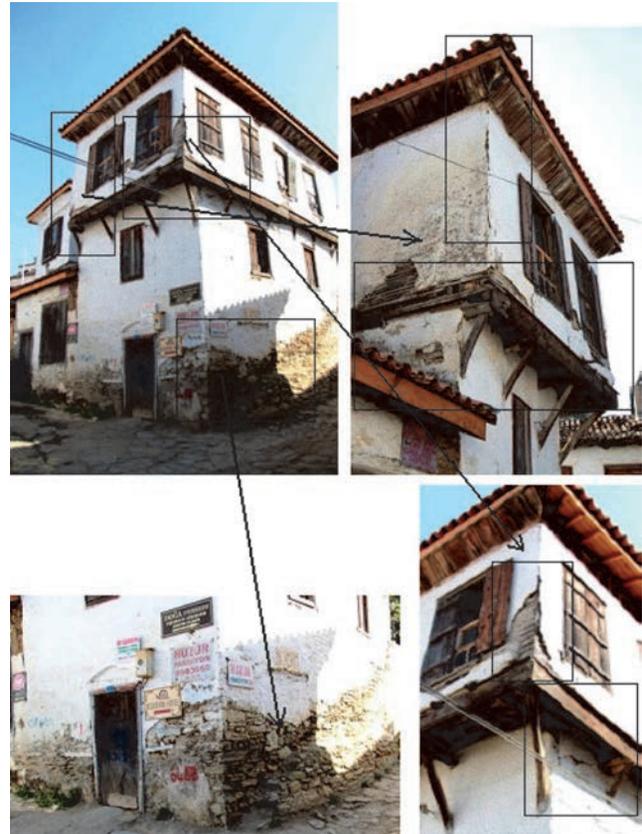
Although biological decay of wood is not commonly seen in traditional Şirince houses, the discoloration and staining are extensively observed on wooden windows, door sills and wooden boards that are used for covering the bottom of eaves and projections. This type of decay in wooden boards is caused by the presence of rainwater

Figure 15. Typical examples of structural damage and material decay in traditional Şirince houses (August 2013)

on their surfaces and negative effects of sunlight. In fact, wooden boards underneath the eaves become wet mostly because of the lack of gutters on the roofs of these houses. The roof deterioration is also observed as the roof structure sagging, although it is not a deterioration commonly observed in these types of structures (Figure 14). In addition, the condition of the exterior lime wash is poor. The flaking and staining can be observed on wall surfaces. Most common instances of structural damage and material decay registered in traditional Şirince houses are shown in Figure 15.

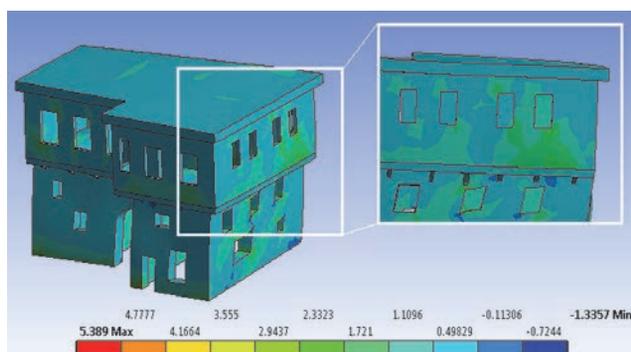
Figure 24. Maximum principal stress contours (MPa)

It was established that maximum principal stresses amount to about 5.389 MPa around the connection to the entrance gate, at window sides, and at upper parts of the entrance wall.

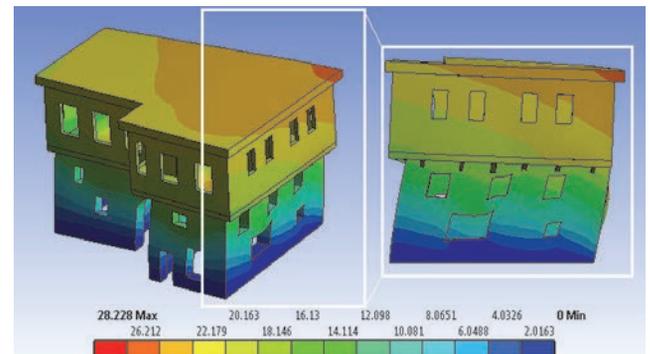
Lateral displacement of about 28 mm was registered at the top of the roof (Figure 25.).

Figure 25. Maximum lateral displacement contours (mm)
