# VERIFICATION OF THE MATERIAL PROPERTIES OF THE STRUCTURE ELEMENTS OF COMPRESSOR STATION FOR THE NEEDS OF THEIR REDESIGN

This paper discusses the importance and complexity prediction of fatigue life in connection with reconstruction or rebuilding of compressor station and in connection with degradation of material and change of its static and fatigue mechanical characteristics. The subject of the research is the piping ring, which was removed above a T-module of a turbocompressor of compressor station. The paper brings partial results of testing and analysis of the macrostructure and mechanical properties of the base material and the material in the weld area of removed piping ring.

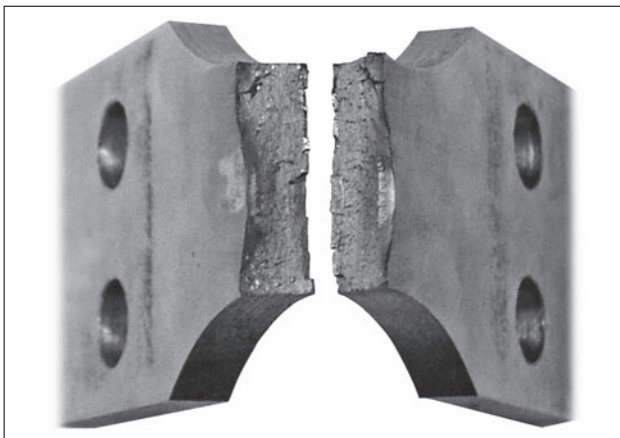
**Figure 6** 2 parts of specimen after the low-cycle fatigue test

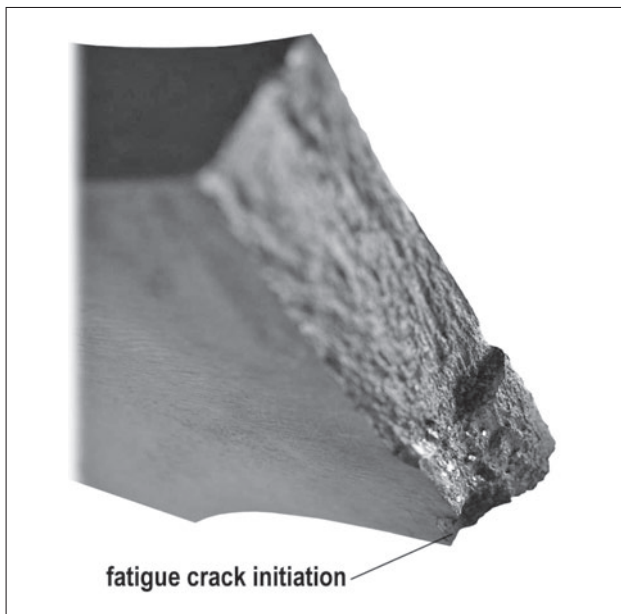
For the fatigue properties tests specimens were removed from the detached ring from location 11 and specimens containing weld from locations 12, 13 for test by flat bending and from locations 14 and 15 for tensile tests (Figure 4). Shape and size of the test specimens were selected so that the transition area of the weld was located in the thinnest part of the specimen. Tests were performed on a testing pulsator, which allowed dynamic tests during alternating symmetrical bending at loading up to 400 Nm. In first stage of the tests stress amplitudes  $\sigma_a = 240$  MPa were selected. In this mode, specimens remained undisturbed even at  $2,6 \times 10^6$  cycles. In second stage, the amplitude was increased to level  $\sigma_a = 450$  MPa, which for given material already represents an area of low-cycle fatigue. Specimens failure occurred at level  $8 \times 10^3$  cycles, with the shape of fatigue fracture according to Figure 6. Fatigue crack initiated at the edge of the test specimen according to Figure 7, in location of welding joint imperfection. Nature of the fracture line is illustrated on Figure 8

**Figure 7** Test specimen failure during cyclic stress

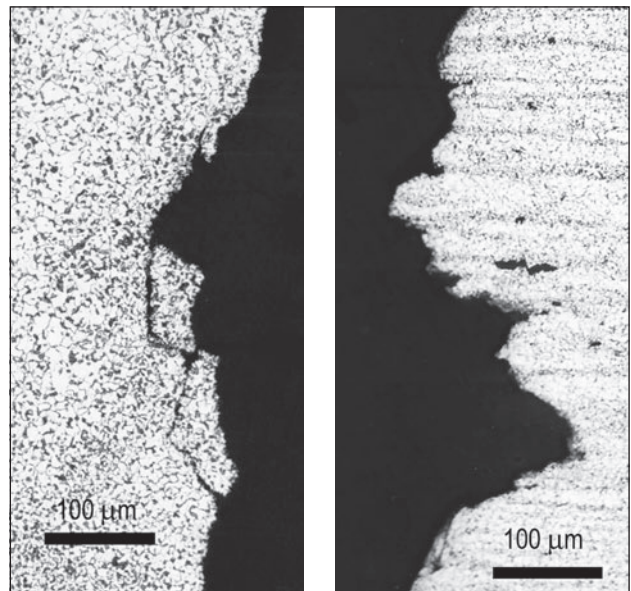
**Figure 8** Profile of the fracture line on the failed test specimen and on the specimen with secondary cracks

on the left. Fatigue crack spreading was also influenced by inclusions in base material and by rows of perlite. Secondary cracks parallel to rows of perlite are visible in Figure 8 on the right.

The results of metallographic analysis show that under given conditions of stress initiation of fracture process occurred in the area of weld metal and the spread of the fracture itself took place in base material.

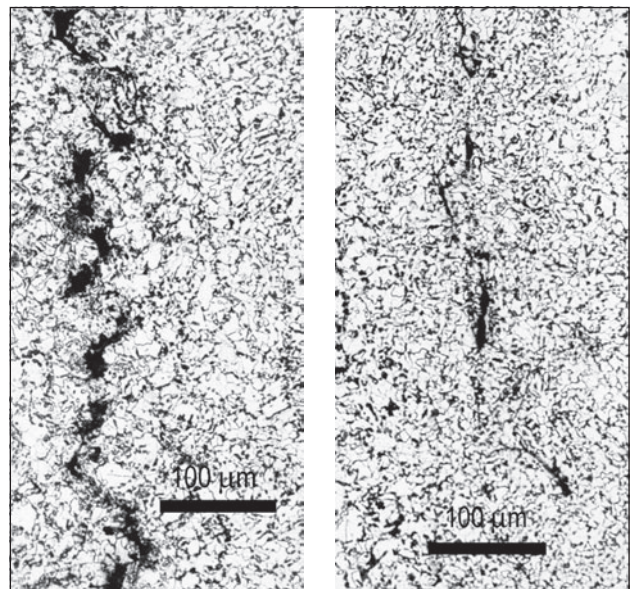
Figure 9 shows microstructure of the transition area. Microcracks were identified in the area of the welding joint, specifically on the intersection of weld metal (Figure 9 left) and heat affected area (Figure 9 right).

**Figure 9** Microcracks in the area of welding joint and in the transition area

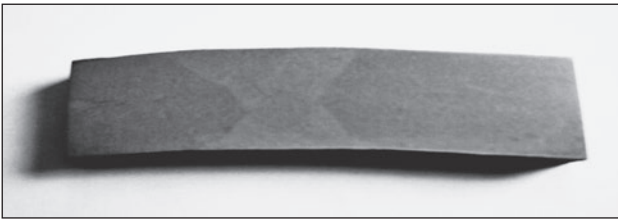
Weld metal is entire, shaped as “X” and comprised of multiple layers (Figure 10).

**Figure 10** Cross-cut section of pipe wall with welding

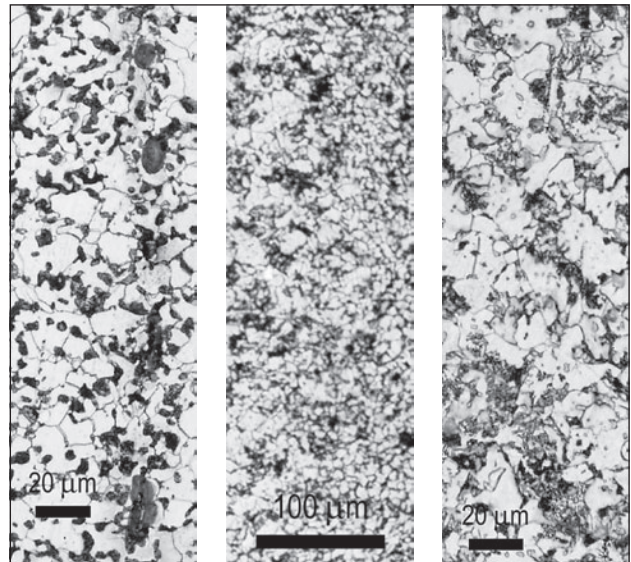
Microstructure of the base material (Figure 11 left) is ferrite-perlite of ferrite grain less than  $0,015 \mu\text{m}$ . Characteristics of structure correspond to a state after

annealing. Figure 11 in the middle illustrates transition from the heat affected area to the area of weld metal. Transition is smooth; ferrite-perlite structure is coarser with oriented arrangement. Figure 11 on the right shows microstructure in the area of weld metal. Structure consists of ferrite and perlite with directed arrangement of perlite. Structure also contains small cement particles.

**Figure 11** Microstructures: base material, heat affected area and weld metal
