THE POSSIBILITY OF TRIBOPAIR LIFETIME EXTENDING BY WELDING OF QUENCHED AND TEMPERED STAINLESS STEEL WITH QUENCHED AND TEMPERED CARBON STEEL

Key words: welded joint, martensitic stainless steel, tribopair, carbon steel, life time

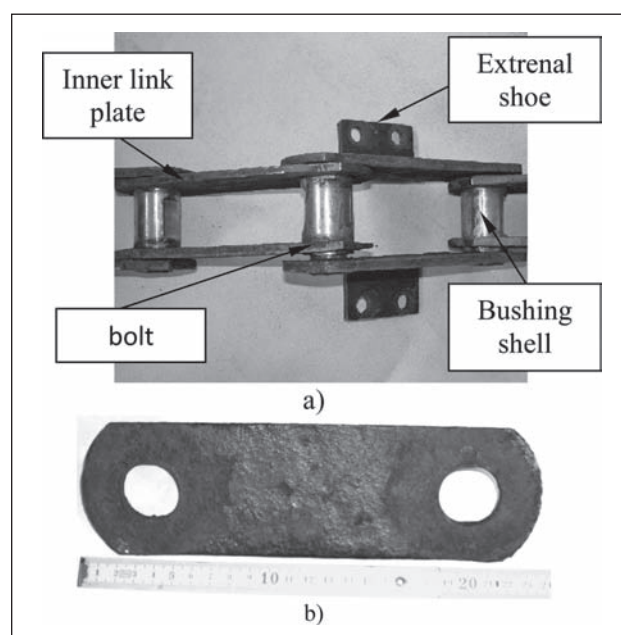
bolt, and buckets that are bolted on link shoes. Link shoes are every third connecting link of the chain. The measured sprocket surface hardness was between 56 and 59 HRC. Figure 1 shows the parts of the original elevator chain after approx. six months of work. It should be noted that original bolts are welded for external link plates and internal link plates are attached with bushing shell by pressing. On several connections of internal link plates there are several loose connections.

Values measured during the dimensional control are wear of a bolt ≈ 3 mm (Only the surface of bolt which is in contact with bushing shell is worn), and ear

Figure 1 The appearance of damaged chain (a), and original damaged link plate (b)

of a bushing shell on the outside $\approx 2,2$ mm and on the inside to ≈ 1 mm, with emergence of upsetting compound bushing layer of bushing shell/link plate and increasing the gap at about 0,8 mm by every loose connection. Chain pitch is 160 mm and a total length is 32 m. Estimated total elongation at that chain length is 1 600 mm.

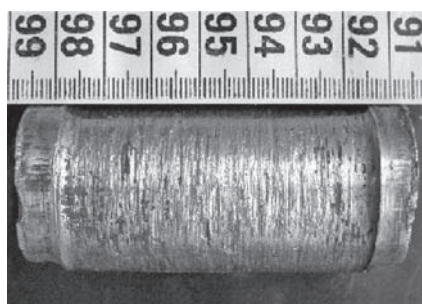
Figure 2 The appearance of the original bolts "worn place"

- Bushing shells and bolts are made of austenitic stainless steel and were damaged by abrasion particles of crust but also by adhesion in the area of mutual contact,
- Because of a corrosion impact of aggressive media on link plates and link shoes, damaging of their connecting spots with pressed bushing shells has been observed.

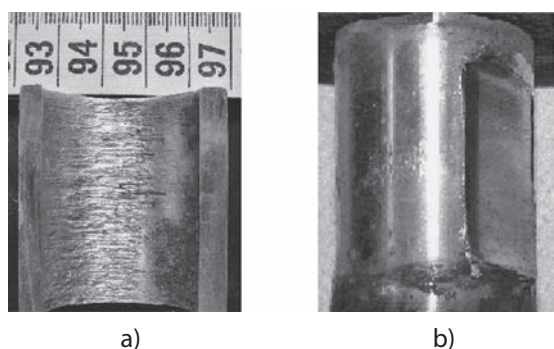
Figure 3 The appearance of the original bushing shell on spot „worn place“ (a), macro recording of cross-sectional sample (b)

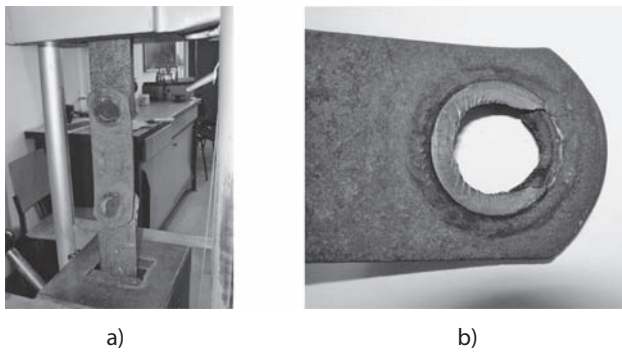
In order to verify welded joint of bolt/link plate, static tensile tests, were conducted on the testing machine, Figure 4a. The load is added until the termination of welded joint, and broken places served for metallo-

Figure 4 Testing of welded joint of bolt/link plate (a); External link plate after breaking (b)

graphic examination and hardness control. The appearance of the welded compound link plate/bolt after testing is shown on Figure 4b. Welded joint of external link plate was broken at 170 kN force.

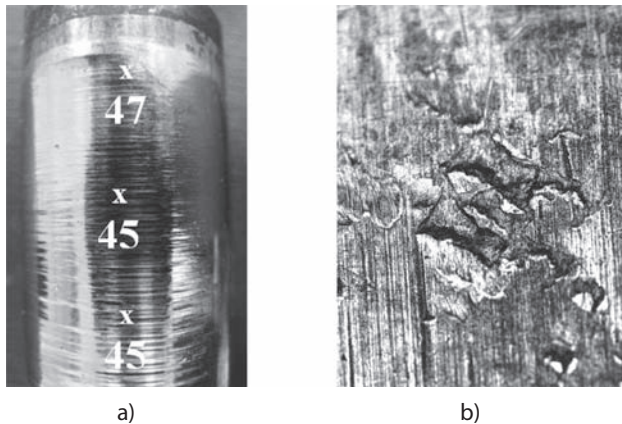
Figure 5 Characteristic wear traces of bolts, macro (a); micro, magn. 50 x (b)

Typical wear traces of bolts are shown at Figure 5a and 5b.

Dimensional control was conducted on test sample of bolts with calibrated calliper. Conclusion was based on measurements on dozen positions. On the most spent part, a diameter is 29,7mm. Compared to the measurement of a new bolt, that is wearing of $\approx 0,3$ mm. Wear traces of the towing part of the stud, are characterized by radial furrows caused by abrasive action of tiny particles of sunflower and bushing shell. These particles, came in contact with bolt/bushing shell, during the work and considering the hardness of micro abrasives of ≈ 6 Mohs „furrows“ are interrupted at the point of encountering on harder carbides. Microstructures and hardness of bolts, plates, weld and HAZ are shown in Figure 6.

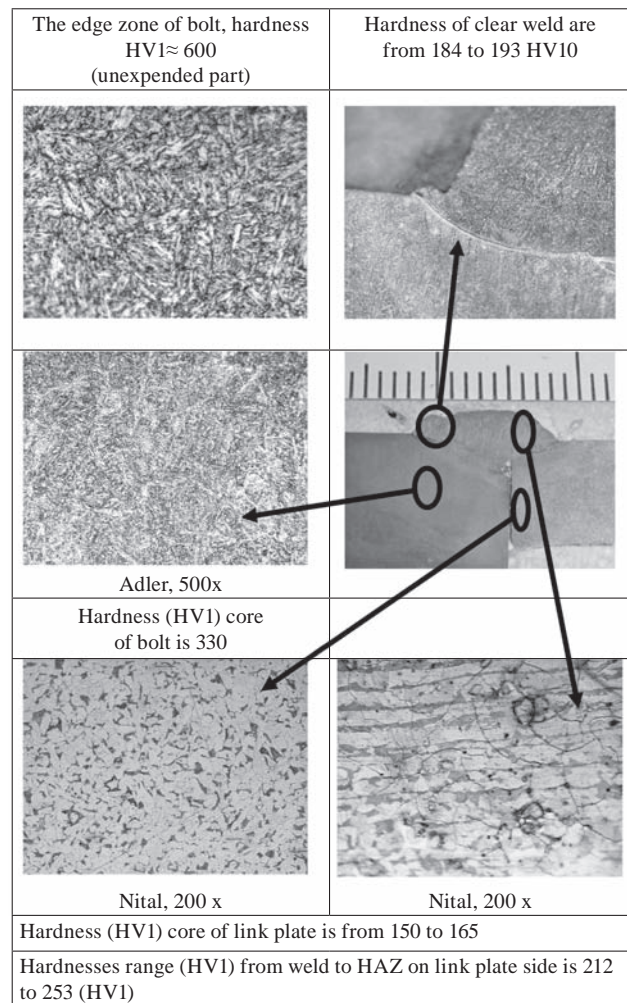
Figure 6 Microstructures and hardness of bolt and link plate

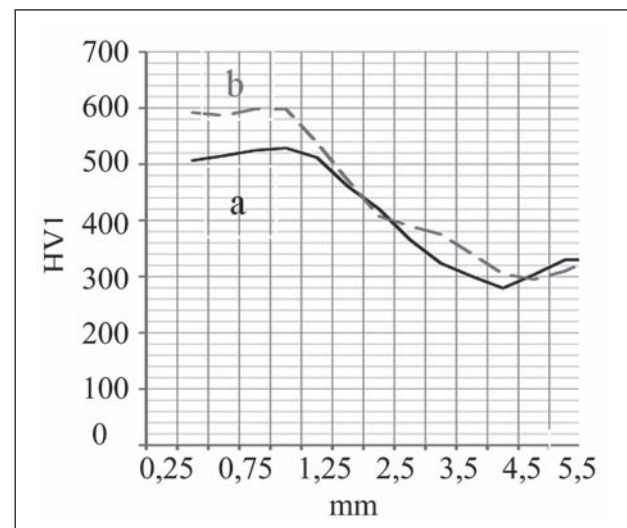
Diagram in Figure 7 shows the flow of hardness HV1 from the edge to the core of the bolts (curve *a*) and on bushing shell (curve *b*). Results of bushing shell dimensional control shows that there is an intensive wear in contact area with the bolt, and wall thickness is reduced from 6 to ≈ 3 mm.

Figure 7 Hardness flow; bolt (a); and bushing shell (b)

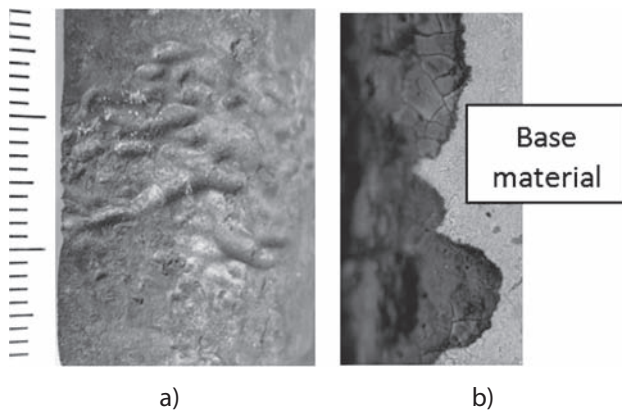
Figure 8 a shows characteristic wear traces of external surface of bushing shell, and Figure 8 b shows wear traces of bushing shell from the inside in contact with bolt.

Figure 8 A typical wear traces of external carburized surface of bushing shell (a); the outer surface (macro), inner surface (magn. 500 x) (b)

- carburized bushing shells are damaged by abrasion and corrosion due to action of acid media that has pH value $\approx 5,2$,
- maximum measured breaking force of weld joint bolt/link plate is higher than the calculated breaking force of chain. Although, the main task of weld in this tribosystem is, to maintain a continuous connection between bolt and bushing shell during the use. It helps to avoiding unexpected damages noticed on original chain caused because of “riveting” of that joint and consequently jumping upon connecting links on the sprocket teeth.
