Monika PETROVIĆ

RESTAURACIJA NOVOVJEKOVNE STAKLENE ZDJELICE IZ PULE

THE RESTORATION OF A MODERN AGE GLASS BOWL FROM PULA

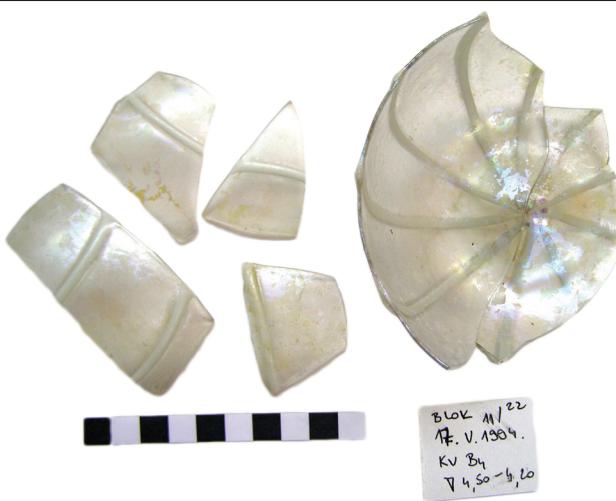
Od cjelovitog, izvornog stanja zdjelice bilo je sačuvano pet ulomaka koji su se međusobno spajali. Bilo je moguće ustanoviti da u odnosu na cjeloviti predmet nedostaje oko 30 % tijela. Stakleni su ulomci oprani mekanim kistom u destiliranoj vodi (sl. 1).

Sl. 1 Sačuvani ulomci staklene zdjelice.
Fig. 1 The preserved fragments of the small glass bowl.

There were only five mutually connecting fragments that were preserved from the entire bowl. It was likewise possible to establish that approximately 30% of the body of the bowl is missing. The glass fragments were washed in distilled water with the help of a soft brush (Fig. 1).

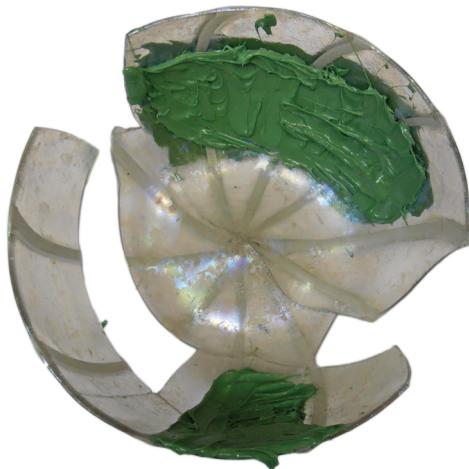
Sl. 3 Istraženi vanjski i unutarnji otisak dvokomponentnim vinil-polisilosanskim silikonom.

Fig. 3 The outer and inner impressions made with bi-component vinyl-polysiloxane silicone.

Slijedila je izrada nadogradnje nedostajućih dijelova. Izrađeni su precizni vanjski i unutarnji otisci s originala, dvokomponentnim vinil-polisilosanskim silikonom (*3M ESPE express*) (sl. 3). Kalup je zatim pažljivo smješten na odgovarajuću poziciju tik uz originalno staklo i zalipljen cijanoakrilnim ljepilom (*Super Attakom*) na nedostajući dio predmeta. Na odgovarajućim mjestima vanjskog kalupa napravljene su perforacije za lijevanje dvokomponentnog epoksidnog ljepila (*Araldite 2020*) te odušak za zrak (po potrebi jedan ili više njih). Zatim su na otvore postavljene PVC slamke (sl. 4). Predmet je stabiliziran u odgovarajuću poziciju u posudu s pijeskom, a zatim je u najnižu slamku lijevano dvokomponentno epoksidno ljepilo. Nakon 24 sata sušenja nadogradnje silikonski kalup je uklonjen, a višak je odstranjen vatiranim štapićima u etanolu te mehanički uz pomoć skalpela.

What followed was the actual reconstruction of the missing parts. A precise outer and inner impression was made from the original, using a bi-component vinyl-polysiloxane silicone (*3M ESPE express*) (Fig. 3). The mold was then carefully placed on the required position next to the original glass, and glued with cyanoacryl glue (*Super Attak*) onto the original part of the object. Perforations were subsequently made on the appropriate spots of the outer mold, in order to pour the bi-component epoxy glue (*Araldite 2020*), as well as air escape vents (one or more of them, according to need). PVC straws were then placed into these openings (Fig. 4). The object was

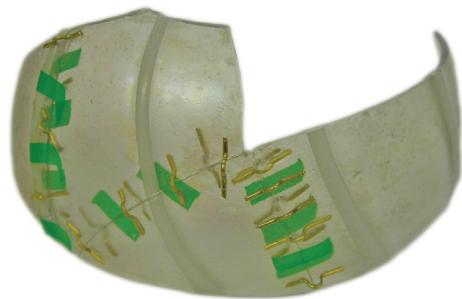
Sl. 2 Zdjelica učvršćena ljepljivom trakom te s vanjske strane dodanim pomoćnim klemficama od mesinga.

Fig. 2 The bowl that has been strengthened with self-adhesive tape and on the outer side with auxiliary brass clamps.

Usljedilo je privremeno fiksiranje ulomaka tankom ljepljivom krep-trakom. Cijanoakrilnim ljepilom (*Super Attak*) pričvršćene su s vanjske strane ulomaka dodatne pomoćne klamfe od mesingane žice. Nakon što su ulomci spojeni ovim postupkom, uklonjena je ljepljiva krep-traka. Privremenim su učvršćivanjem zdjelici vraćeni kompaktnost i oblik. Uz pomoć klamfi svi su sačuvani ulomci učvršćeni te je na spojeve loma naneseno dvokomponentno epoksidno ljepilo (*Araldite 2020*) (sl. 2). Nakon 24 sata sušenja zdjelica je uz pomoć skalpela očišćena od viška ljepila, zatim su polako mehanički i uz pomoć obloga etanola odstranjene metalne klamfice te je laganim tapkanjem vatom natopljenom alkoholom staklena površina do kraja očišćena.

The fragments were then temporarily attached together using thin, self-adhesive masking tape. In addition, auxiliary brass wire clamps were fastened on the outer surface of the fragments with the help of cyanoacryl glue (*Super Attak*). After the fragments were connected together with this procedure, the self-adhesive masking tape was removed. With this temporary measure, the vessel obtained its compactness and form. The clamps

were used to affix the preserved fragments, and a bi-component epoxy glue was put onto the breakage joints (*Araldite 2020*) (Fig. 2).

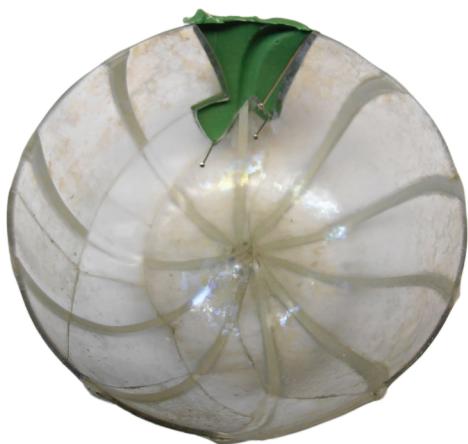
Sl. 4 Kalup smješten na odgovarajuću poziciju uz original.
Fig. 4 The mold that has been placed in an appropriate position next to the original.

stabilized in the required position in a vessel containing sand. The bi-component epoxy glue was then poured through the lowest straw. After the reconstruction was left to dry for a 24-hour period, the silicone mold was removed, the excess material was eliminated either with cotton swabs soaked in ethanol, or mechanically, using a scalpel.

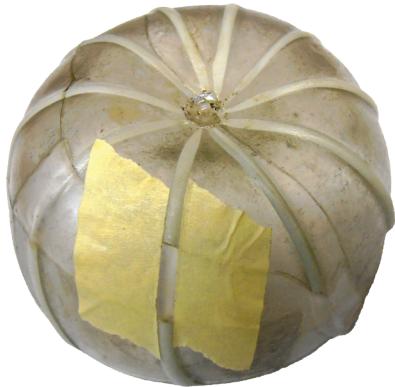
Sl. 5 Zaštita krep ljepljivom trakom prije bojanja nadograđenih rebara zdjelice.
Fig. 5 A protection consisting of crepe self-adhesive tape, before painting the reconstructed ribs of the bowl.

Učinjena je test-proba najprikladnije vrste boje (tempera, akril i uljana). Najbolje je rezultate davala uljana boja, zbog najsličnjeg vizualnog efekta, viskoznosti i trajnosti. Nadograđena rebra staklene zdjelice retuširana su bijelom uljanom bojom (sl. 5, sl. 6).

A test-trial was made in order to determine the most appropriate kind of paint (tempera, acryl or oil paint). The best results were obtained with oil paint because the visual effect was most similar to the original, but also due to its viscosity and durability. The reconstructed ribs of this small glass bowl were then retouched with white oil paint (Fig. 5, Fig. 6).

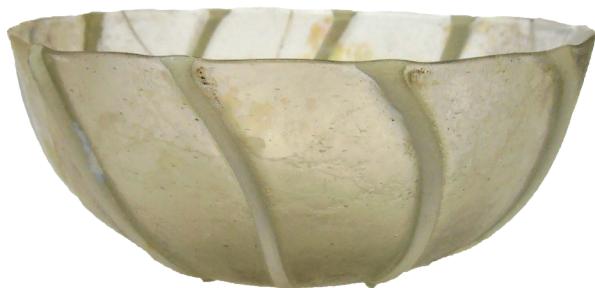
Sl. 6 Novovjekovna staklena zdjelica nakon restauratorskih zahvata.
Fig. 6 The Modern Age glass bowl after restoration.
