# RELIABILITY, CONDITION DIAGNOSTICS AND RECONSTRUCTION OF THE EXTREMELY DAMAGED BUILDING

**Slobodan Grković, Danijel Kukaras, Petar Santrač, Viktorija Aladžić, Željko Bajić**

Subject review

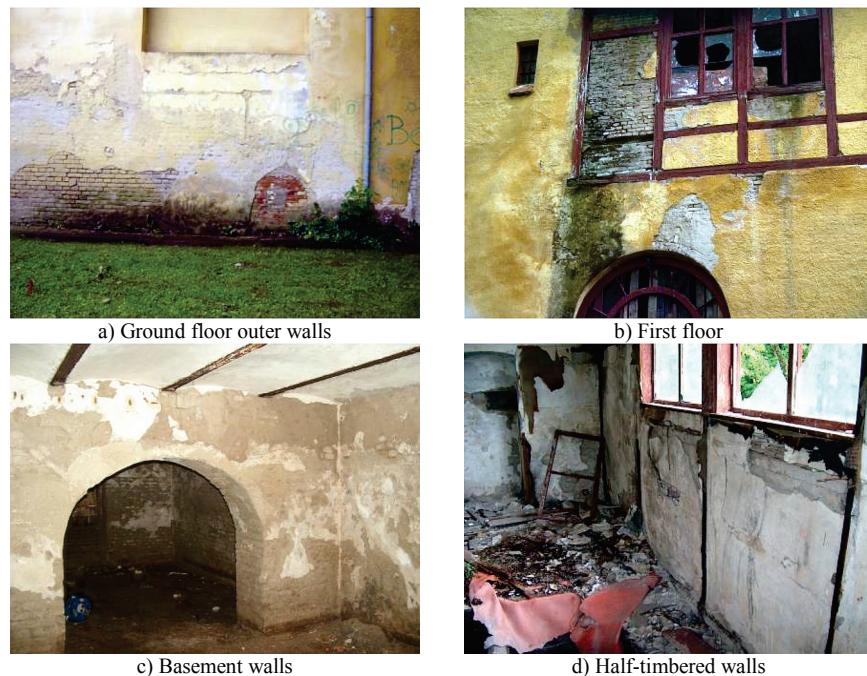
Figure 2 General condition of the walls

**Walls** (Fig. 2). The building was constructed with bricks produced in the "old" format  $30 \times 15 \times 7,5$  cm; foundations are 90 cm wide. Outer bearing brick walls in the basement are 80 cm wide, in the ground floor 60 cm

No.	Condition grading	Description	Intervention and maintenance type	Deadline	Manifestation
2	Not satisfactory	Very damaged	Reconstruction/sanation	Up to 1 year	Damp, porous mortar joints, mould spots
3	Poor	Damaged	Intervention and maintenance	Up to 2 years	Damp, fissures, cracks

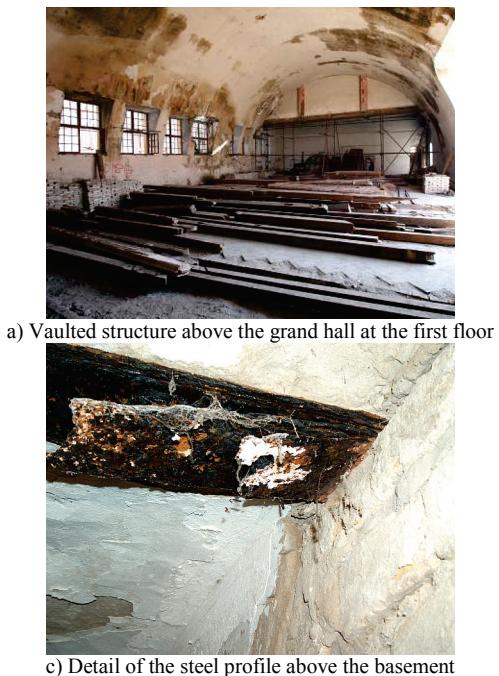
**Figure 3** General condition of floor structures

Inspection revealed significant damages of floor structures above the grand hall, first storey, basement and a greater portion of the ground floor that resulted from years of poor maintenance and intensive atmospheric

effects, water and moisture. Parts of the structure were deformed or devastated beyond any tolerance. Steel profiles above basement were completely corroded and partially collapsed. Quality of bricks, concrete and steel was determined through test samples taken from undamaged portions of structural elements and they revealed a good compliance with code requirements what leads to conclusion that material choice during construction from 1909 to 1912 was sound.

No.	Condition grading	Description	Intervention and maintenance type	Deadline	Manifestation
1	Dangerous	Collapse imminent	Urgent reconstruction/sanation	Urgent	Localized failures, deformations, rusted rebar, cracks
2	Not satisfactory	Very damaged	Reconstruction/sanation	Up to 1 year	Mould spots, fissures, rusted/exposed rebar

On floor structures above the basement a replacement of bigger portion of the structure was conducted with new, full depth RC slab of 16 cm thickness. This slab is

supported by the new basement RC structure walls and/or it was supported within existing brick walls by means of cutting the slab into these walls. This structure, together with RC structure in the basement improved the seismic resistance of the building. Smaller portion of the structure above the basement - brick barrel vaults with steel profiles - were completely reconstructed: old steel profiles were replaced by the new ones and then shallow brick vaults were constructed. Structure of brick barrel vaults and steel profiles above the ground floor (beneath the grand hall) is joined with new RC slab with new steel shear connectors thus creating a composite steel-concrete structure with increased load capacity that also contributes to overall stability and load resistance of the structure. All damaged brick arches were repaired and/or reconstructed [17].

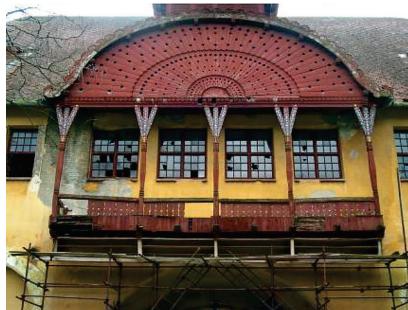
a) Terrace located at the northern facade

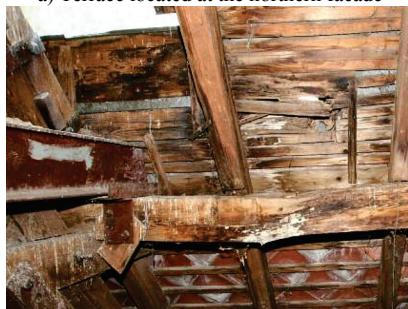
c) Detail of the roof structure

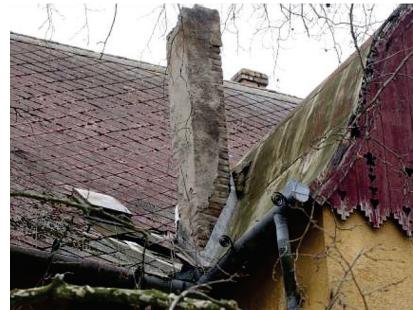
b) Detail of the central roof section

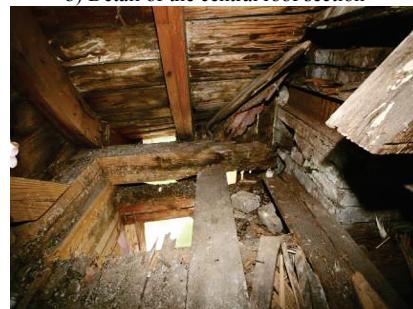
d) Detail of the roof structure

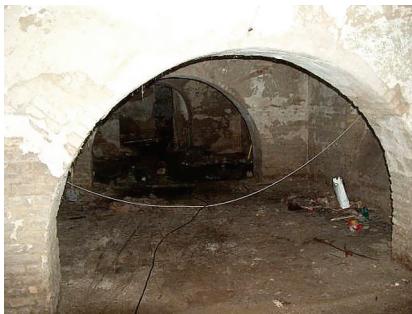
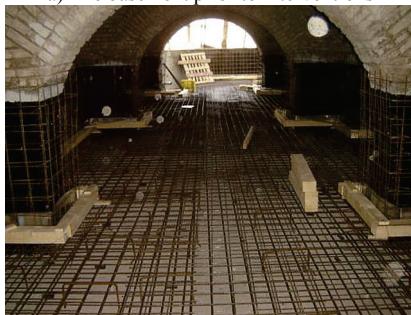
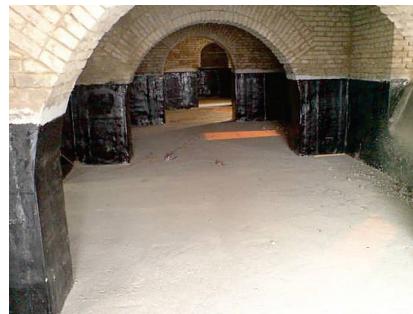
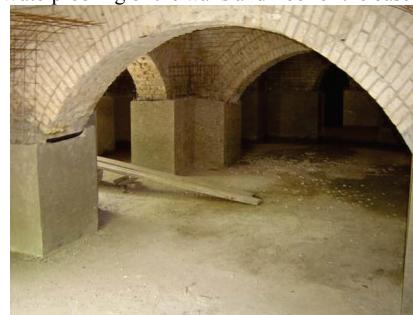
**Figure 7** Interventions in basement

a) The basement prior to interventions

**Phase II – reconstruction, repair and strengthening of remaining structure** (Figs. 7, 8 and 9) [5, 11]. According to the determined condition of the structure, preliminary design and functional demand by the Investor, Phase I was followed by Phase II which included interventions of divers levels: foundation strengthening, construction of the RC water tight structure, repair and strengthening of the floor structures, construction of new and strengthening of the existing stairways and construction of the new semi-circular bays on the northern facade. Construction of the water tight RC structure in the basement (RC slab of 25 cm thickness for horizontal section and 15 cm thickness for walls) was initiated by the Investor's demand for proposed basement use (wine cellar and restaurant kitchen, etc.) and it represented a demanding construction task due to the fact that the lower horizontal slab surface was considerably lower from the bottom level of the foundation and construction was conducted under high ground water level that had to be constantly monitored and lowered. This intervention required all existing wall foundations to be lowered by constructing concrete foundations in sections beneath the whole building. Concrete used for this purpose had specially and precisely defined properties. Special waterproofing layers were placed as the first line of defence from the ground water.

c) Reinforcements of the slab and walls of the RC structure

b) Waterproofing of the walls and floor of the basement

d) The basement after interventions
