A MECHANISM ANALYSIS OF TRANSVERSE WELD CRACKS OF MARINE THICK STEEL PLATE

Haibo Wang, Dongpo Wang, Fangjie Cheng, Ying Wang

Original scientific paper

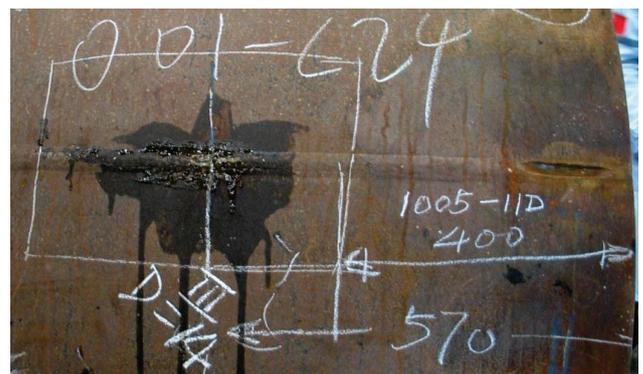
In the process of making welded rods of large thickness and large diameter for offshore oil platform, some defects are detected by ultrasonic wave in rods welded of 30 mm steel plates and are suspected transverse weld cracks. Such rods are made of DH36 (ASTM A131) ship steel plates, which are qualified in reinspection. The plate is rolled into a cylinder with a diameter of 1.6 m and a length of 3 m and is welded with the technique of submerged arc welding (SAW). Then girth weld is done to connect rods using JW-1 welding wire and JF-B flux. Cracks mainly occur in longitudinal joints and 50 % of rods have cracks and one rod has several cracks. There are also same defects in girth welds.

Figure 1 Rods with transverse cracks detected by ultrasonic test

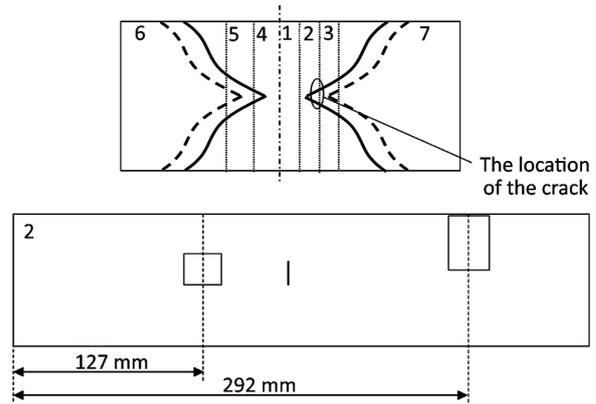
Figure 2 Middle layer of cut samples and the No. 2 spline

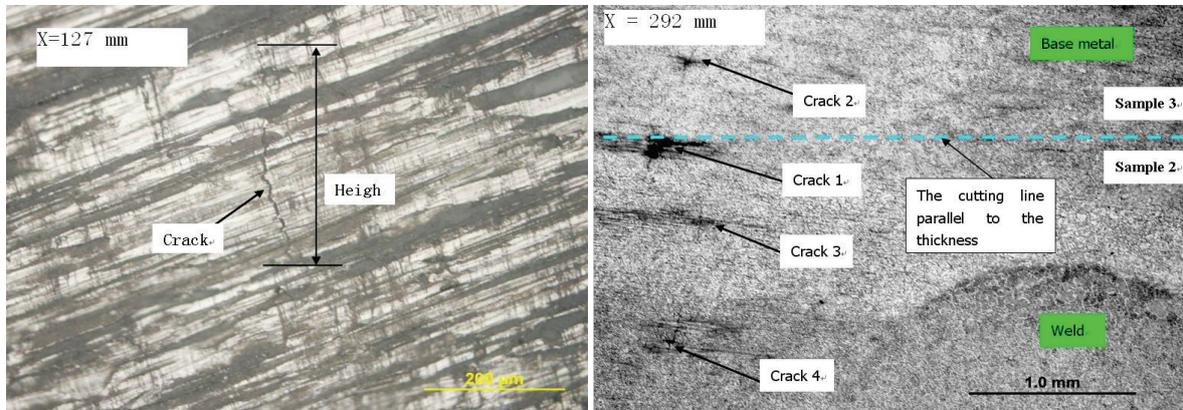
longitudinal coordinate positions are $X=127$ mm and $X=292$ mm, which are in line with the ultrasonic flaw detection results (Fig. 3).

Figure 3 Photos of cracks detected at $X=127$ mm and $X=292$ mm

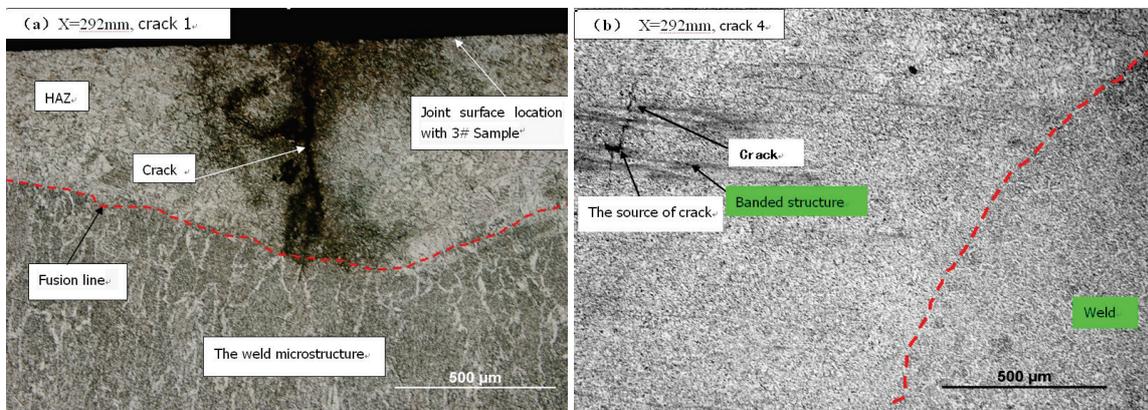
Just as shown in Fig. 4, the crack is all in the HAZ along its longitudinal direction. Several transverse cracks are discovered on this section. Cracks often start from the pearlite strip of incompletely banded structures. There are also cracks parallel to the thickness direction, crossing transverse cracks.

Figure 4 Longitudinal direction and microstructure of crack 1 at $X=292$ mm

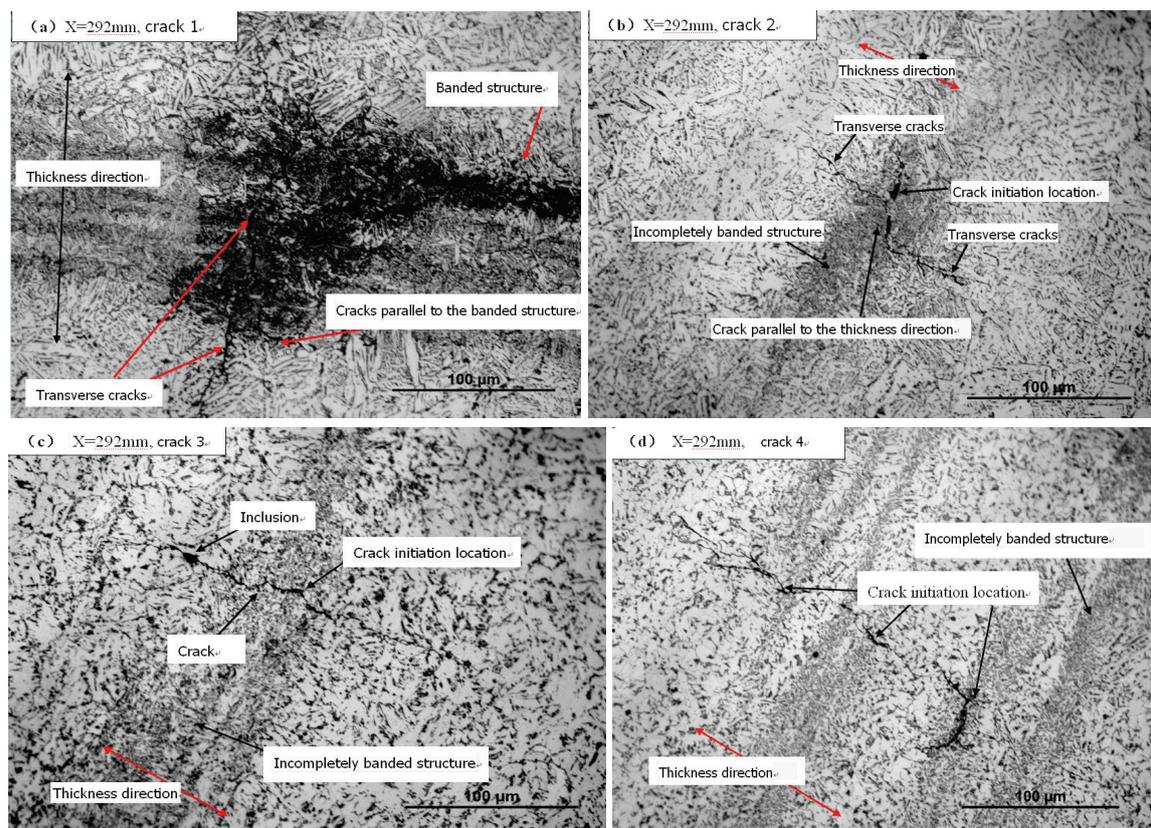
From Fig. 5 we can see that along the crack's thickness direction, it is also in the HAZ of the base steel.

Several inclusions are discovered in the cracks and there is an obvious incompletely banded structure. These minor

cracks all start from the pearlite strip of incompletely banded structures. There are also cracks parallel to the thickness direction, crossing transverse cracks. Therefore,

we have reasons to doubt whether the occurrence of cracks is related with the banded structure.

Figure 5 Thickness direction and microstructure of crack 1 at $X=292\text{mm}$

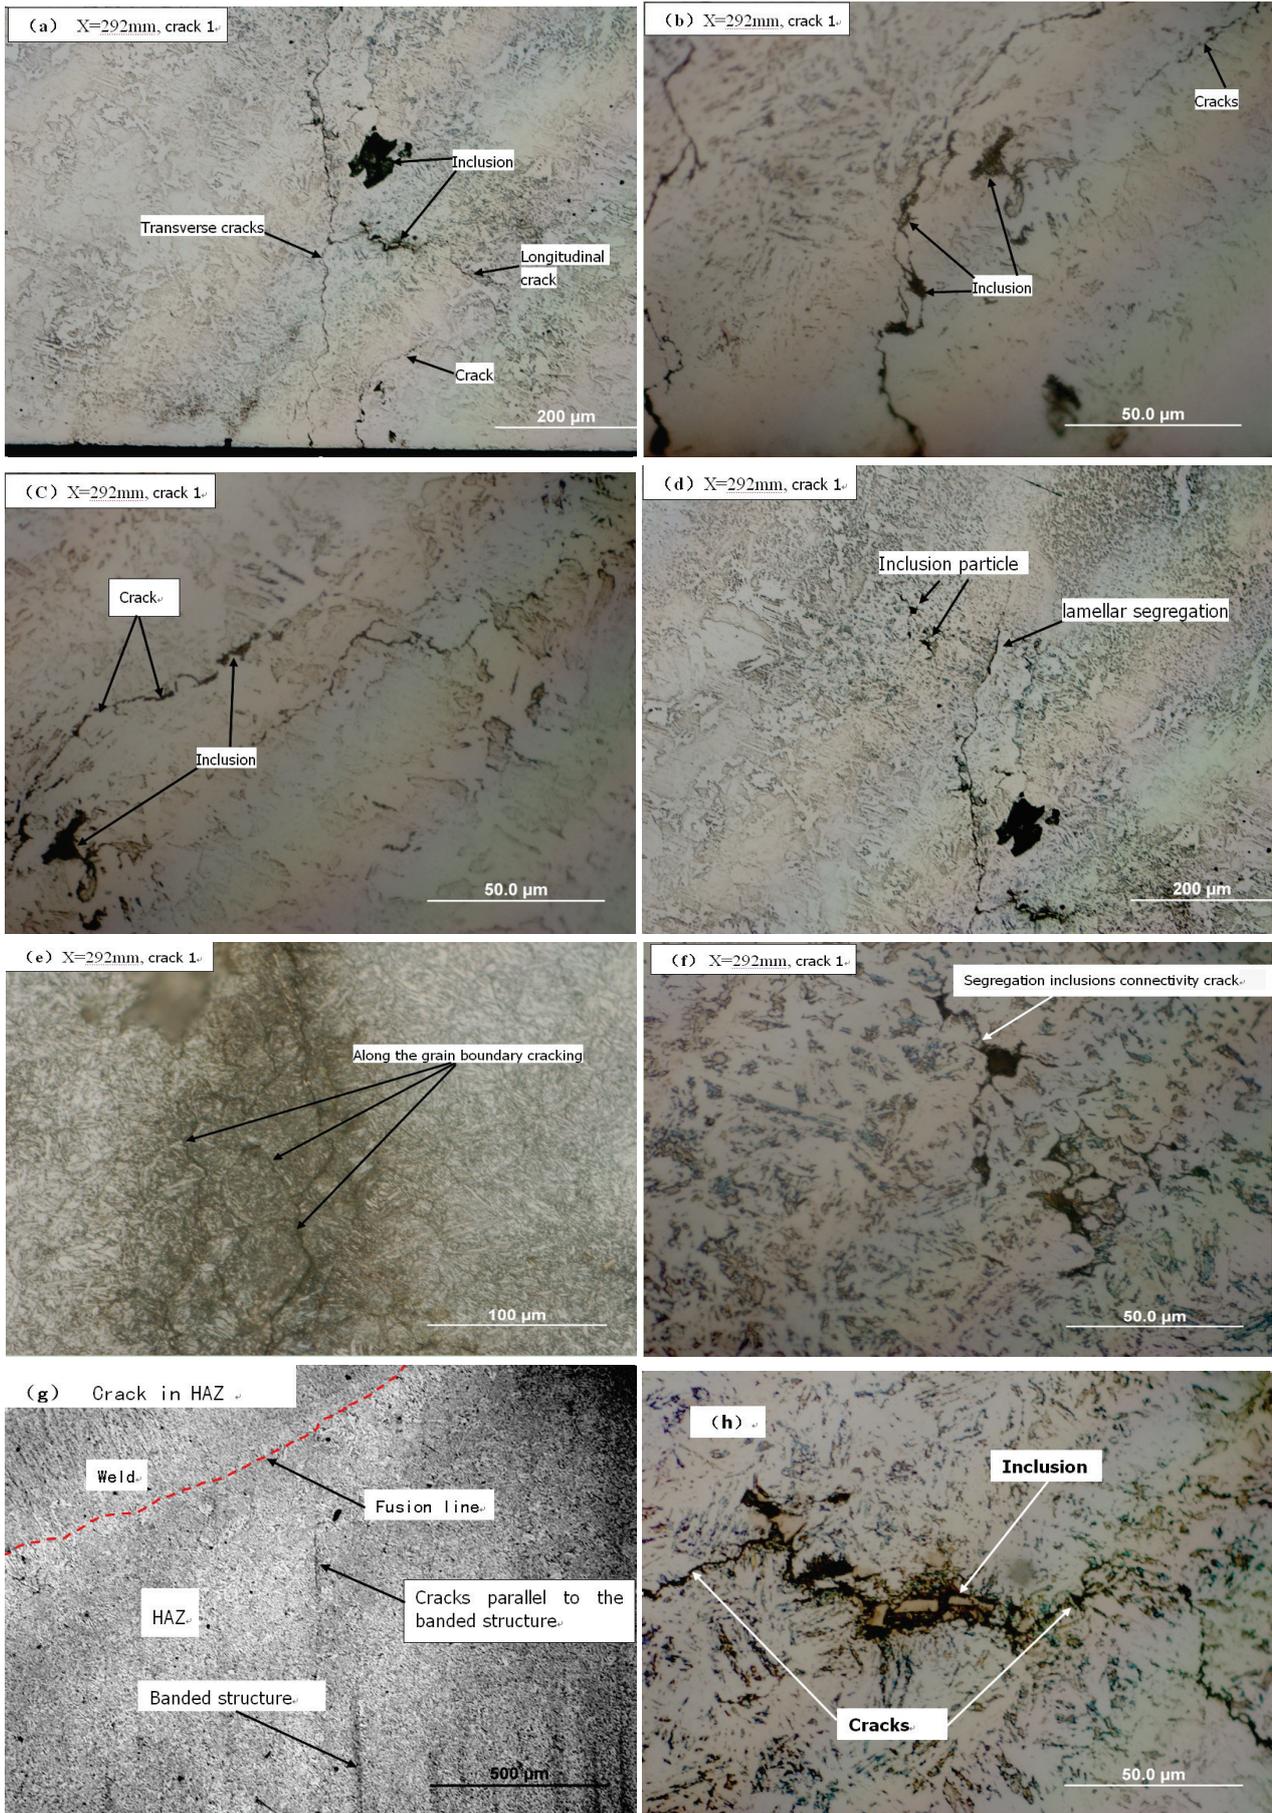
From a-h of Fig. 6, we can see that cracks are closely related to inclusions and banded structures. The severity of banded structure is closely related to dendrite segregation of alloying elements such as Mn, Si, S and P. There are serious banded structures in the microstructure of the 30mm base metal, so regional segregation and segregation in grain boundary pearlite strip of S and P is also serious. Therefore, although S and P content of the steel is very low, low melting point eutectic film of high density of S and P is formed in pearlite bands. In the welding process, this area is heated and liquefied and under the longitudinal welded strain transverse liquefied cracks occur in the HAZ. Therefore, segregation of elements of low melting point eutectic impurities (formed in the continuous casting and rolling of steel) in dendrite boundaries is the root cause of the liquefied transverse cracks in the HAZ. The occurrence of banded structure just reflects the serious segregation of impurity elements in the dendrite boundary. Of course, wide HAZ and big longitudinal weld shrinkage strain caused by the welding technique SAW, which has high linear energy, are also important reasons.

Figure 6 Cracks, banded structure and inclusions

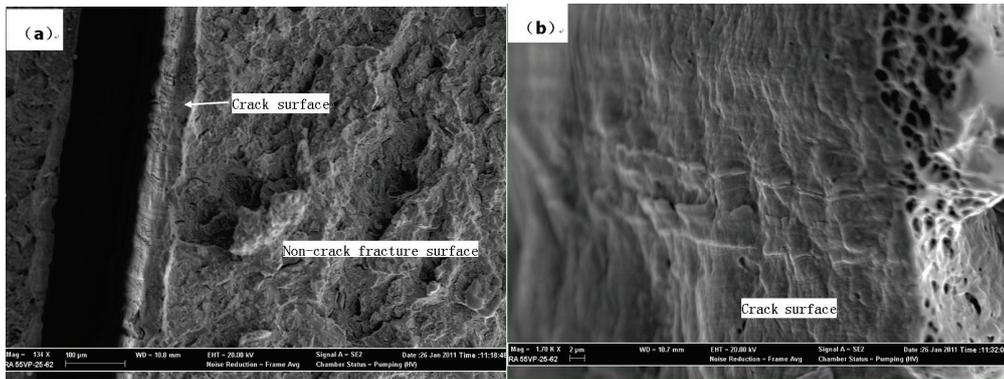
Morphology observation is done by SEM (SUPRA 55VP) (See Fig. 7). We can see that the fracture is smooth, which is a typical feature of hot cracks starting from Austenite grain boundaries, not the feature of cold cracks. To further determine the occurrence mechanism of cracks, we need to conduct chemical analysis of the crack surface to see whether there is low-melting-point eutectic composition of elements such as S and P which give rise to hot cracks, whether there is segregation of elements of low melting point such as Pb and whether there is enrichment of Si, Mn and other elements that can form grain boundary inclusions. First researchers do EDS analysis under FESEM (field emission scanning electron microscope). EDS chemical analysis of the crack (Fig. 8) shows that chemical composition of this area has no significant difference with non-crack area of the fracture and no signs of segregation of S, P, Si and other elements are discovered. As EDS detects the average composition within several micron under the surface, so it cannot accurately reflect the chemical composition of the crack. Segregation layer can be as thin as several nm, so EDS alone cannot exclude the possibility of segregation. Therefore, we need to conduct AES analysis.

Figure 7 SEM photo of transverse crack at X=127 mm

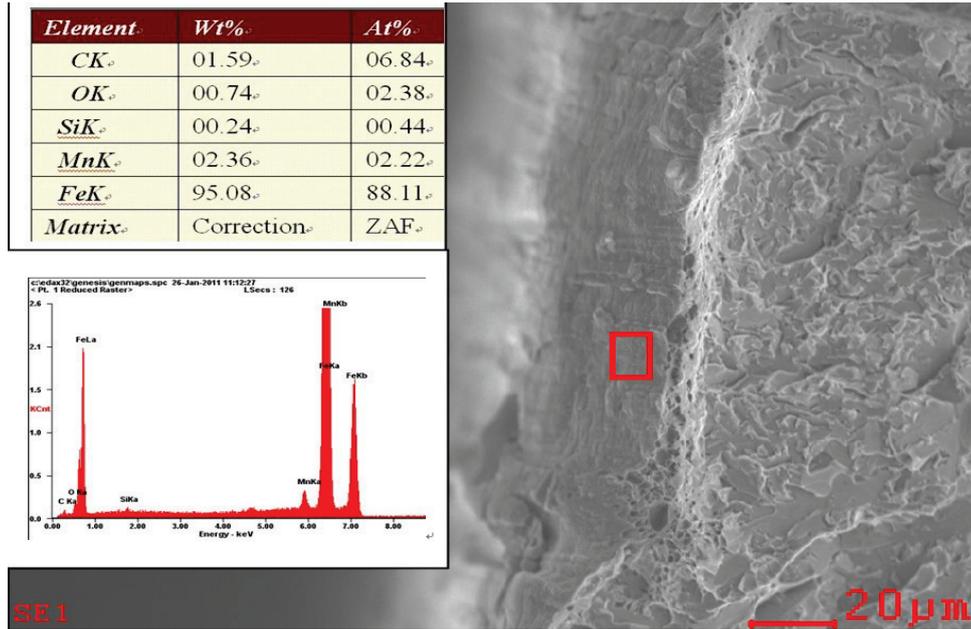
Figure 8 EDS chemical analysis of crack

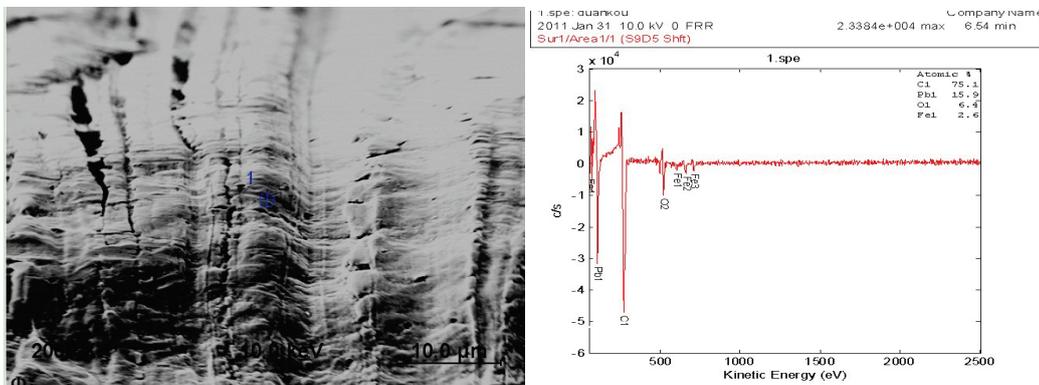
Figure 9 Bulging zone 1 of fracture surface, AES analysis and the spectrum curve

Chemical analysis (counted in numbers of atoms) of bulging zone 1 of fracture surface (shown in Fig. 9) and

the AES spectrum indicate that apart from some C and O, which are contaminants, the main chemical composition

is Pb and Fe. As there is very low level of Pb in the non-crack area of the fracture surface, that shows Pb, as an inclusion, is likely to have severe segregation in some areas. The melting point of Pb is as low as 328 °C [7], and

these areas are in the grain boundary of the HAZ. The existence of Pb is likely to facilitate the occurrence of liquefied cracks.

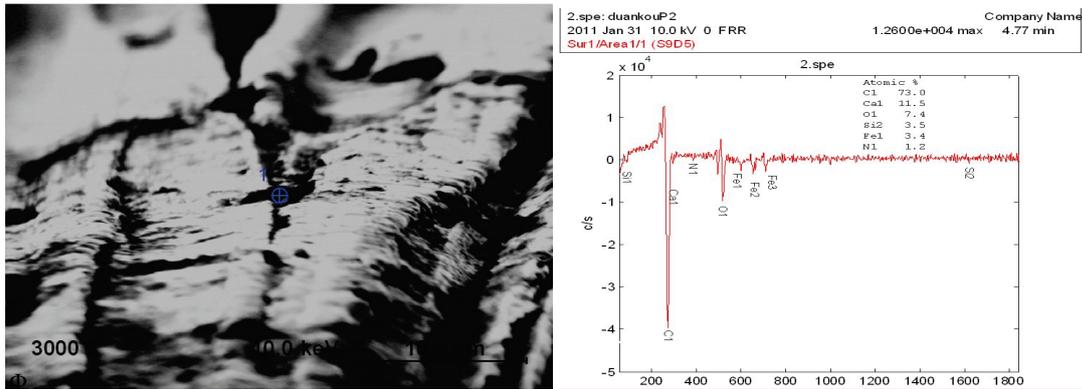
Figure 10 Recessed zone of fracture surface, AES analysis and the spectrum curve

Chemical analysis (counted in numbers of atoms) of recessed zone of fracture surface (shown in Fig. 10) and the AES spectrum indicate that apart from some C and O,

which are contaminants, the main chemical composition is Si, Ca and Fe. As there is very low level of Si in the non-crack area of the fracture surface that shows Si is

likely to have severe segregation in some areas. It is also possible that Si exists as SiO_2 inclusions.

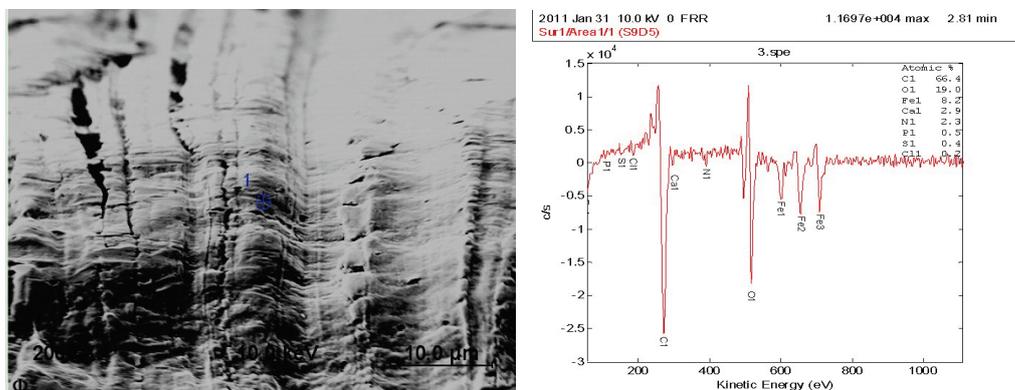
Figure 11 Bulging zone 2 of fracture surface, AES analysis and the spectrum curve

Chemical analysis of bulging zone 2 of fracture surface (shown in Fig. 11) and the AES spectrum indicate that apart from some C and O, which are contaminants, the main chemical composition is Fe, S, P and Ca. As there is very low level of S and P in the non-crack area of the fracture surface, that shows S and P are likely to have severe segregation in some areas. According to the proportion of elements, eutectic materials of low melting point such as Fe-FeS and Fe-Fe₃P may be formed, the melting point of Fe-FeS is 998°C [7]; the melting point of Fe-Fe₃P is 1040°C [7]. The existence of such matters is likely to be one major reason for the occurrence of liquefied cracks.

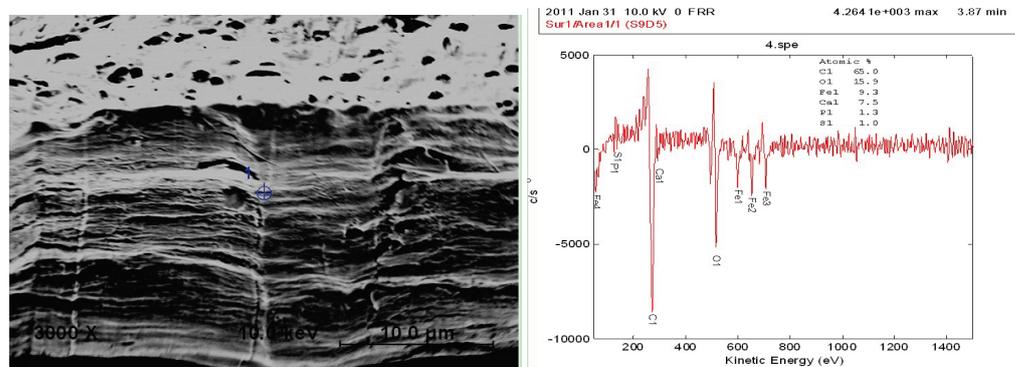
Figure 12 Grain boundary junction of fracture surface AES analysis and the spectrum curve

Chemical analysis of the grain boundary junction of fracture surface (shown in Figure 12) and the AES spectrum indicate that apart from some C and O, which are contaminants, the main chemical composition is Fe, S and P, and the content of S and P is more than twice that

of fracture surface. As there is very low level of S and P in the non-crack area of the fracture surface that shows the segregation of S and P is likely to be severer in this area than bulging zone 2. It is likely that there is a large amount of eutectic materials of low melting point such as Fe-FeS and Fe-Fe₃P.

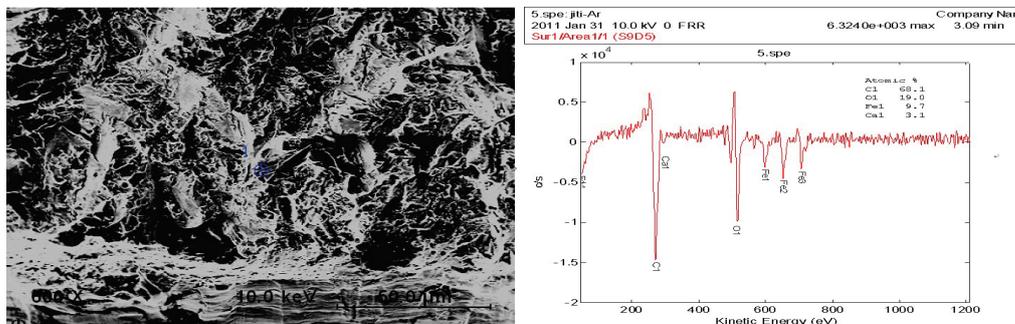
Figure 13 Non-crack area of fracture surface, AES analysis and the spectrum curve

Chemical analysis of the Non-crack area of fracture surface (shown in Figure 13) and the AES spectrum indicate that apart from some C and O, which are contaminants, the main chemical composition is Fe, and elements such as S, P, Ca, Si and Pb are not displayed because their contents are too small.
