FAILURE ANALYSIS OF GREY IRON ENGINE FLYWHEEL

Abstract:

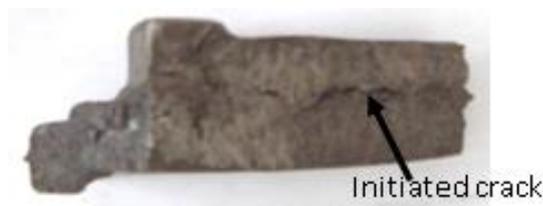
Fig. 1 shows a partial view of the failed flywheel as received from the foundry. The intact flywheel is shown for comparison in Fig. 2. It can be inferred from it that the crack initiated in the centre of the flywheel and propagated toward the fringe surface (Fig. 1). From the colour of the section in Fig. 1, we deduce that this crack should belong to cold crack, rather than hot crack.

Figure 1. The as-received section of failed flywheel.

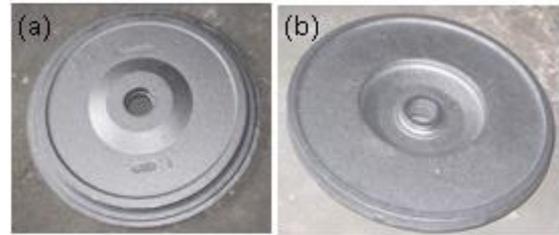
Figure 2. The intact flywheel.

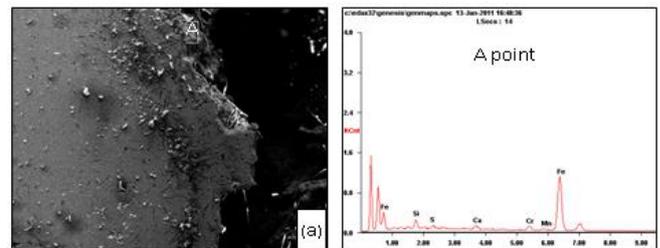
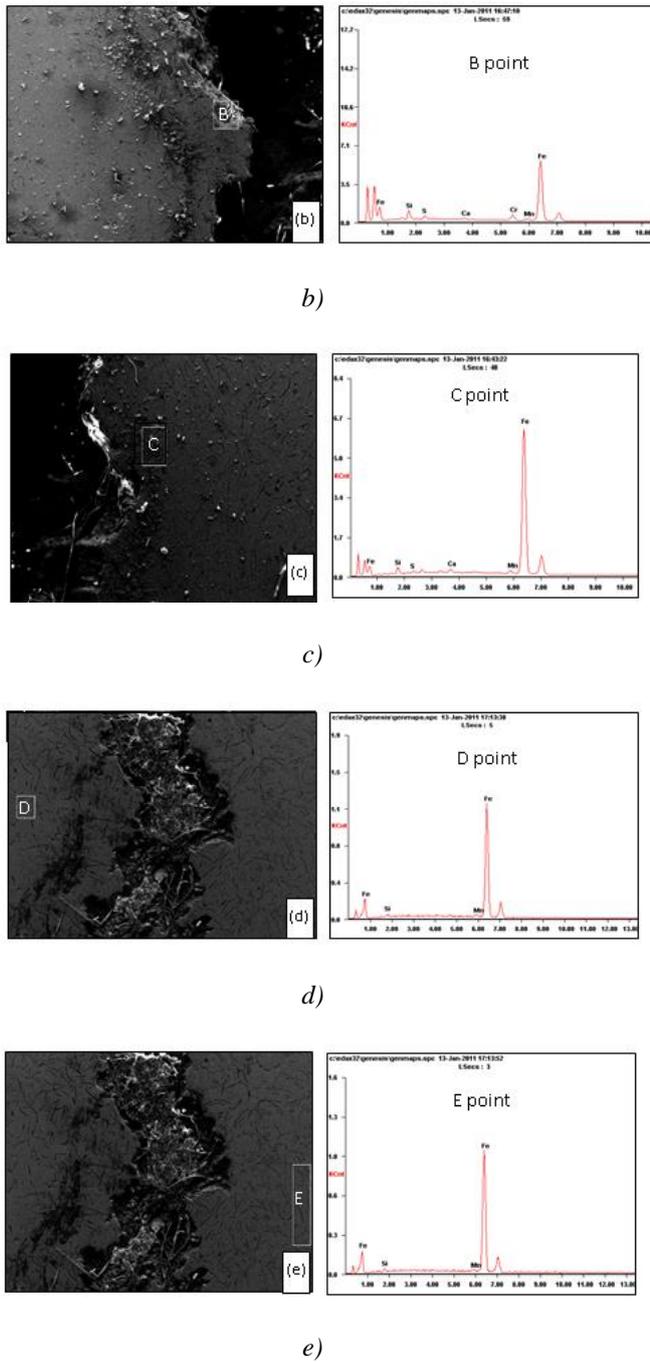
Fig. 3 shows EDS analysis of the fracture surface by SEM: the EDS result shown in Fig. 3 is also given in Table 2. It can be seen that regions A and B near the crack zone contain higher Si, S, and Ca, while the normal regions C and D remote from the crack have less Si, and no S or Ca. This indicates that some inclusions containing Si, S, and Ca may have been responsible for the fracture of the flywheel. During casting, potential origins for such inclusion formation were:

Figure 3. EDS analysis of the fracture surface (a-e).

Position	Si	Mn	S	Cr	Ca	Fe
A	9.98	1.85	3.11	3.45	2.82	78.79
B	8.89	1.21	2.75	4.78	1.01	81.36
C	3.56	1.95	0.66		1.12	92.71
D	2.36	2.18				95.46
E	2.47	1.70				95.83

- 1) The molten iron oxidised when it was tapped from the 6 t intermediate frequency induction furnace while being poured into the sand mould for casting the flywheel.
- 2) During inoculation treatment, the temperature of the molten iron was lower than the specified range of 1450 to 1500°C: this could result in incomplete melting of the inoculants. A 75SiCaFe alloy with the addition rate of 0.2-0.5 wt.% was used as the inoculants during production of this particular flywheel.
- 3) The inclusion occurred at the former stage and afterwards was not cleaned-up.
- 4) The slag-blocking measures in the pouring system were not properly designed for pouring the molten iron into the flywheel mould.

It can be inferred from the results of Fig. 3 and Table 2 that the aforementioned causes of inclusion formation may be the second, and/or third, and/or fourth, rather than the first (*i.e.* due to the absence of oxygen).

- 1) During inoculation treatment, the tapped temperature of the molten iron controlled was within the specified range of 1450 to 1500°C, thus ensuring the complete melting of the inoculant.
- 2) Before pouring molten iron into the casting mould, the coating agent and inclusions such as slag on its surface should be completely eliminated.
- 3) A ceramic filter was not used in this pouring system to block slag and so on from entering the mould for casting the flywheel while the molten

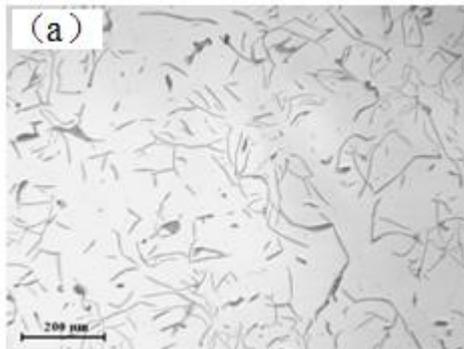
The sample for metallographic investigation was taken from the cracked zone of the fractured flywheel. Microstructural observations and hardness inspection both near-crack and far-field were conducted. The results are shown in Fig. 4 and Table 3, and evaluated according to the properties of this flywheel. The lower hardness correlated well with the presence of higher ferrite content in the near-crack zone.

a) graphite near the crack zone

Position examined	Graphite		Matrix		Hardness (HB)
	Morphology	Length	Morphology	Amount of pearlite	
C zone (near crack)	A	3-4 grade	pearlite	95%	179, 177, 181, 179, 183
D zone (normal zone)	A	4-5 grade	pearlite	98%	202, 207, 197, 207, 197
the specified	A type (B+D+E ≤ 20%), C type isn't allowed		pearlite	≥95%	187-250

The aforementioned results indicate that the cause of flywheel fracture is due to more inclusions containing higher Si, S, and Ca. The composition of the material corresponds to the specified composition range, but the graphite plate length in the vicinity of the crack is longer than the one specified, and the hardness is lower than the lower limit allowed by the standard. As a result, some improved measures are to be adopted to prevent flywheel fracture:

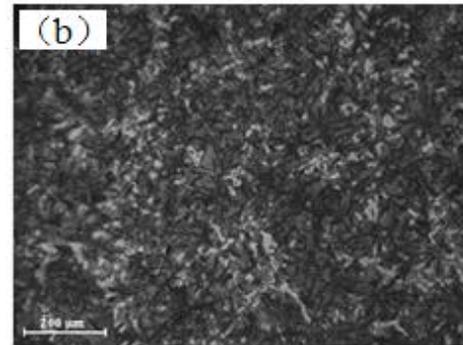
b) matrix near the crack zone

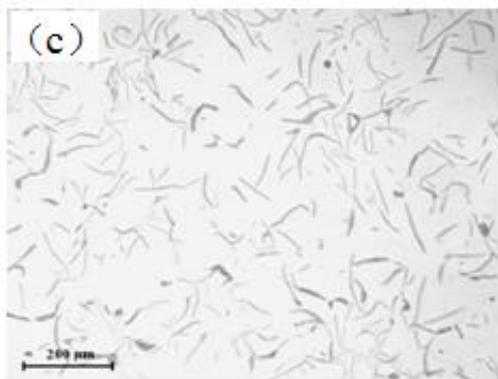
c) graphite of the normal zone

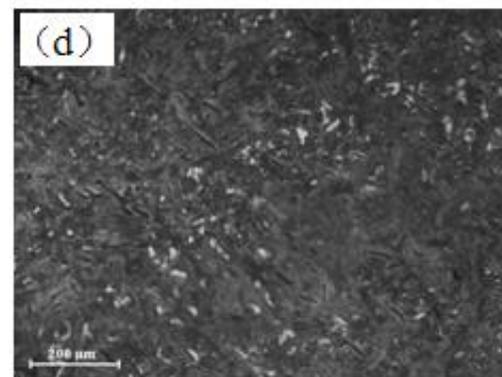
d) matrix of the normal zone
