**INVESTIGATION OF REASONS AND POSSIBILITY OF PARAMETERS ELIMINATION
INFLUENCING CRACKING OF LEAF SPRINGS ON CONTINUOUS CASTING MACHINE**Received - Priljeno: 2006-04-20
Accepted - Prihvaćeno: 2007-04-15
Preliminary Note - Prethodno priopćenje

At the first look very simple and for several hundred years used elastic element can be critical part in complex equipment where its failure invokes extraordinary high losses. In the paper is given a treatment for the solution of this problem by experimental methods and resulting proposal for its final solution.

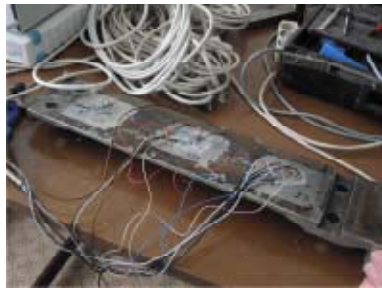
Figure 2. Locations of strain gages RY 61 for the hole drilling method
Slika 2. Lokacije tenzometra RY 61 za metodu bušenja rupe

The maximal level of residual stresses (pressure) does not exceed 40 MPa.

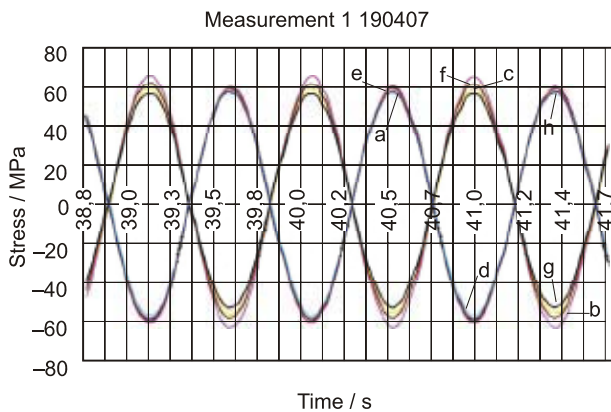
Figure 6. Time-dependent chart of stresses in spring during frame vibration
 Slika 6. Vremenski ovisni dijagram naprezanja opruge za vrijeme vibracije okvira

At the same time were measured horizontal and vertical displacements of crystallizer frame as well as accelerations of points in vertical direction in the center of the springs. The measurements did not show any phenomenon during vibration of crystallizer in testing frame that could result to the failures. The measurements were realized for various casting velocities, various slabs widths, for small and big changes of their dimensions and various materials. Detailed analysis was also performed by the finite element method. The computations were accomplished for prescribed displacements of the center of leaf spring in axial direction to the value of 0,2 mm and in vertical direction by 2,95 mm. Analyses have confirmed that the spring from the point of view of fatigue loading conforms to all conditions.

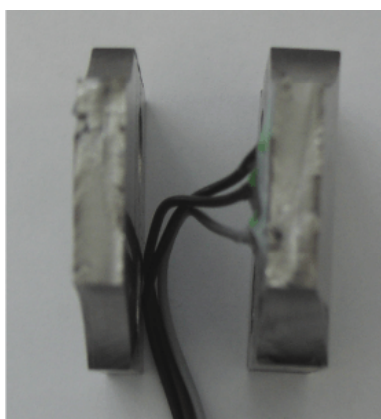
Figure 13. Fracture surface of boundary specimen 1
Slika 13. Površina pukotine rubnog uzorka 1

of the fracture surface is seen that it contains segregates inclusions visible without microscope. These were probably introduced into the material by incorrect technology of leaf spring production. Inhomogeneous structure of material is located in several points of the cross section

(see Figure 13.).

For the solution of problem of spring breaking, at least to the time of determination of extraordinary load combination, we suggest to use material with markedly higher strength properties.

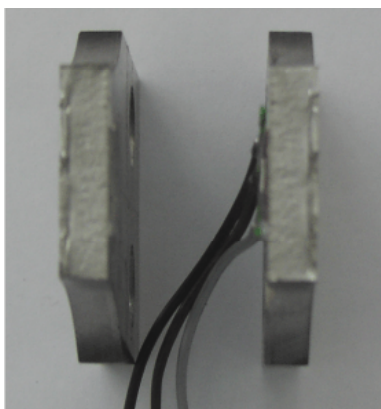
Figure 14. Fracture surface of specimen 2
Slika 14. Površina pukotine uzorka 2

In the Figure 14. is shown fracture surface of the specimen 2 that was taken from the middle part of spring. This part is without any segregates inclusions or visible defects.

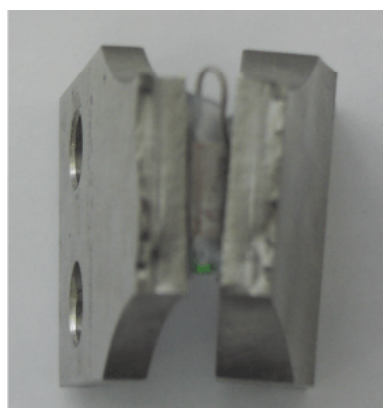
Figure 15. Fracture surface of middle specimen 3
Slika 15. Površina pukotine srednjeg uzorka 3

In Figure 15. is fracture surface of the specimen 3 in the area of transition from thin to thicker middle part of spring. In this part of cross section are again visible conspicuous inclusions in the fracture surface.
