FAILURE ANALYSIS OF BOLTED JOINT FOR THE COLUMN OF AN AERIAL PLATFORM

Original scientific paper

This paper focuses on the identification of failure causes of a bolted joint used for the bedding of a primary column of an aerial platform. The tests conducted to determine chemical composition and mechanical properties have confirmed the 12.9 grade of the bolts. Also, mechanical properties tests and metallographic examination did not indicate any hidden defects caused by heat treatment (e.g. decarburisation etc.). On the other hand, visual and metallographic examination of cross-section as well as electron microscope scanning confirmed fatigue fracture of the bolts. Therefore, further analyses were done to check the dimensioning and the installation of the bolts. The effects on stress states in the bolts are presented from the standpoint of rated operating regimes, stiffness of joined elements, lubrication conditions of thread surfaces and temperature incompatibility between the bolts and elements being joined. Pre-tightening torque value incompatible with lubrication conditions was found to be the main factor that led to high stress values that initiated and later intensified the fa

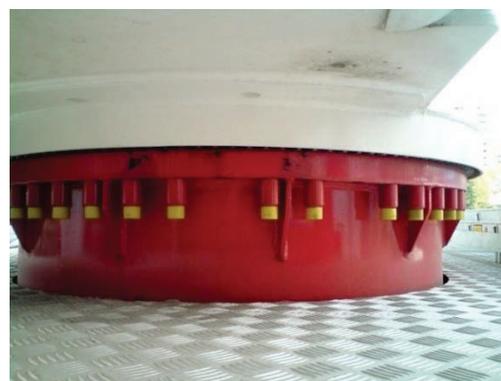
Figure 2 Problematic bolted joint

Aerial platform operating conditions and working principle define operating regimes characterised by distinct stochastic nature regarding the level and the nature of loads on whole construction [1]. Fig. 1 shows subject platform and Fig. 2 shows problematic bolted joint.

Data from real life show that the subject platform was used for extremely low number of hours, during which failed bolts were replaced several times (Tab. 1).

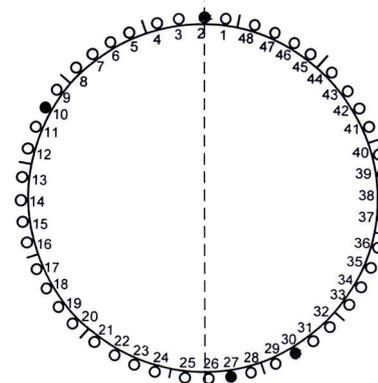
Figure 3 Bolt failure positions

Fig. 3 shows bolt failure positions after complete bolt replacement (Tab. 1).

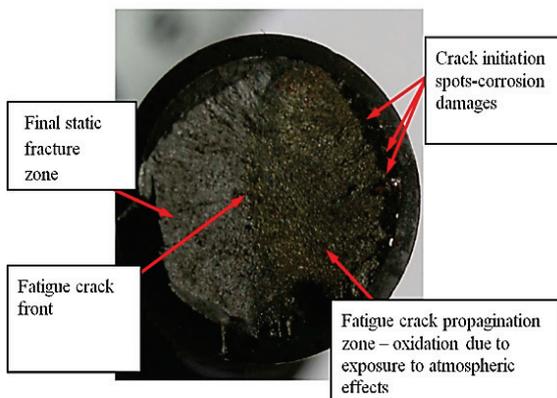
Figure 4 Fracture surface of the bolt (detail)

Visual examination of failed bolts indicates fatigue fracture under moderate stress levels due to a joining of several minor cracks initiated in places with low stress concentration at the bottom of the thread due to corrosion (Fig. 4).

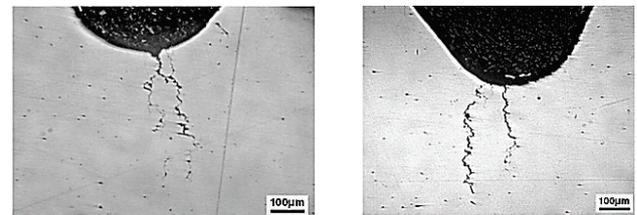
Bolt material microstructure was analysed by testing the embedded metallographic ground specimen taken from the cross-section of the supplied bolts, with and without etching [10]. Figs. 5 and 6 show characteristic illustrations, as well as necessary comments and notes. Metallographic analysis of the microstructure was performed by using metallographic microscope METAVAL (Carl Zeiss Jena, Germany) and by using bright field technique.

Figure 5 Inter-crystal cracks on longitudinal section of the bolt, without etching

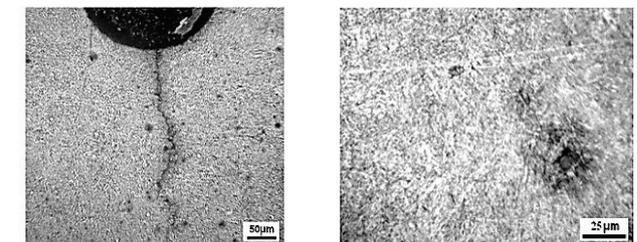
Figure 6 Microstructures on longitudinal section of the bolt, with etching

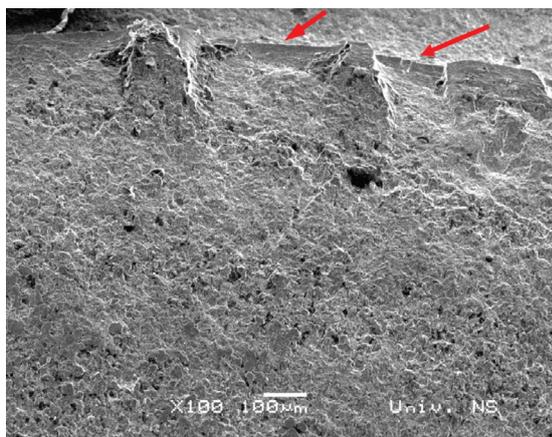
JEOL JSM 6460 [8]. Fig. 7 clearly shows corrosion pits at the bottom of thread as crack initiation spots, whereas Fig. 8 clearly shows oxidised surface in fatigue crack propagation zone (see Fig. 4).

Figure 7 Crack initiation spots at the bottom of thread

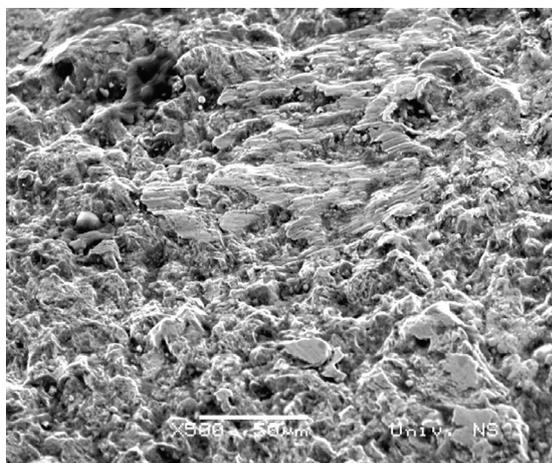
Figure 8 Oxidised surface in fatigue crack propagation zone

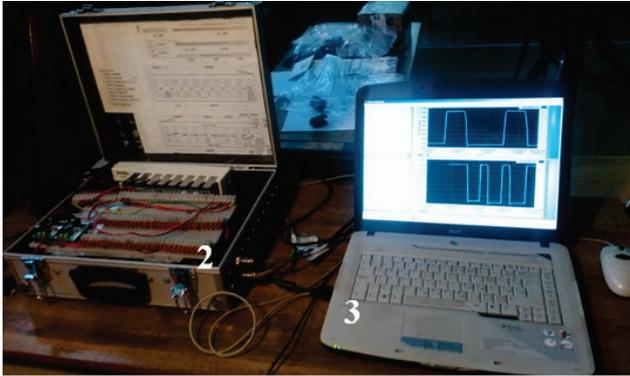
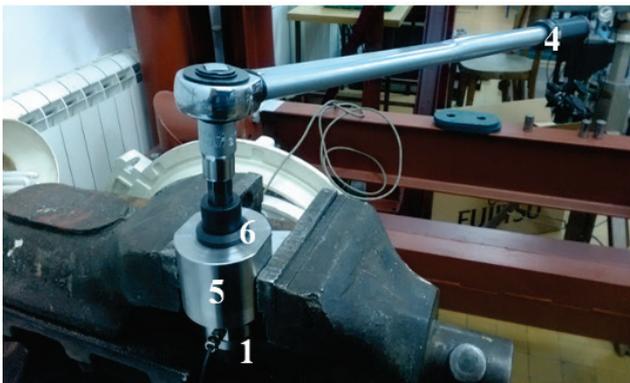
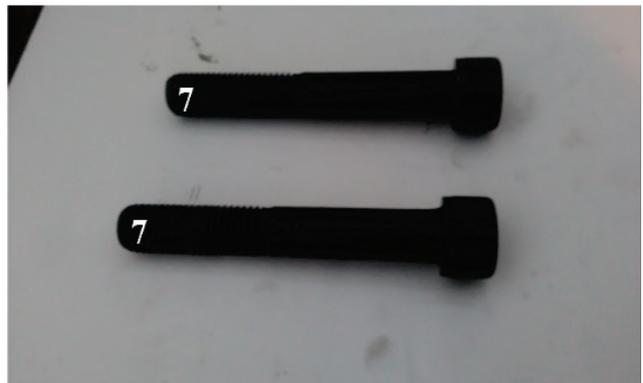
Figure 9 Experimental determination of the effect of lubricant within the bolted joint on pre-tightening force

The effect of thread surface lubrication on pre-tightening force, i.e. stress within the bolt, while applying relevant tightening torque, was determined experimentally. Fig. 9 shows applied testing procedure, acquisition system, as well as necessary comments and notes. Bolted joint was formed by using adapters and washers made of original bushes, so that testing conditions of bolts could be identical to real conditions of bolted joints on the platform.

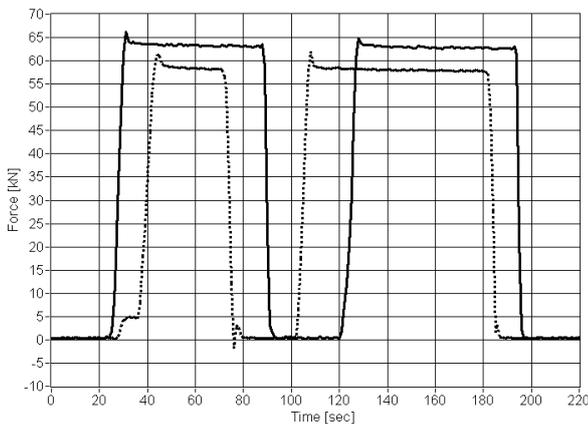
Fig. 10 shows the comparative overview of tightening forces obtained by applying the same tightening torque of 150 N·m. Tightening force of lubricated bolted joint is 8,5 % greater than that of non-lubricated bolted joint.

Based on the obtained values and known geometry of the bolt, it is possible to define k coefficient in both cases. For non-lubricated joint $k = 0,144$, whereas for lubricated joint $k = 0,132$. Tightening torque recommended by the platform manufacturer is $M_p = 460$ N·m. Based on experimentally determined value of k coefficient, it is possible to evaluate bolt forces and stresses when applying recommended tightening torque. In case of non-lubricated joint, bolt tightening force is 178 kN, whereas stress is 930 MPa. By applying rated tightening torque in case of lubricated joint, bolt force increases to 193 kN, whereas stress increases to 1007 MPa. Difference between bolt stress state of 77 MPa is very important because it represents 6,4 % of material performance regarding strength ($R_e = 1,200$ MPa). This effect is especially interesting because of frequent partial bolt replacements in this specific case, in which it is difficult to precisely determine the state of the bolted joint regarding presence of lubricant.

Figure 10 Tightening forces obtained by applying tightening torque of 150 N·m (Full line - lubricant present on thread surface; Dashed line - dry non-lubricated thread surface)

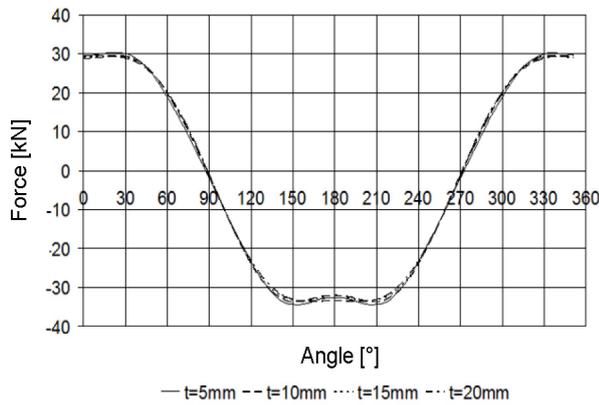
Figure 12 Bolt loads in zone of bolted joint

Fig. 12 gives graphical display of bolt loads as a function of stiffness of the platform structure in zone of bolted joint (varied thickness of platform column wall $t = 5 / 10 / 15 / 20$ mm). Fig. 13 illustrates bolt load in relevant zone with tensile bolts opposite to the acting arm of external load, whereas Tab. 4 gives relevant numerical values of bolt forces.

the effect of stiffness of elements in the bolted joint on stress states of the bolts is practically negligible and equals 2 % of the effect of maximum operating load, which is about 0,2 % compared to material performance.

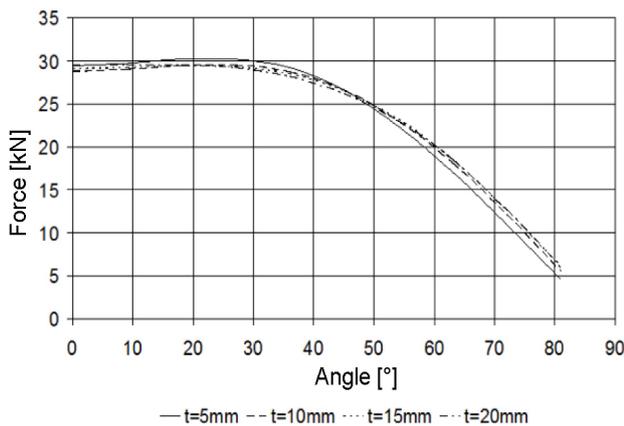
Figure 13 Bolt loads in relevant zone with tensile bolts opposite to the acting arm of external load

Based on obtained loads, stress caused by rated functional operating loads equals 156 MPa, which is 13 % of bolt material yield strength ($R_e = 1200$ MPa). Besides,
