THE FAILURE ANALYSIS OF THE HOLDER OF A CRUSHER MOVING KNIFE

The paper deals with the analysis of the causes of knife holder failure. The holder is a part of the car tyre shredding equipment. Based on the evaluation of the operating conditions of the machine, examination of the condition of the knife holder after the failure, analysis of the fractured surface, as well as the material properties of the examined structural elements, it was possible to draw conclusions as to the reasons of eventual failures.

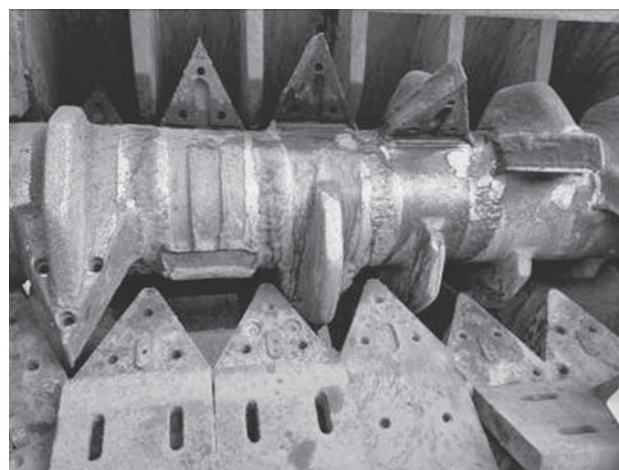
On the holders welded with fillet welds to the rotor of the shredding machine there are twelve cutting (moving) triangular knives arranged in two rows with six knives in each row. Stationary knives are fixed with bolts in the holders to the stationary parts of the machine. They are placed in one level with five full knives in the centre and one half-knife at each end. Tyres are shredded by the combined action of the moving and stationary knives during rotation of the machine rotor. Mechanical stress of the rotor substantially affects the sharpness of the knives' edges, as well as the size of the cutting gap between the knives. Therefore, optimal cutting conditions are provided by frequent adjusting and sharpening of the knives at the intervals specified in the instructions for the operation of the machine.

Figure 1 Moving and stationary knives of the shredding machine

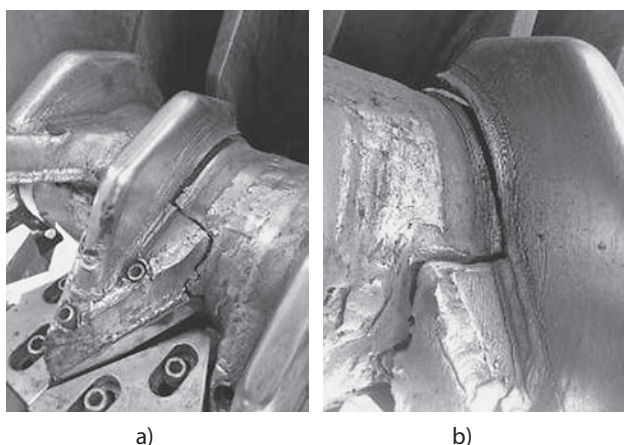
Moving knives are fixed by three bolts in the holders which are welded with fillet welds to the rotor of the shredding machine (Figure 1). The broken weld of the moving knife holder is shown in Figure 2a. The details of the broken weld joint of the holder are given in Figure 2b.

Figure 2 Failure of the welded joint of the moving knife holder a) general view, b) detailed view of the broken welded joint

- The analysed part of the machine failed due to the repetitive mechanical stress. Fatigue failure initiated at a point of a defective, poor quality welds and stress concentration.
- The failure could also occur because of the increased mechanical stress of the welds of the holder of the moving knife, as it was not supported by the holder along its whole length.
- Another cause of the failure could be attributed to improper thermal processing of the material of the moving knife that led to wear and the increase of shear force during tyre shredding.

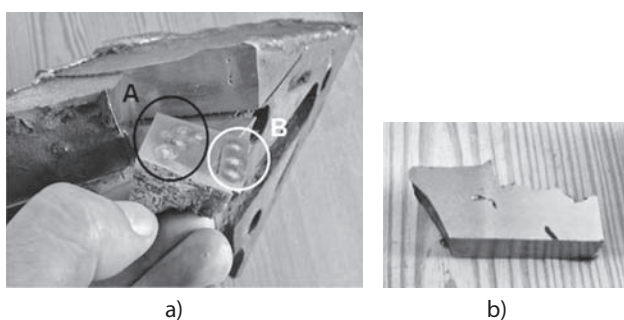
Samples were taken from the location of the fractured surface of the knife holder in order to determine its chemical composition and hardness, as well as to perform metallographic analysis with the aim to identify material quality and assess its welding properties (Figure 3a). In the samples, subsurface cracks were found in the locations of the welds (Figure 3b).

Chemical composition was determined by spectrometric analysis in two areas: A and B (Figure 3a), since two different materials were used there. To adjust the moving knives, steel plates were welded to the holders to support the knives. Table 1 and Table 2 contain average values of the chemical composition obtained by

Figure 3 a) Locations, where samples were taken and analysed, b) subsurface cracks in the samples

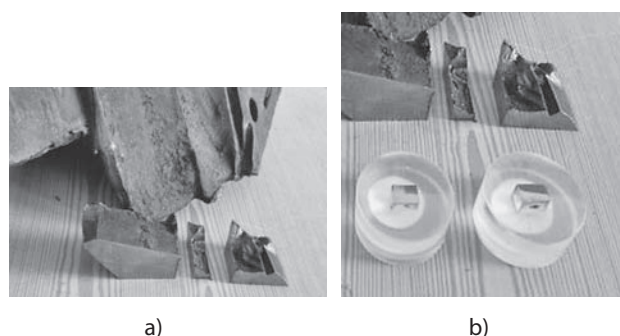
The place on the holder, from where the sample was taken for metallographic documentation, is shown in Figure 4a. Metallographic analysis was performed in

the cross-sections of two mutually perpendicular planes. Figure 4b shows the cuts in these planes.

Figure 4 a) Samples taken for the metallographic analysis, b) cuts in two mutually perpendicular planes

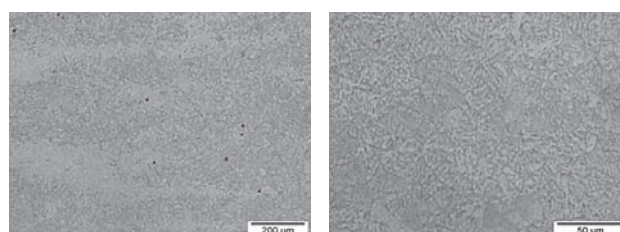
The microstructure of the material is shown in Figure 5. Based on the results of the metallographic analysis of the basic material of the knife holder, it appeared that the structure of the material in both planes was identical. Their microstructure was consisted of ferritic-carbide mixture with polyhydric grains and a local line, like the arrangement of the carbide particles.

Figure 5 Microstructure of the material at various scales
