THE ANALYSIS OF FAILURE CAUSES OF THE ROTOR SHAFT OF STEAM TURBINES

The rotors of steam turbines belong to the extremely loaded parts of turbo generators due to various mechanical and thermal influences during their operation. The following paper presents the results of the analysis of failure causes of the rotor shaft of a steam turbine with the power of 6,43 MW, which occurred after approximately one year of operation. The analysis was performed on the basis of the analysis of the chemical composition and microstructure of the material, the mechanical properties of the material under static and fatigue loading, as well as operational loading of the critical location of the shaft, using numerical and analytical methods. The conclusions about the possible causes of the shaft failure were drawn on the basis of the results obtained.

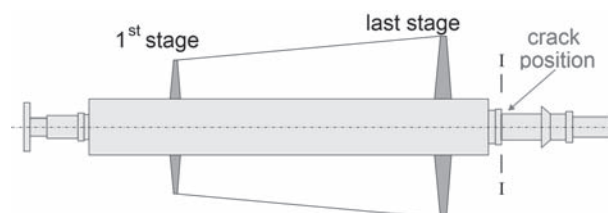
Figure 1 Shaft of turbine rotor

After a relatively short operation time (approximately one year), a failure of the turbine rotor shaft occurred, when it broke in the cross-section I - I (Figure 1). Figure 2a shows a view of the fracture surface of the shaft from the side of the turbine. Figure 2b gives a view of the broken part of the turbine shaft.

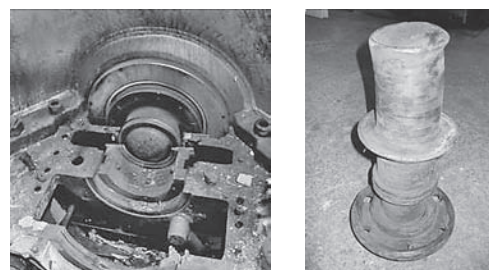
Figure 2 a) View of the fracture surface on the side of turbine, b) view of the broken part of turbine shaft

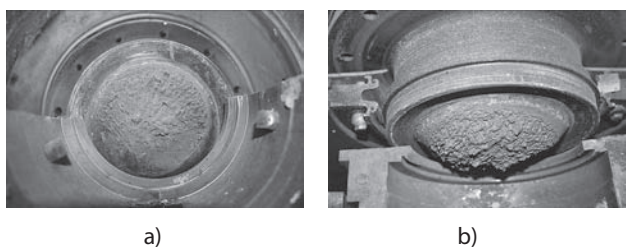
Figure 3 Details of the fracture surface of the shaft from the side of turbine

fracture surface on the broken part of the shaft. As Figures 3,4 show, the fracture surface exhibits the area of fatigue damage (glossy part of the cross-section on the periphery of the surface) in the shape of an eccentric circular ring and the internal area of brittle fracture.

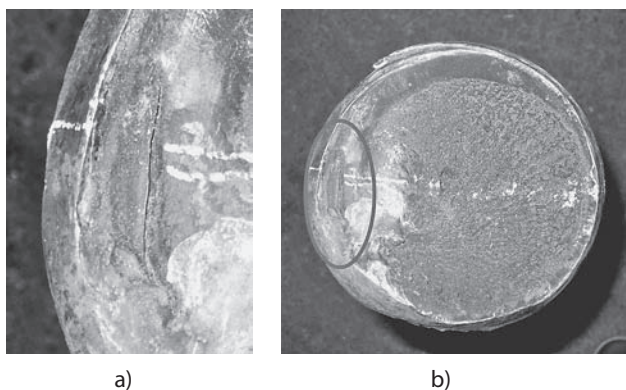
Figure 4 Fracture surface on broken part of shaft

In the location, where the area of fatigue damage is broader (left side of the fracture surface in Figure 4b), an approximately 30 mm long macro fracture is visible in the circumferential direction at the distance of approximately 15 mm under the surface of the shaft (Figure 4a). A more detailed insight into the macro fracture (Figure 5) leads to the conclusion that it is a strip introduced during forging of the shaft.

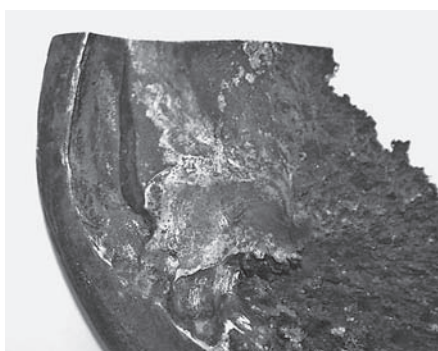
The initiation of fatigue damage in the circumferential direction of the shaft cross-section proves that its spreading in the cross-section is caused by combined loading of the bending moment and torque. The crack in the cross-section was initiated by the above mentioned stress concentrator strip that together with the sharp groove on the surface of the shaft, localizes the area of the first failure of the turbine rotor shaft. The location of fatigue crack initiation is seen in Figure 5.

Figure 5 Detail of macro fracture

- The analysis of the fracture surface of the shaft showed that the location with the deepest fatigue crack contained a crack in the circumferential direction, the initiation of which could not be connected with loading, but with inappropriate production technology of the turbine rotor. With high probability, these problems were connected with the presence of a strip that resulted from forging. This crack led to a sharp notch on the surface and under variable loading, it caused the failure of the shaft.

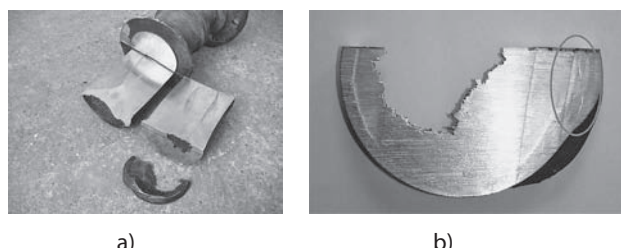
Figure 6 a) material taken from the broken part of turbine shaft, b) view of the separated end segment from the side of cross-section with crack

The material for tests was taken from the broken part of the shaft Figure 6a, while from the sample of the material, the end segment, on which the fatigue part of the fracture with a macro crack (strip) lay, was separated. The separated end segment (Figure 6b) provided evidence that the strip as a result of inappropriate technology of forging created a groove that in some locations ran to the surface of the shaft.

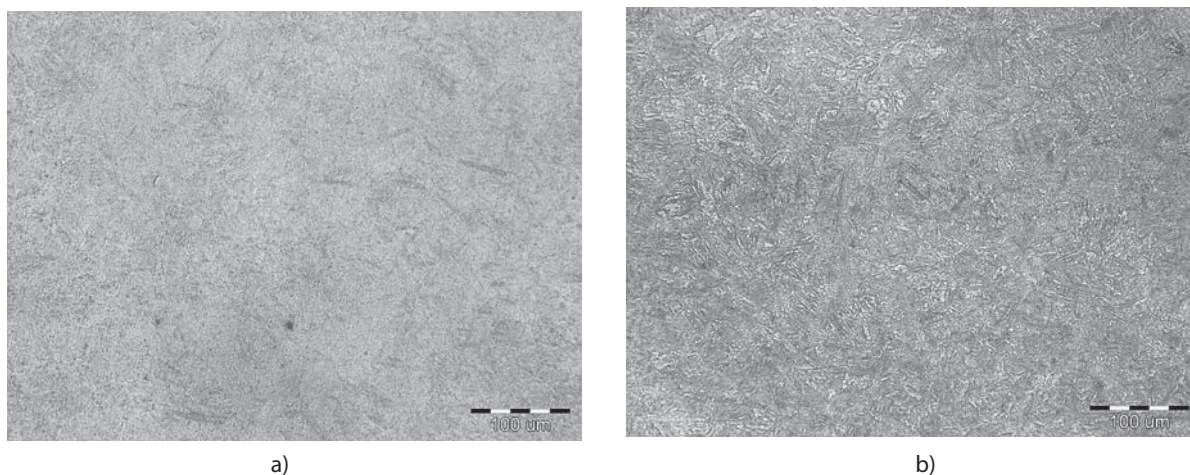
The microstructure of the shaft is given in Figure 7. It consists of tempered martensite – sorbit, which provides evidence of a suitable technology of thermal processing.

Figure 7 View of the microstructure. a) in direction of shaft axis, b) perpendicular to shaft axis
