**BRIJUNSKA KOČIJA TIPA  
MILORD, POVIJEST I  
KONZERVACIJA**

**THE MILORD CARRIAGE  
FROM BRIJUNI, HISTORY  
AND CONSERVATION**

**Sonja Kirchhoffer**

**Zoran Kirchhoffer**

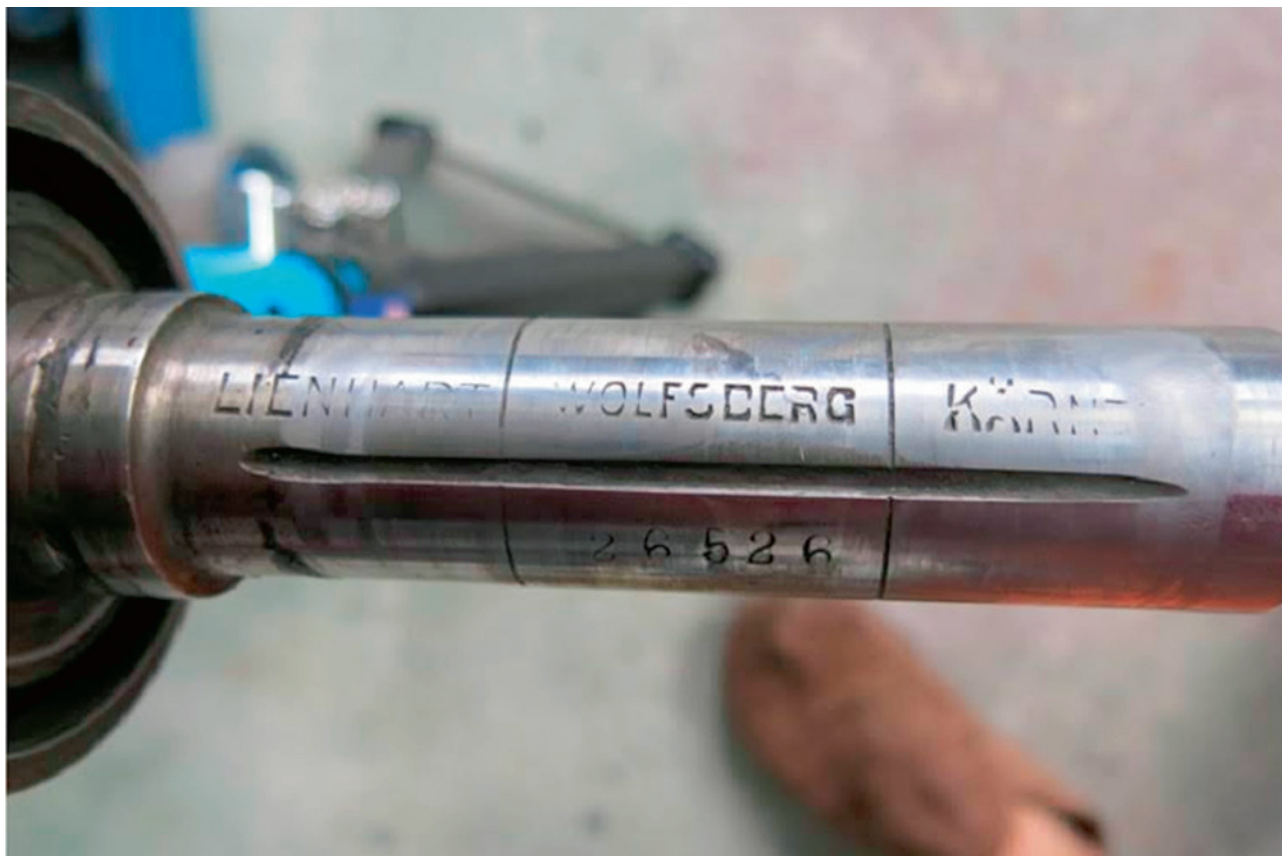
Although the Milord carriage was most popular at the end of the 19th century, it seems that the renovated one was built at the beginning of the 20th century. Such dating is suggested by the stamp on the axle. Namely, the only inscription recorded on the renovated carriage was found on the metal parts, i.e. undercarriage, where we find the following information: LIENHART WOLFSBERG KÄRNTEN 26526 (Fig. 3).

This inscription indicates that the carriage was most likely produced in Austria and that Leopold Lienhart from the city of Wolfsberg in the county of Kärnten participated in its production. The same producer also made the undercarriage of an Austrian funeral carriage which was built in the workshop "Peregrin Kern" in Graz in Austria in 1912. On the latter funeral carriage several participants in its production were mentioned, and it is clear that people of various professions took part in the production of carriages: carpenters, blacksmiths, and

Sl. 3. Natpis na osovini (aksi) kotača (snimio: Z. Kirchhoffer).

FIG. 3. Sign on the wheel axis (photo by Z. Kirchhoffer)

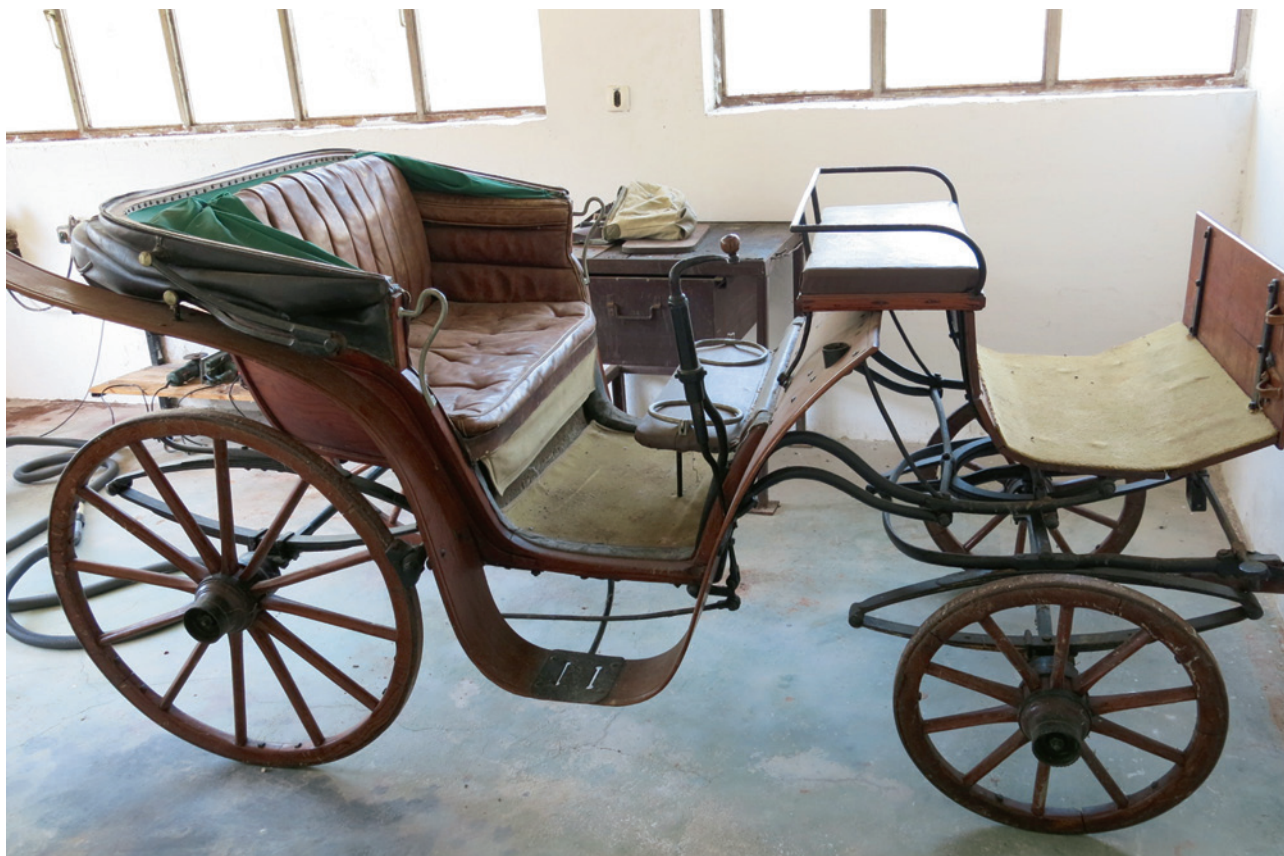
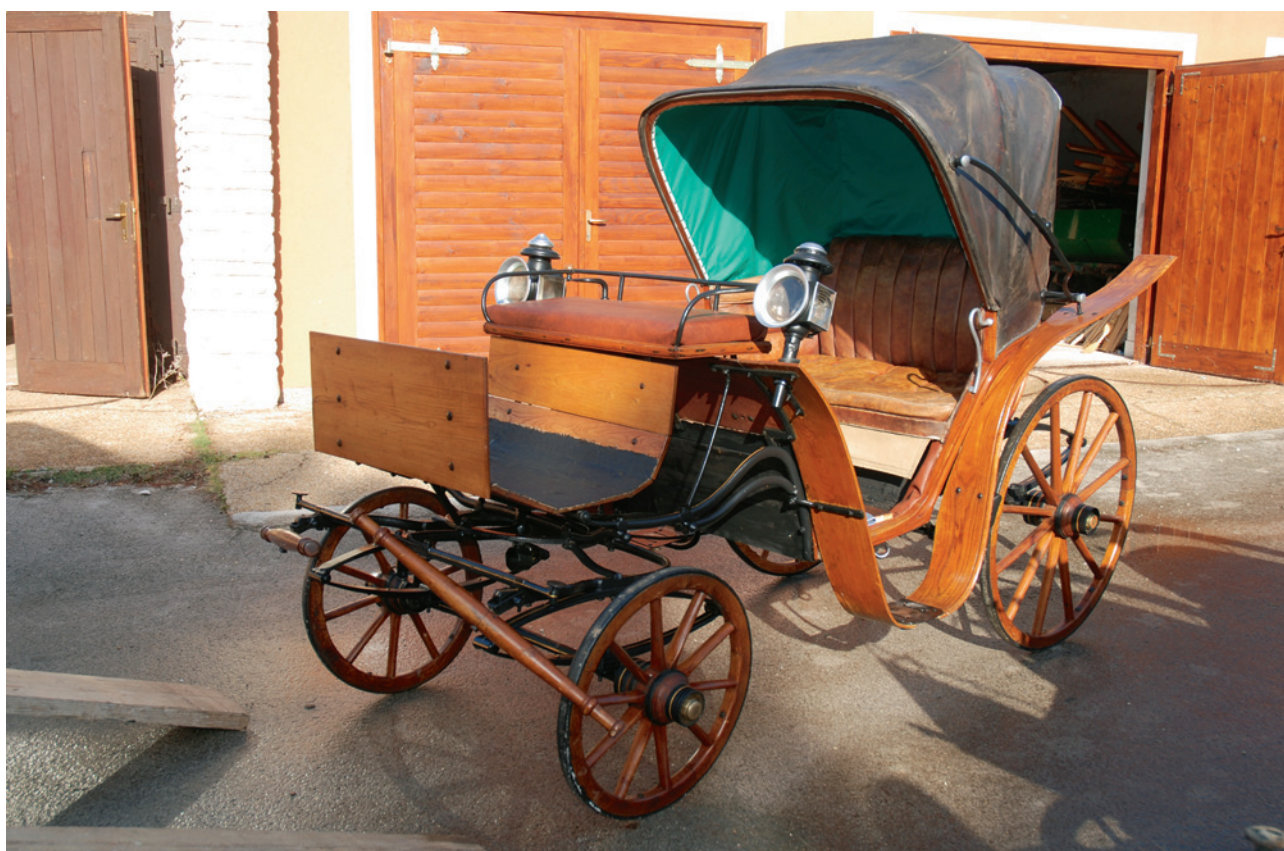
The carriage was received in a bad condition, damaged on all its parts (Fig. 5a). Wooden parts were damaged most heavily with cracks, woodworm and mine fungus (*fibroporia vaillantii*) (Fig. 6a-d). Parts covered with leather were also damaged, such as the calash (Fig. 10a) and seats made of leather. All metal parts of the carriage were corroded.

Sl. 5. a) Brijunska kočija prije obnove; b) Brijunska kočija poslije obnove (snimio: Z. Kirchhoffer).

FIG. 5. a) Carriage from the Brijuni archipelago before restoration; b) Carriage from the Brijuni archipelago after restoration (photo by Z. Kirchhoffer).

The carriage has profiled fenders (two front and two rear fenders) connected with steel tread in the middle (Fig. 5a-b; cf. Fig. 1). Wooden profiled fenders have metal (steel) fittings as props, and they were made of steamed or cooked beech. First the wood was washed, dried and cleaned mechanically (by sanding and brushing) and chemically (with alcohol and solvents) to remove the old coat, then it was treated chemically with wood preservative in order to conserve it, and holes resulting from woodworm and mine fungus were filled with two-component epoxy putty. Missing part from the left rear fender edge was repaired with same type of wood. Then the entire surface of fender was polished and coated with (linseed oil) varnish, which is recognized empirically to be the type of protection that was used on technical wood exposed to atmospheric agents and microclimatic conditions. The complete fenders, front and rear, were returned to their positions together with metal fittings. Mentioned props were cleaned mechanically, conserved and lacquered with primer for metal and selected glossy black paint.

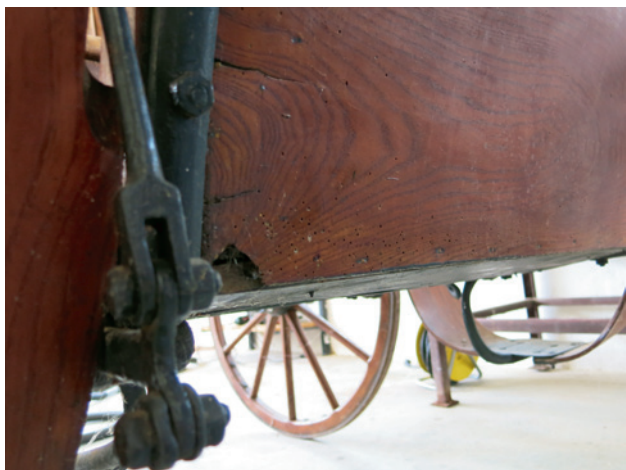
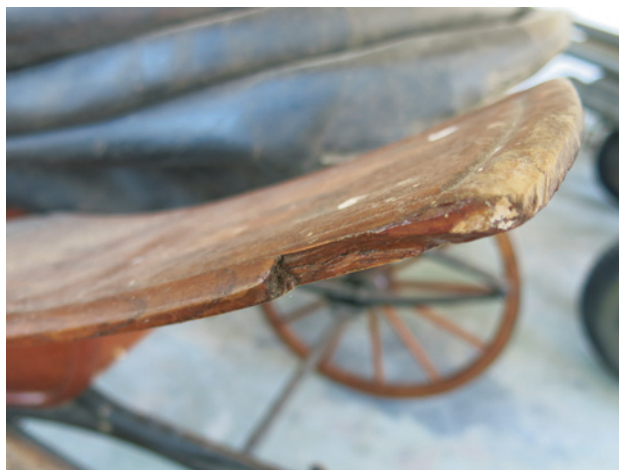
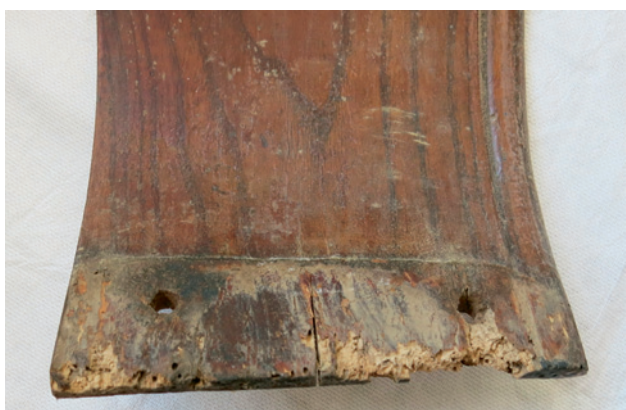
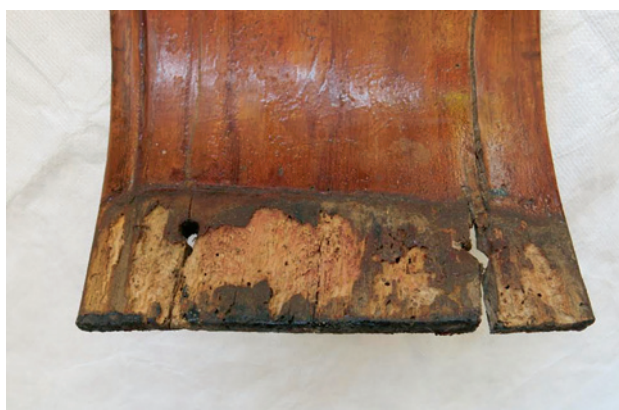
Sl. 6a-d. Detalji oštećenja na drvu (snimio: Z. Kirchhoffer).

FIG. 6a-d. Details of damages to the wood (photo by Z. Kirchhoffer).

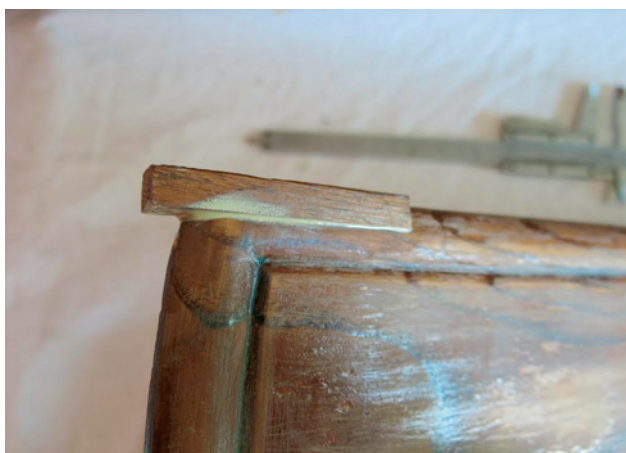
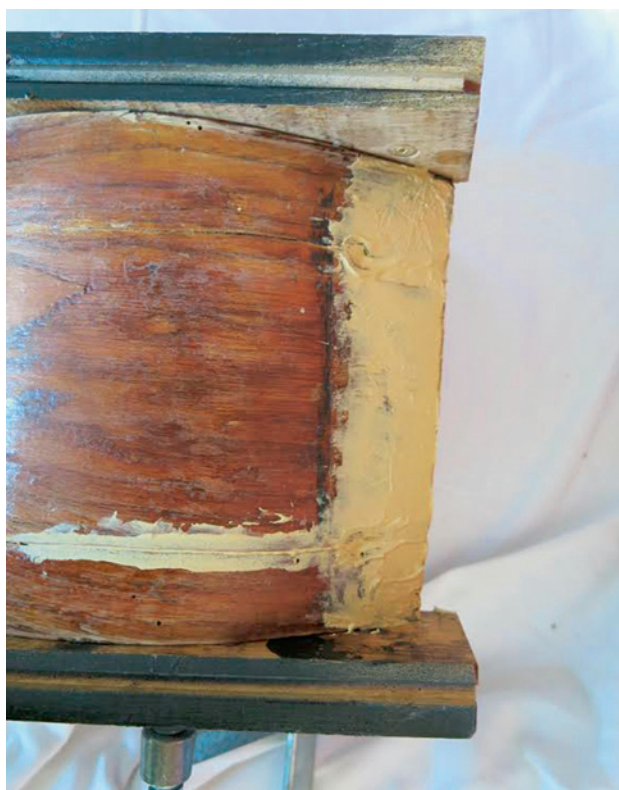
Sl. 7a-b. Detalji postupka obnove drva (snimio: Z. Kirchhoffer).

FIG. 7a-b. Details of the wood restoration process (photo by Z. Kirchhoffer).

After it was received in the workshop, the carriage was disassembled completely. Wooden parts were washed with water to remove coarse impurities (mud). Since no additional cleaning was necessary, carriage parts were dried and polished with sandpaper with grits from 80 to 800 in various phases of polishing. First an object was roughly sanded, and at the end sandpaper of fine granulation was used. After cleaning and sanding, decaying parts of the carriage were treated with two-component putty and D3/D4 wood glues acceptable in modern conservation-restoration practice for technical heritage.<sup>15</sup> Decayed planks were replaced with new ones in cases where no consolidation could have restored their mechanical hardness and transport capacity. Attention was paid to wood types used in order to achieve absolute correspondence to the original materials so the floor planks were replaced with fir, and beechwood was used for the seat. Wood preservative (insecticide and fungicide) was injected in the worm-eaten parts, and then they were coated with two-component quick-dry epoxy adhesive (araldite). After these basic procedures varnish was renewed in two layers to protect and preserve original wood colour (Fig. 7a-b).

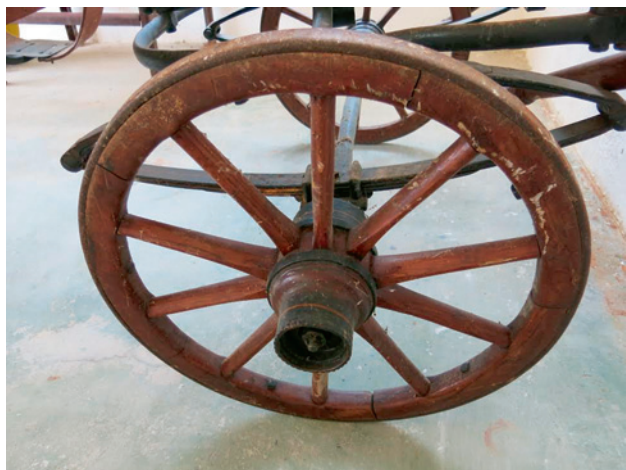
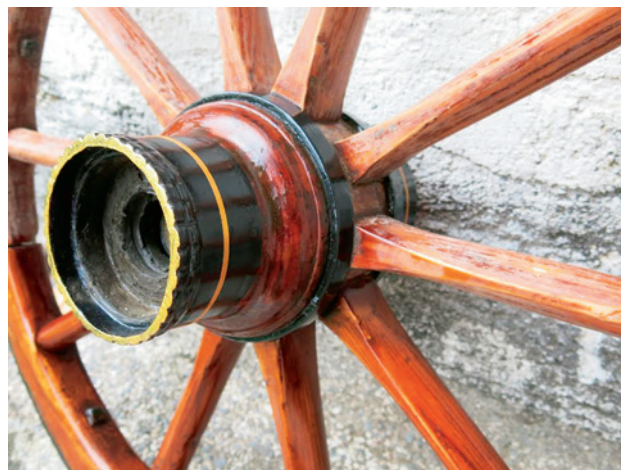
SL. 8. a) Kotač prije obnove; b) Kotač tijekom obnove (snimio: Z. Kirchhoffer).

FIG. 8. a) Wheel before restoration; b) Wheel during restoration (photo by Z. Kirchhoffer).

After works on the wooden parts of the carriage were finished, metal parts were cleaned from impurities, old paint, grease and corrosion with various hand tools such as files, scalpels, scrapers, chisels, spatulae, sandpapers on modified mats specially adjusted to treated surfaces and electrical hand tools (various types of vibratory grinders and belt sanders) which enabled removing all corrosive products wherever they appeared. After they were conserved with inhibitors, varnish damage was repaired and entire undercarriage and fittings were coated with glossy black. This colour was chosen according to the original coating of black paint based on cellulose and nitro solvents, discovered in several layers after the mechanical scraping. Thin golden lines decorated the undercarriage. They were retouched with golden paint i.e. drawn on the undercarriage and wheel hub<sup>16</sup> (Fig. 8b), at places where they originally were.

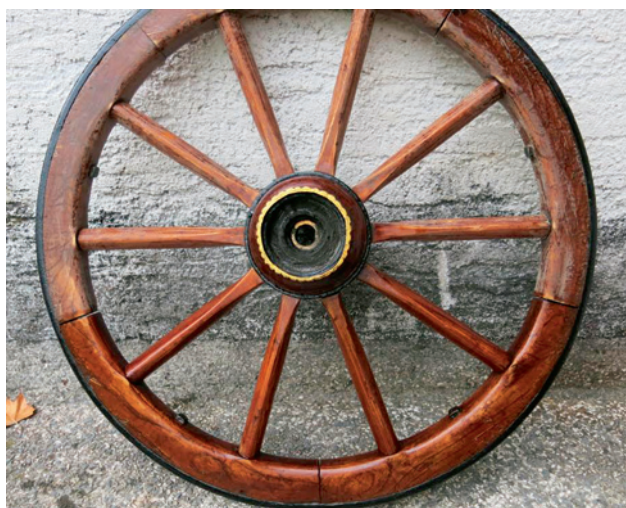
ed to be used on carriage wheels approximately in the mid-1840s.<sup>17</sup> Absence of tyres on this carriage may indicate that wheel and consequently carriage were built before the mid-19th century.<sup>18</sup> However, despite the relatively early emergence of tyre, until the beginning of the 20th century it was not used often on the wheels. Accordingly, tyres are not reliable indicators in determining the age of a carriage. The renovated Milord carriage had four wooden wheels, and it was made mostly of beechwood. Front wheels were approximately 20 cm smaller than the rear wheels and they were all without tyres (Fig. 9; cf. Fig. 1).

SL. 9. Prednji kotač tijekom obnove (snimio: Z. Kirchhoffer).  
FIG. 9. Front wheel during restoration (photo by Z. Kirchhoffer)

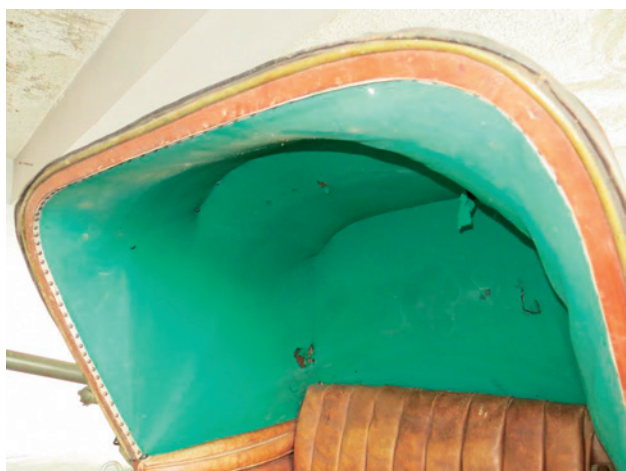
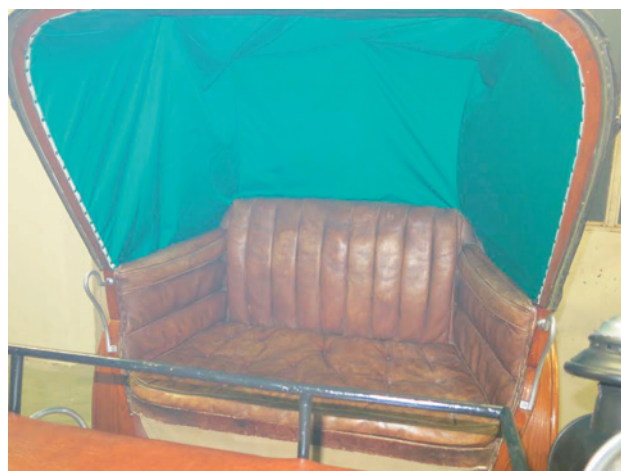
SL. 10. a) Unutrašnjost kabine prije obnove; b) Unutrašnjost kabine poslije obnove (snimio: Z. Kirchhoffer).

FIG. 10. a) Cabin before restoration; b) Cabin after restoration (photo by Z. Kirchhoffer).

Other interesting procedures include using the mechanical sewing machine for sewing of new textile for the roof lining. Special attention was paid to the fabric (green cotton textile) which would correspond best to the original both in type and colour nuance while number of knots per unit of surface area was not taken into consideration. Driver's seat was covered with artificial leather in accordance with existing condition. Passenger's seat was restored (by manual sewing) and conserved with a coating for impregnation and protection based on lanolin, solvent, wax and cedar oil (Fig. 10b). Dark neat's leather on the roof was not replaced as it was complete but it had a lot of small damages and patches which were consolidated with polyurethane adhesive after which the calash was folded. Floor of the carriage was covered with glued linen cloth which was cove-

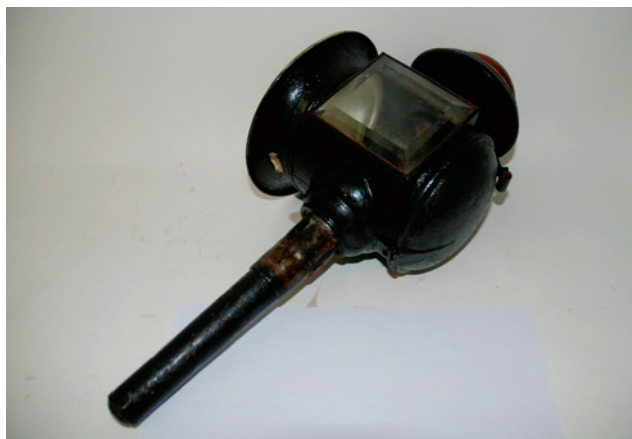
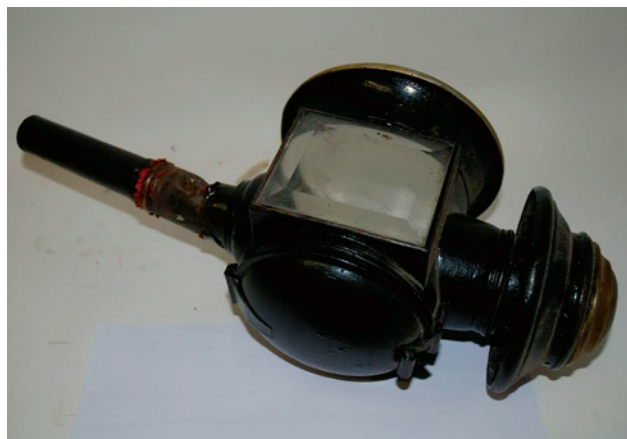
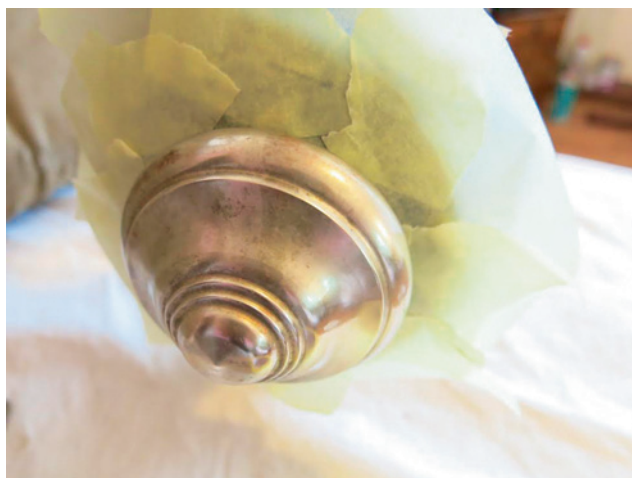
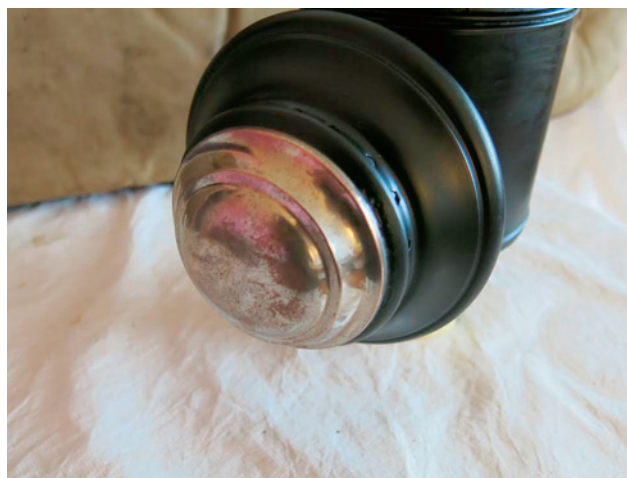
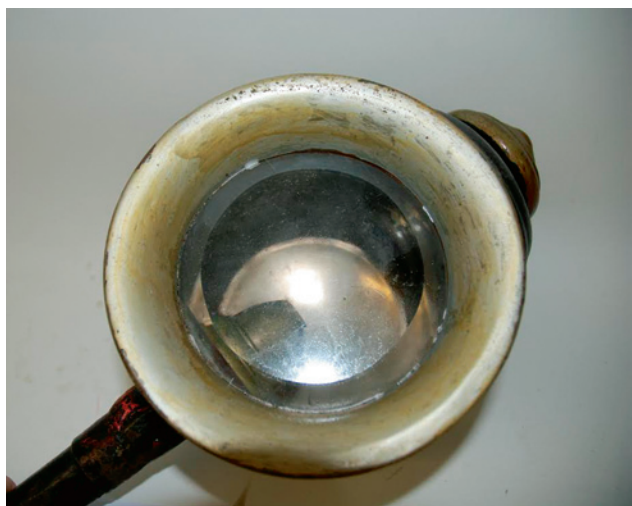
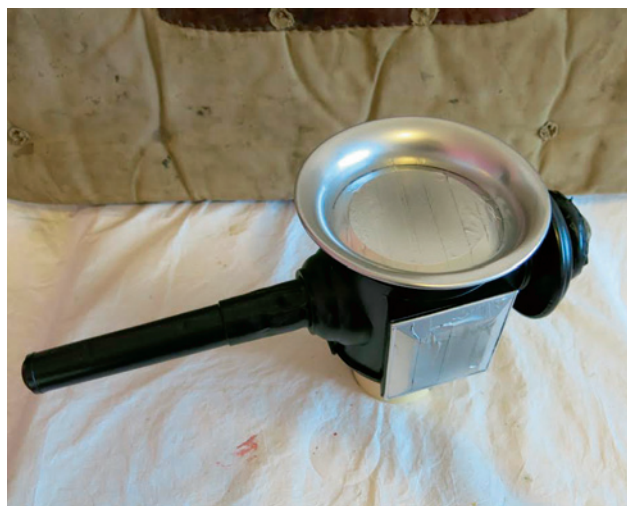
Restored carriage had two lamps made of steel sheet with added two profiled glasses. Although at first it does not seem so, these two lamps differ in dimensions and appearance (Fig. 11a-b). Lamps are basically round with certain differences on "lids", one of them being profiled, and the other rounded (Fig. 11c-d). Lighting system had to be identical on both lamps, but it is different because one protrusion for the tallow candle can be detached from the lamp body, and the other cannot, which is a consequence of alterations.<sup>19</sup> The best indicator of old interventions on the carriage which were not performed professionally is evident in the fact that on one lamp chrome plated bottom of a can was used as a "mirror" instead of concave metallized surface (Fig. 11e). Unprofessional replacements or, more accurately, compensations of shortcomings are testified by the fact that both lamps were originally intended for the same side of the carriage, which proves that definitely one lamp was replaced. Mentioned inadequate repair and replacement of the lamp indicate that these repairs and alterations happened while the carriage was still in use.

Body of the lamp is black, and thin lines surround the glass while silver paint was used for covering outer edge of the front part of the lamp headlight. Unfortunately there are no marks on them, and they are both damaged (Fig. 11a-b). Lamps were cleaned in detail with ultrasound cleaning, they were conserved and existing damage was repaired by flattening the sheet by small rubber mallets and various wooden tools suitable for such precise sheet metal works, and finally paint was renewed.

SL. II. a-b) Fenjeri prije obnove; c-d) Razlike poklopca fenjera; e) Dno konzerve umjesto ogledala; f) Fenjer poslije obnove (snimio: Z. Kirchhoffer).

FIG. II. a-b) Lanterns before restoration; c-d) Differences between lantern caps; e) Bottom of the tin can used instead of the mirror; f) Lantern after restoration (photo by Z. Kirchhoffer).
