SURFACE CONTAMINATION OF ALUMINA CERAMICS BY CARBON

Stoja Rešković¹ – Tin Brlić^{1*} – Suzana Jakovljević² – Ivan Jandrlić¹

Abstract:

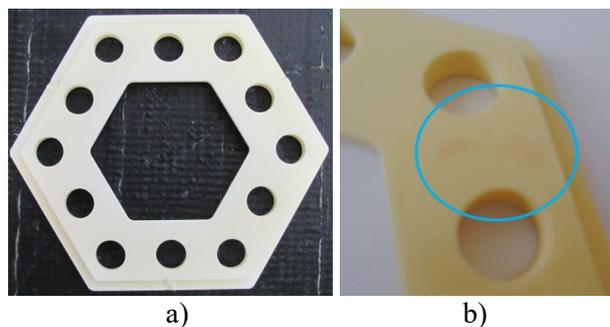
Figure 1. a) Panorama of alumina ceramics hexagon [10].

b) Contamination of alumina ceramics [8,10].

After polishing, contaminations were observed on almost all the products from the same batch, Fig. 1 (b), in the form of brown colored stains of varying intensity coloration on a certain number of products. Chemical composition tests were performed with inductively coupled plasma atomic emission spectroscopy (ICP-AES) [10]. The specimens from the contaminated area were taken to examine the causes of hexagons contamination with the scanning electron microscopy so that the same specimen had contaminated and uncontaminated parts. The specimens were sputter coated with palladium and gold with Emitech SC 7260 Sputter Coater, Fig. 2.

Clearly, the surface contamination of alumina ceramic hexagons has come from carbon plates. So, in order to avoid contamination, particular attention is to be paid to the quality of carbon plates, especially at the early stage of sintering of alumina ceramic hexagons, but also at the beginning of their use.

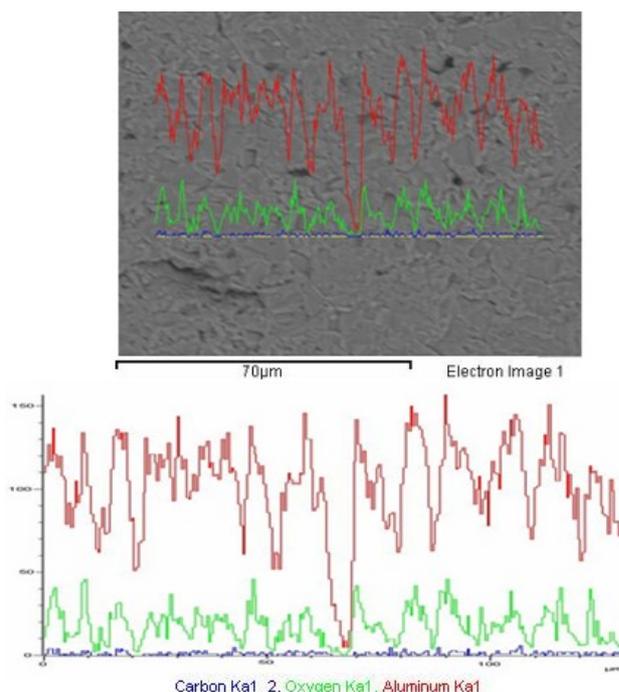
In the sample there is the presence of carbon visible in addition to aluminum and oxygen. Other elements are presented and identified (Mg, Si, Ca, Na, Ti and Fe) in the ceramic composition, but they are not shown in figures for reasons of clarity. Fig. 3 shows the presence of the carbon in the sample 1, which is homogeneously distributed along the length of line tests. The tests were repeated on several parallel samples and almost identical results

are obtained. The line analysis of elements shows no significant differences in the carbon content in contaminated and uncontaminated areas.

Figure 3. Line analysis of the elements in the sample 1.

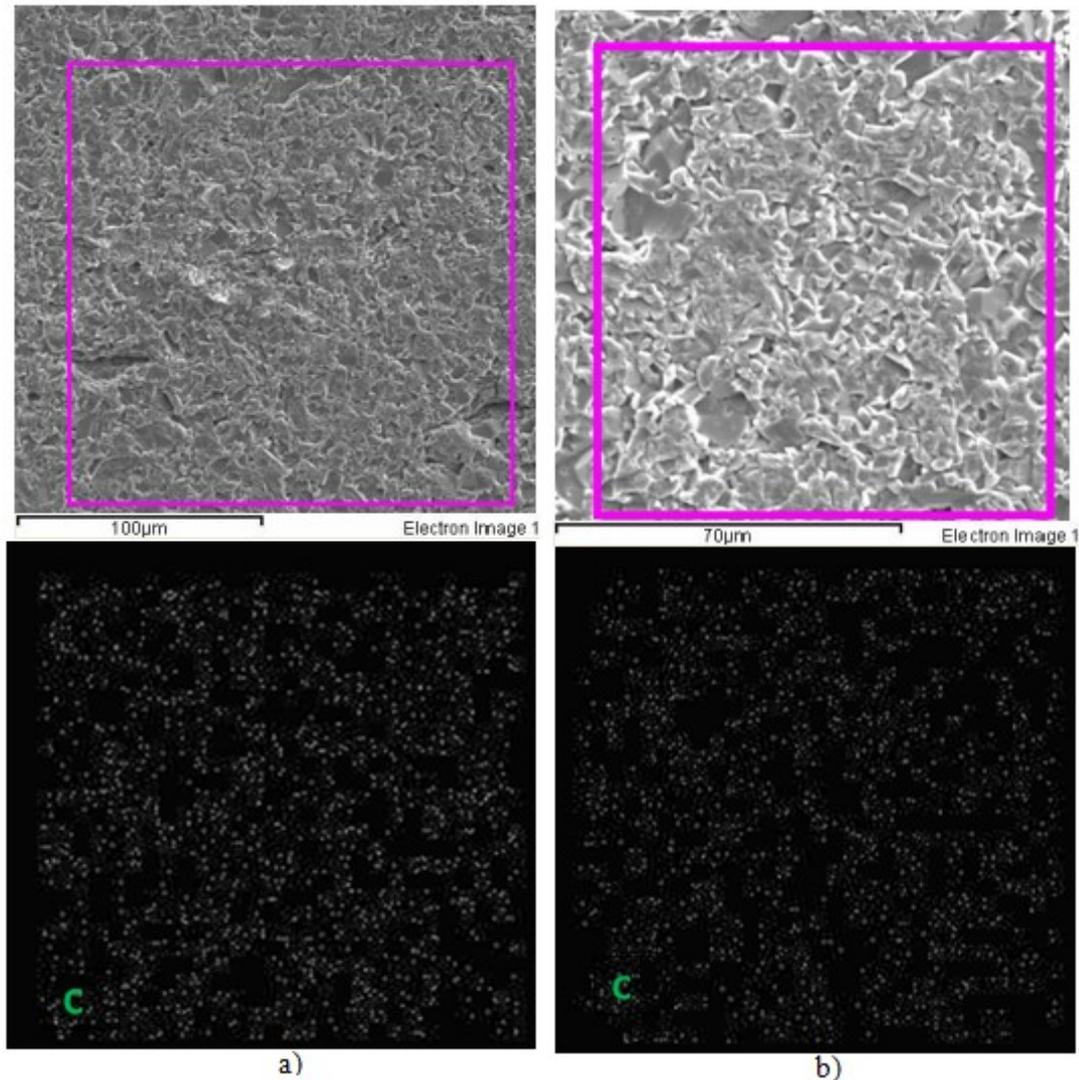
At low magnification, most of the contaminated area is analyzed, Fig. 4(a). Distribution of carbon is more visible at larger magnifications, Fig. 4(b). An analysis of elements distribution has shown that the carbon existing in ceramics does not exist in compounds with other elements.

Figure 4. a) Distribution of carbon in the sample tested at magnification 500x
 b) Distribution of carbon in the sample tested at magnification 1000x

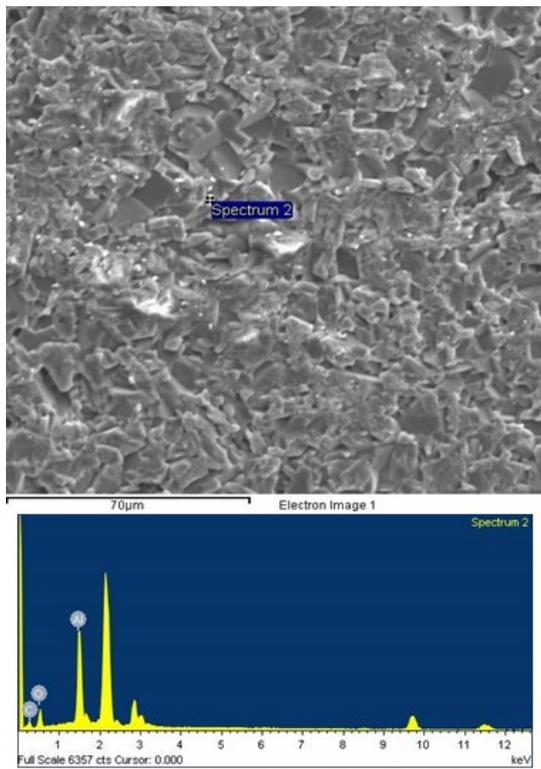
It was necessary to carry out the test method and a microchemical analysis (EDS method) in point to come to the conclusion with certainty. The obtained results are shown in Fig. 5, Fig. 6, Table 2 and Table 3. An increased content of compounds arranged in the form of points that contain carbon is visible in Fig. 5 and Fig. 6, at magnifications 1000x and 2000x. A microchemical analysis in point, shown in Table 2 and Table 3 presents that the sample surface is contaminated with carbon particles located at the surface.

Figure 5. EDS spectrum of elements in the sample 2, magnification 1000x

Element	Sample 2
	1000x
	Normalized content [wt.%]
Al	33.92
O	37.05
C	29.03
Σ	100

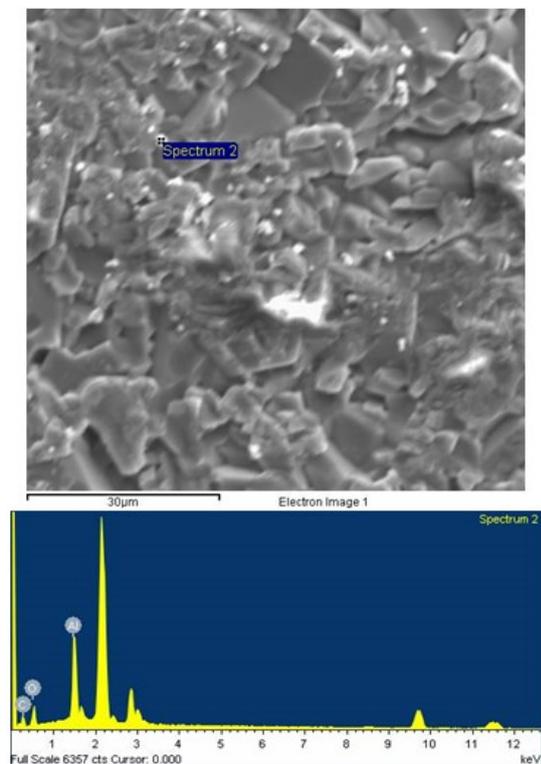
Figure 6. EDS spectrum of elements in the sample 2, magnification 2000x

Element	Sample 2
	2000x
	Normalized content [wt.%]
Al	28.24
O	37.41
C	34.35
Σ	100
