CORROSION DAMAGE OF SEAM WELDED GALVANIZED HOT WATER PIPELINES

Original scientific paper

The aim of this paper was to determine the cause of corrosion damage on hot water seam welded galvanized pipelines. Chemical analysis of the pipeline samples as well as their microstructure analysis has been undertaken. Visual inspection of samples of the internal surface of the pipelines was conducted, as well as the chemical analysis of water samples from specific regions of the hot water pipeline. The analysed samples came from the damaged pipeline, replaced pipeline and also from the new, unused pipelines and compared. The effects of the locally developing corrosion processes have been investigated. The influence of the welded joint structure and its heat-affected zone on the corrosion process intensity was analysed. The synergistic effect of zinc from the pipeline coating and the copper ions from the heat exchanger on the water systems corrosion development has been analysed. The fundamental preconditions of formation and development of various copper corrosion types were investigated, as well as the affecting influence of copper ions. The influence of hot water temperature against corro

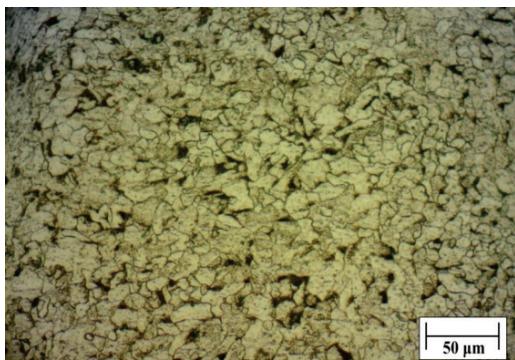
Figure 1 Microstructure of damaged pipeline's base metal

- Metallographic analysis of all tested samples showed:
- The structure of the base metal and the heat-affected zone was similar for both samples; i.e. there were no significant differences in size and shape of the crystal grains. The structure was ferritic-pearlitic;
- Differences in the galvanized coating thicknesses existed. For the damaged pipeline, the coating

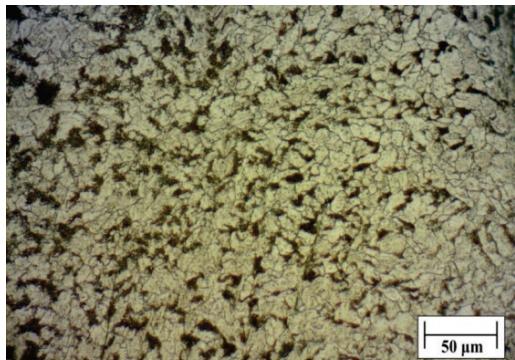
Figure 2 Microstructure of damaged pipeline's heat-affected zone

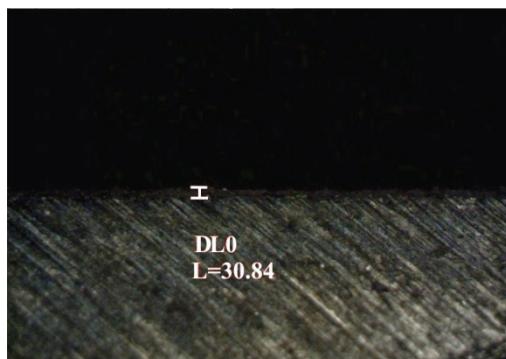
Figure 3 Galvanized coating thickness of damaged pipeline's sample (30,84 μm)

thickness was 30,84 µm which could be a consequence of the galvanized coating wear due to the tested sample being exposed. Other galvanized coating thickness measurements (for new pipe samples) were inside within the proposed standards ($> 55 \mu\text{m}$).

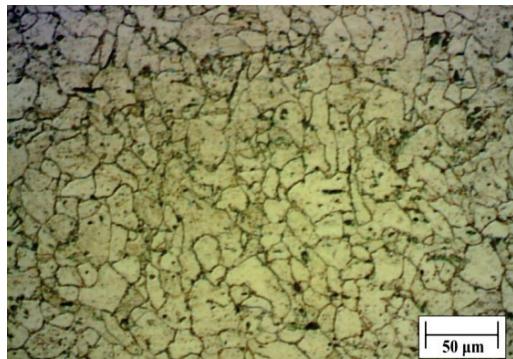
Figure 4 Microstructure of new pipeline's base metal

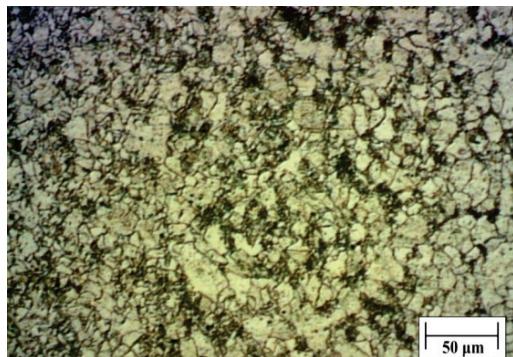
Figure 5 Microstructure of new pipeline's heat-affected zone

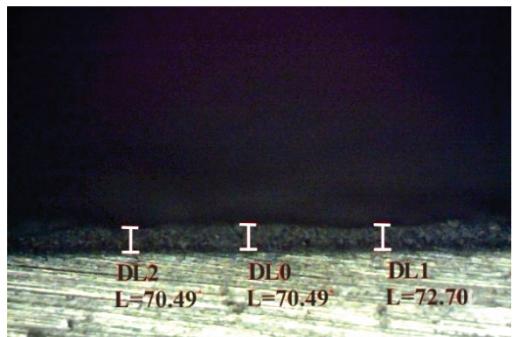
Figure 6 Galvanized coating thickness of new pipeline's sample (~ 71 μm)

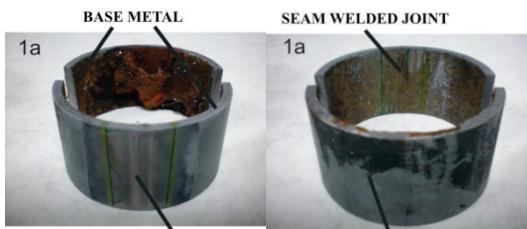
Figure 7 Damaged pipeline - base metal and seam welded joint; sample 1a

The visual inspection of all samples, except for the new ones (samples 3 and 4) showed that the corrosion process was in progress throughout all the inner surfaces of the pipes. Furthermore it was noted that on certain parts of the inner pipe walls, a significant cluster of corrosion products formed.

Based on the visual inspection, it was obvious that the corrosion process produced clusters. The copper ions were found in the clusters. The clusters were also found inside the pipes base metal, not only in the welded joint area. Moreover, an onward progression of the corrosion process was noted (Fig. 7 ÷ 12).

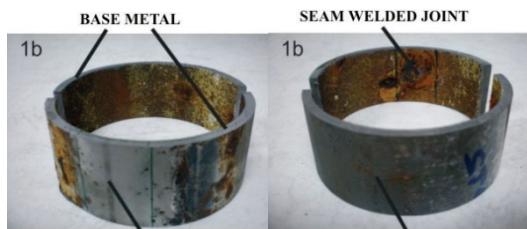
Figure 8 Damaged pipeline - base metal and seam welded joint; sample 1b

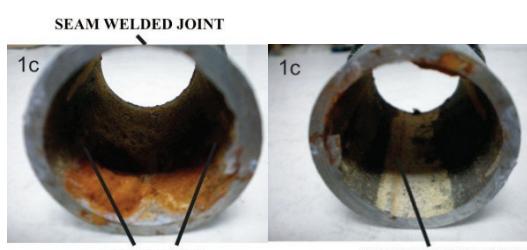
Figure 9 Damaged pipeline - base metal and seam welded joint; sample 1c

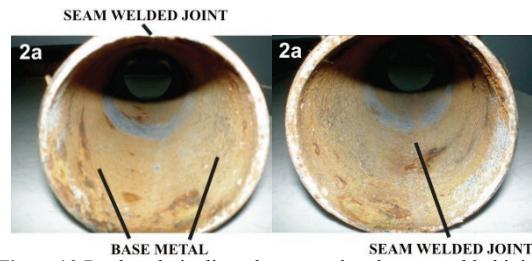
Figure 10 Replaced pipeline - base metal and seam welded joint; sample 2a

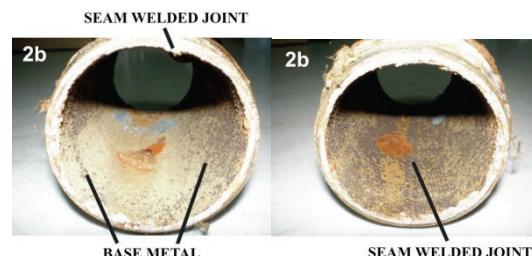
Figure 11 Replaced pipeline - base metal and seam welded joint; sample 2b

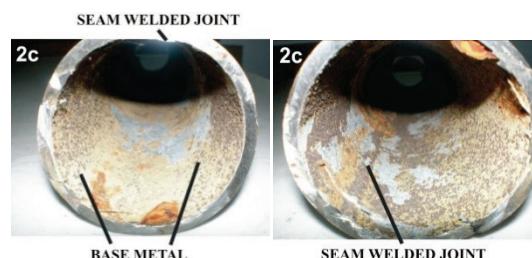
Figure 12 Replaced pipeline - base metal and seam welded joint; sample 2c

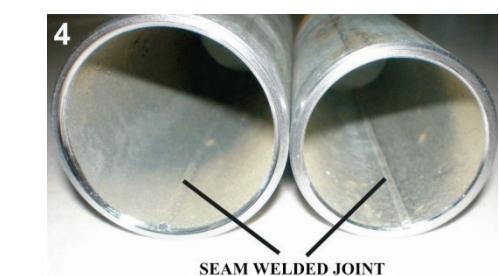
Figure 13 New pipeline – base metal and seam welded joint; samples 3 and 4
