RESTORATION OF THE BISHOP DANILO'S MAUSOLEUM AT EAGLE'S ROCK, CETINJE (MONTENEGRO)

Svetislav G. Popović, Dragutin Đuričić, Svetlana K. Perović

Professional paper

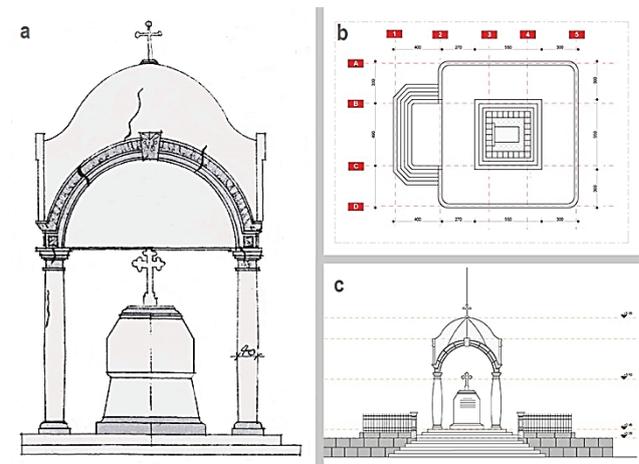
Due to the earthquakes in 1979 and 1980, the structure of the mausoleum was significantly damaged, especially at the joints of decorative stone arches of the cupola. The investigation in 1984 ascertained damages to the object as follows: penetration of moisture through the damaged roof cladding, formation of mould and mildew, dissolution and leaking of plaster inside the body of the cupola and the lower layer of the cupola. Disruption in the corpus of the stone pillars, perceived caverns resulting from weather conditions (rain, wind, frost, etc.) along the pillars. Visible irregular shapes of caverns on the pillars spread out in width and depth like a thread network which in some parts reaches a width and depth of 5mm. Observed damages on the object caused by the human factor - firearms (piercing through the copper cover of the cupola, tearing off parts of decorative stone arches of the cupola and parts of the stone pillars). In the fundament zone there were no damages, given that the bottom is a rock.

Figure 2 (a) Impairments recorded in 1984; (b) The basis of the mausoleum; (c) The appearance of the mausoleum from the west side

The restoration proposal included the injection of connectors of all stone elements with epoxy resins and bonding of the tie rods to the bodies of the capital with clamps. The drill holes in the connector zone are of a max. 8mm in diameter, made at a distance of 30 to 40 cm, depending on the size of the stone blocks. The drill holes were dusted off with compressed air. In order to achieve the required connection of the structure elements, the needed pressure was 70 MPa and tensioning of 30 MPa [11].

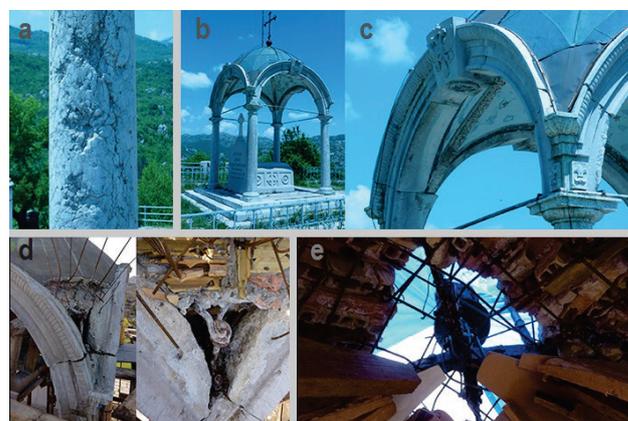
- The arches of the cupola are in very poor condition. All of the stone elements are in a poor connection with each other, having virtually no binder between them. The lack of high-quality connectors has caused a disruption in the geometry of the arch, and therefore a shift (lowering) of the individual parts of the arch, which has then caused direct contact between the stone elements, and the occurrence of sporadic fragmentation. (Fig. 3b and 3c).

- Vertical Doric pillars (Fig. 3a) are in danger of collapsing. At the bodies there are visible vertical cracks with damages present on the pedestal and the capital. The pillar located in the south-west has cracked to such an extent that there is risk of fracture. Other pillars are structurally somewhat better. In the upper levels of all four pillars there are visible, very dangerous cracks. Existing cracks allow atmospheric water to penetrate into the interior of the pillars which is a further destructive activity that is threatening the rest of the healthy part of the material. The part where pillars and arches connect has an iron sag rod that connects all four pillars, at the support of the cupola, in all four points of the column capitals and thus

The mausoleum was in pretty bad condition. Damages were visible in all segments, starting from the access flight of steps, plinth, stone floor with a considerable number of broken plates, pillars, baldachin and copper sheet with which it is covered, metal cross on top, utterly ruined and damaged "starry sky" (Fig. 3e) and two partially damaged pillars out of four in total. Stone plastic was in good condition and did not require major interventions. Established damages appeared in the zone of the arch support on three capitals in the form of cracks running up to half of the pillar diameter. Ties were placed at the outer perimeter of the capital (Fig. 3d).

Figure 3 (a) Damaged pillar vitality; (b-c) Disruption of the geometry of the vault; (d) Damage of the calotte support; (e) Damage of the vault.

The vault is uncovered, i.e. the copper sheet was removed, the cement screed was cleaned up to the filling - brick blocks, lower surface of the cupola has been removed, also up to the filling. The core of the vault (steel construction with brick block filling) was reinforced from upper and lower surface by a network of Ø8/15 diameter in both directions and it was connected with pins of Ø8/20. Along the contour in the arch zone, a ring of 3 Ø12 was formed. Concreting of the lower surface of the vault gave a reinforced concrete shell with a thickness of 3.00 cm, and concreting of the upper surface gave a reinforced concrete shell with a thickness of 5.00 cm. These two reinforced concrete shells connected with pins, together with the filling and the existing steel structure, have formed an auto-stable vault.

Drilling in the pillar was conducted at the spot of connection of the arcades, in the direction of vertical suspension. Pillars were drilled along the axis, along the entire height. Changes on the pillar matter were reviewed on the extracted samples, i.e. whether and how far did the process of corrosion attack the pillars. It was shown that the core is conserved. Armature of R Ø19 was placed in the holing, suffused with SIKODUR 45, a three component epoxide mortar (Fig. 4b). The procedure included the drilling of all four pillars vertically, their strengthening with reinforced iron and a filling on the basis of epoxy resin.

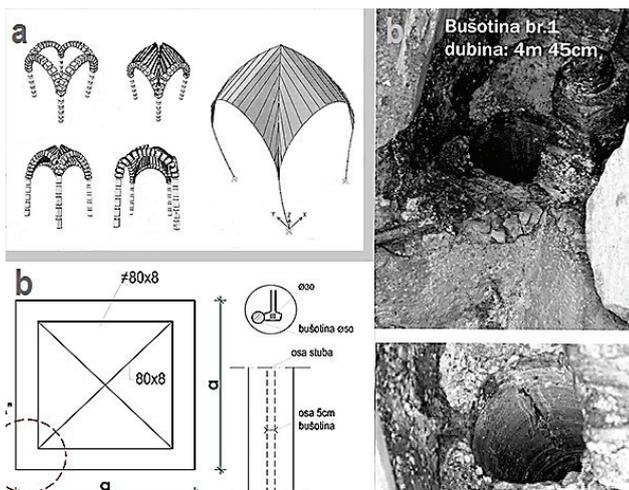
Figure 4 (a) The calculation model; (b) Drilling in the pillar at the point of arcade connection.

Based on the analysis of existing geometry, size and distribution of the load on the calculation model (Fig. 4a), identification of the structure was performed concluding that the foundation is of reinforced concrete, pillars are granite monolith, cupola - vault has a filling of brick

Sikodur mortar penetrates, and fills all pores and bubbles in the holing zone (if there was any), forming a uniform mass of the pillars. Cross-sections of the pillars were computationally tested by about 20 % smaller cross-sectional surface. About 15 litres of Sikadur was needed to fill out individual holing - 42.

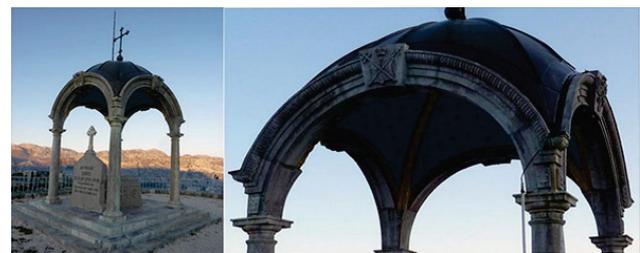
Figure 5 The appearance of the object at completed restoration, 2011.

The restoration implied preserving the authenticity of the monument, while ensuring its stability. The calculation was implemented on a spatial model, gravitational load and inertial force of the earthquake of IX degrees MCS, and has proven its stability. Restoration of the object was realized according to the project, which has provided the preservation of authentic values of architectural and cultural heritage (Fig. 5).
