Baris BARLAS
Reyhan OZSOYSAL
Ertekin BAYRAKTARKATAL
Osman A. OZSOYSAL

A STUDY ON THE IDENTIFICATION OF FIRE HAZARDS ON BOARD: A CASE STUDY

Professional Paper

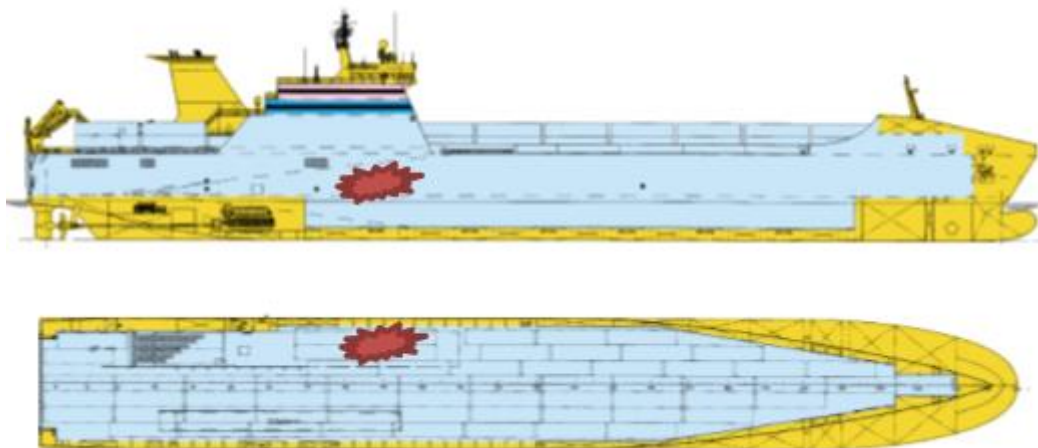
Fig. 1 Starting location of the fire

Fire, heat and smoke in the aft upper deck blocked access to lifeboats and all were trapped in the bridge area. They managed to escape to the fore-castle by descending down from the forward wall of accommodation using fire hoses and flag lanyards. After 15 minutes, the Captain had to give the order to abandon the ship as the fire approached dangerously close. All crew and truck drivers were rescued by about 07:00. The starting location of the fire is depicted in Fig. 1 [12].

After the fire was extinguished, the deck was found covered by knee-deep ash and remnants in an almost indistinguishable state. There were no particular ignition sources to start a fire in the main deck other than the truck and the trailers. Trucks had some equipment which can be considered as potential igniters such as accumulators, electric and fuel connections. They also had other flammable items other than their cargoes such as the fuel storage tanks, tires, small butane/propane canisters and stoves for cooking, nylon covers, plastic and rubber components etc.

Main and lower decks were the enclosed cargo spaces. Main deck which the fire began had a volume of about 35400 cubic meters. This kind of huge volume of air was able to provide the sufficient Oxygen which needs of a fire without any other air supply. Air fans of the main deck and the lower deck were kept to be off during the navigation and air intake was not permitted. However, the ship owner and operators used to prefer voyaging with ventilation closed but refreshing air during daytimes under good weather conditions. The fire on board was noticed to start next to the portside aft ramp of the main deck which was also loaded with trucks on it. The air intake of the machinery room main ventilation fan was close to the fire scene and located on the inboard wall about 1 meter just above the vehicle ramp between the main deck and upper deck.
