# DIJAGNOSTIČKI PREGLED RASPADA ELEKTROENERGETSKOG SUSTAVA NA OTOKU RODOSU DIAGNOSTIC REVIEW OF A BLACKOUT IN RHODES

A technical review of an incident on March 21, 2007 that began at 00:50 a.m. and led to a two-hour blackout of the island of Rhodes electric power system is presented with the complete sequence, including all the relevant registered operational data as well as the on-site field findings. A technical analysis of the disturbance was performed to determine the probable causes and factors that contributed to the duration of the disturbance. Since the system is an isolated one, it is particularly vulnerable to perturbations. The roles of system protection and wind power generation during the incident are examined. Conclusions of practical importance are drawn, including recommendations for corrective measures to be implemented for preventing disturbances of this kind from reoccurring in the future.

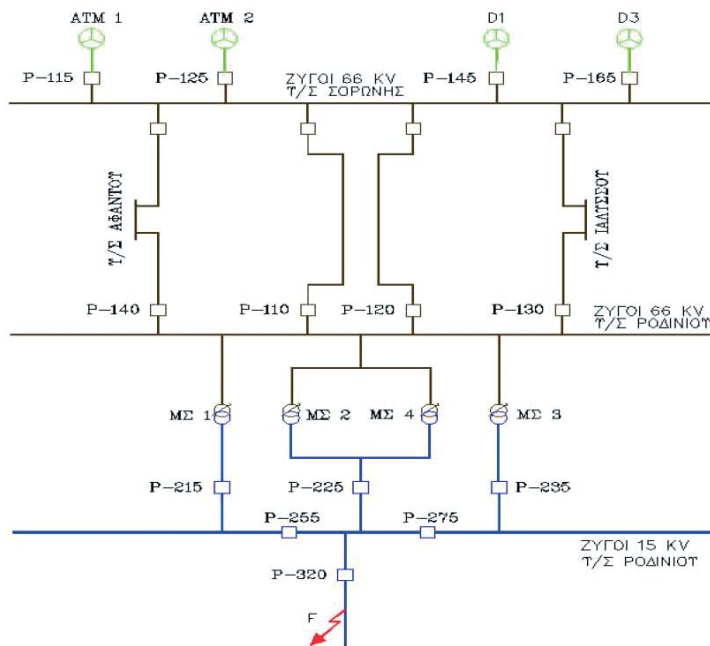
**Slika 1**  
 Jednopolna shema sustava na početku smetnje  
 Figure 1  
 One-line diagram of the system at the start of the fault

The fault occurred at the Rhodini substation on the distribution line fed through the breaker P-320 from the 15 kV bus, as shown in Figure 1. Following the fault, protection was activated and tripped the breakers P-320, P-255 and P-225. As a result of the fault, a wooden pole of the distribution line burned and had to be replaced later. The weather was severe at the time of the fault, with strong wind spraying sea water droplets over the line insulators, thereby increasing the likelihood of a flashover. Post-mortem examination found the jumper wire for the middle phase conductor (in a horizontal arrangement of the 3 phases) cut at another wooden pole of the same distribution line. The same thing also happened to another pole of the same line where, in addition to a broken middle jumper wire, its porcelain insulators were also broken. This would most likely imply that these were the results of the fault current. This initial fault was finally cleared at about 13 sec after it happened. However, 19 sec after the fault clearance, Steam Unit #1 was lost, and 2 min and 45 sec after the fault clearance Steam Unit #2 was lost, resulting in the blackout.

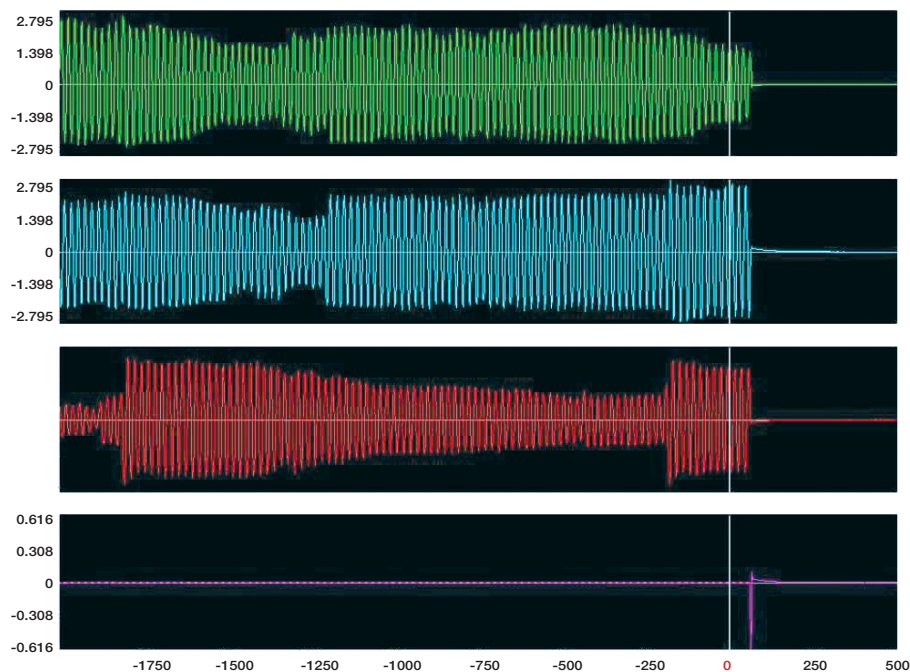
P-255 (Figure 2) breakers, which showed zero earth current. It could also be observed that the fault impedances varied randomly with time, suggesting that the electric-arcing of varying spans was the cause. Oscillograms 1 and 2 (Figures 3 and 4) show the voltages at the 66 kV buses at Rhodini and the currents at the 66 kV breaker P-110, respectively. These oscillograms show oscillation developing as time progresses. Subsequent time Oscillograms 3 and 4 (Figures 5 and 6) show this (100 Hz frequency) oscillation more clearly. This oscillation is sustained to the end (as seen in Oscillogram 5 (Figure 7)). This could indicate that the automatic voltage regulators (AVR) need adjustments.

**Slika 2**  
Vremenske krivulje izmjeničnih struja faza a, b, c i uzemljenja na prekidaču P-255  
**Figure 2**  
Time curves of the alternating currents of Phases a, b, c and ground at breaker P-255

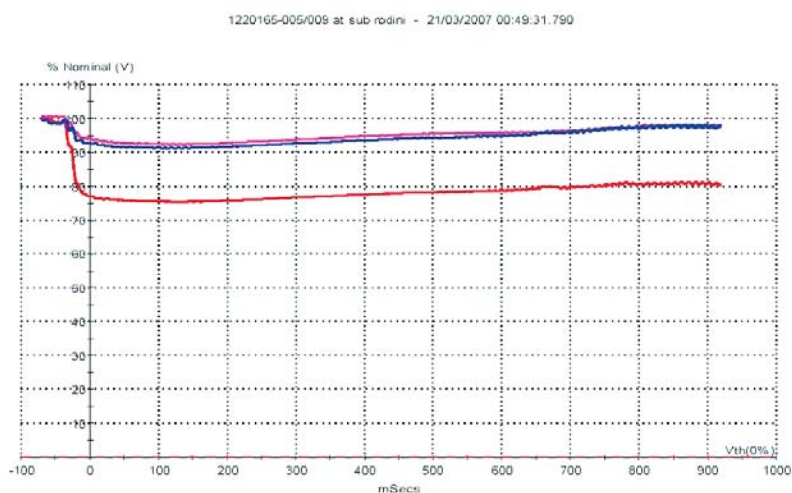
**Slika 3**  
Oscilogram 1 – Naponi na sabirnici 66 kV na trafostanici Rhodini (početak gubljenja struje iz voda)  
**Figure 3**  
Oscilogram 1 – Voltages at the 66 kV bus at Rhodini (the fault begins)

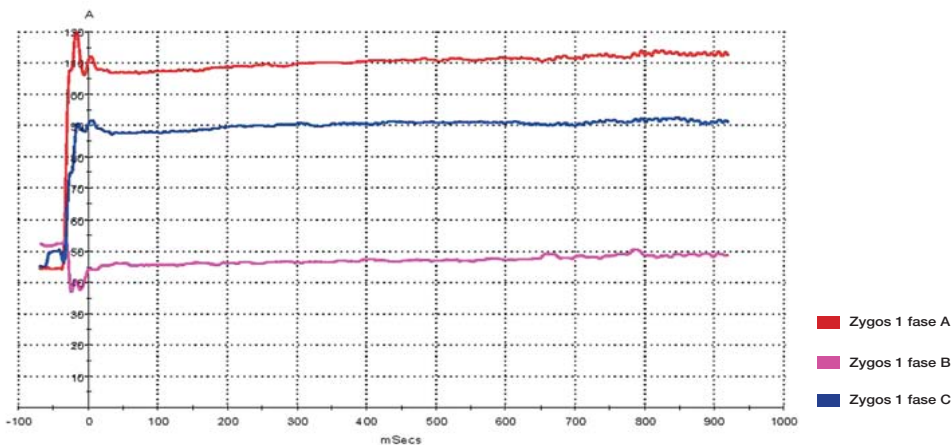
**Slika 4**  
 Oscilogram 2 –  
 Struje zabilježene  
 na prekidaču 66 kV  
 P-110 na trafostanici  
 Rhodini  
 Figure 4  
 Oscillogram 2 –  
 Currents registered at  
 66 kV Breaker P-110  
 at Rhodini

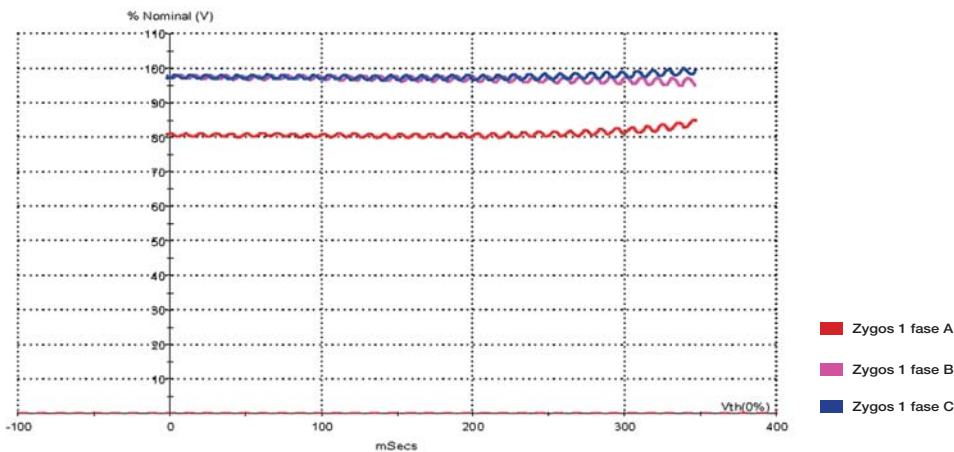
**Slika 5**  
 Oscilogram 3 – Naponi  
 na sabirnici 66 kV na  
 trafostanici Rhodini  
 Figure 5  
 Oscillogram 3 –  
 Voltages at 66 kV bus  
 at Rhodini

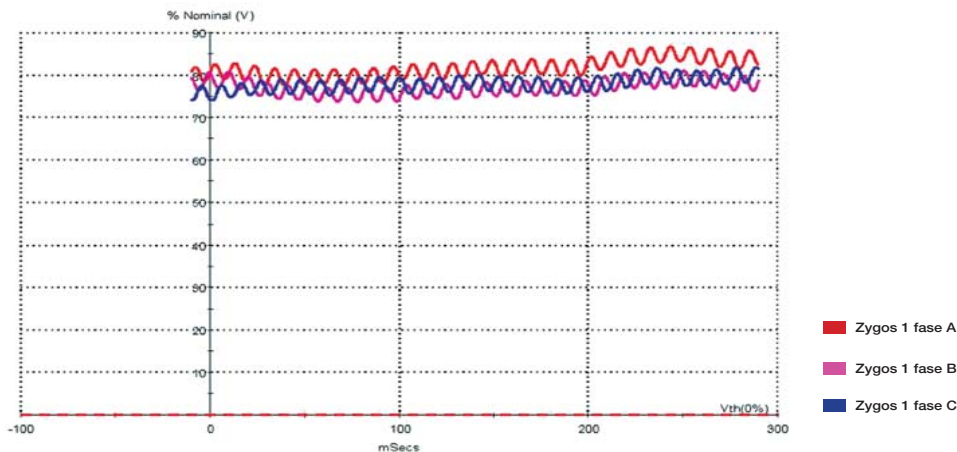
**Slika 6**  
 Oscilogram 4 – Naponi  
 na sabirnici 66 kV na  
 trafostanici Rhodini  
 Figure 6  
 Oscillogram 4 –  
 Voltages at 66 kV bus  
 at Rhodini

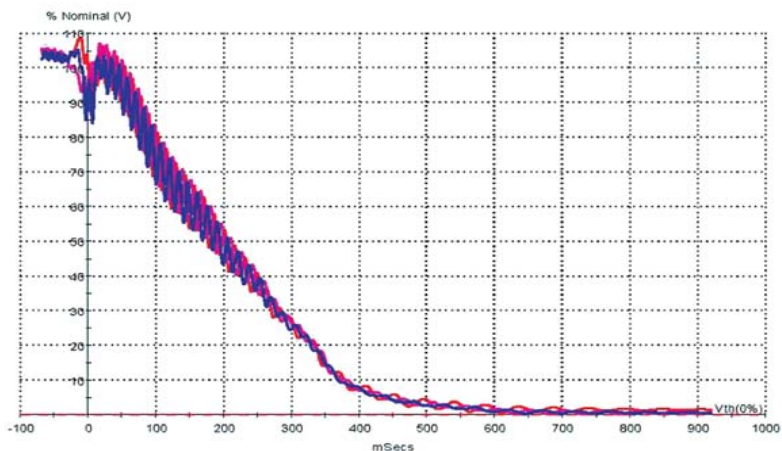
**Figure 7**  
 Oscillogram 5 – Voltage at 66 kV bus at Rhodini (blackout seen at the end)

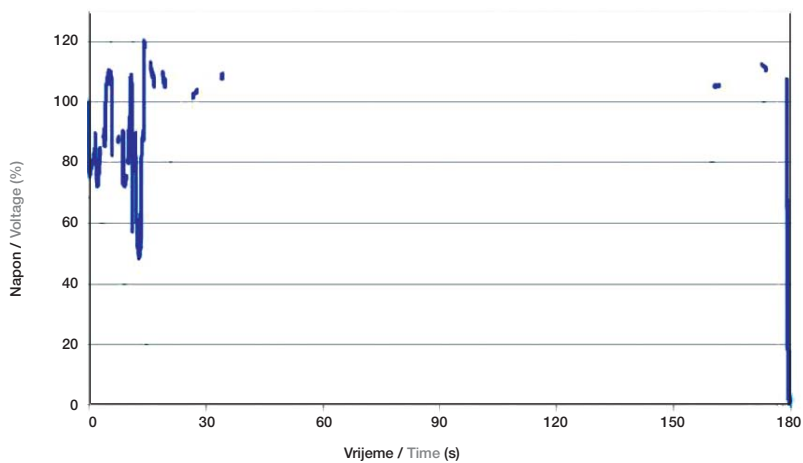
From the voltage oscillogram, one can calculate the voltage magnitude as a function of time, from the occurrence of the fault up to the voltage collapse, as shown in Figure 8.

**Figure 8**  
 66 kV bus voltage variation (in %) during the disturbance

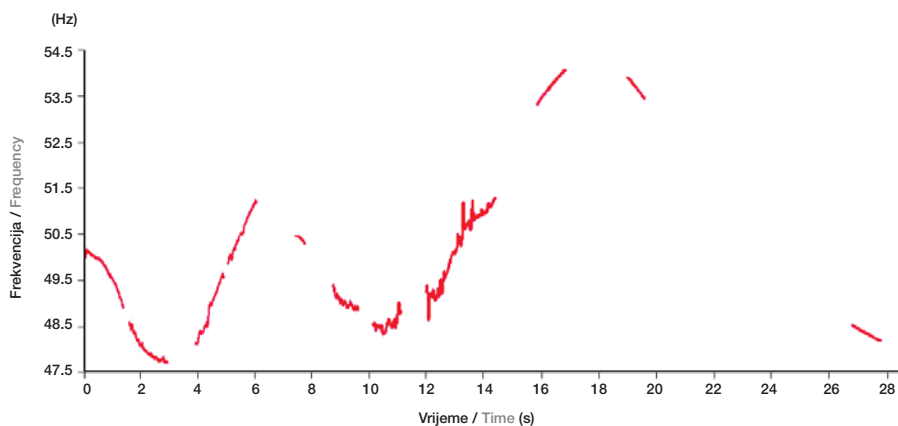
In the course of the disturbance, wide frequency swings were registered. The respective data are shown in Figure 9. In this figure, one can see the minimum frequency of 47,7 Hz (2 s after the start of the disturbance), and the maximum frequency of 54 Hz (16 s after the start of the disturbance).

**Figure 9**  
 Frequency variation trend registered during the disturbance
