Antun Mikulecky
Končar - Electrical Engineering Institute
amikul@koncar-institut.hr

TRANSFORMER BUSHINGS – FAILURE CASE STUDIES

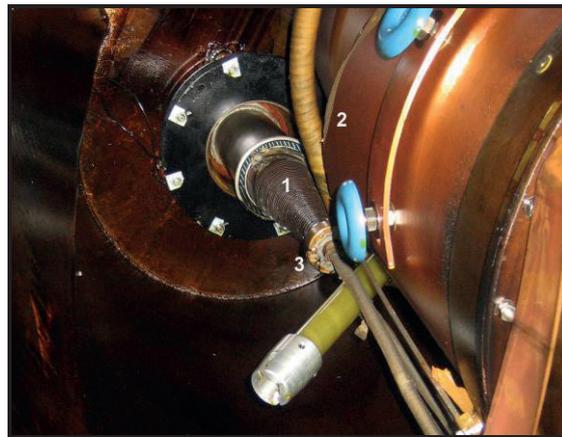
The lower envelope of an OIP type 123 kV bushing on a 150 MVA, 220/110 kV autotransformer, voltage, about 40 years old, exploded in the spring of 2006, during heavy rain, Figure 3. The hydrodynamic shock caused by bushing breakdown was very intense. The transformer tank was ruptured in several places so oil was leaking out. Most of the remaining bushings on the transformer were damaged (upper porcelain envelope damage and dislocation in relation to the head or flange occurred, followed by oil leakage from the bushing). The active part of the transformer was damaged to a great extent (the OLTC was destroyed, tap winding leads were damaged, etc.) and polluted so it had to be scrapped. The bushing was connected to the switchyard by rope.

Figure 3: Exploded 123 kV bushing
(1 – lower part of the bushing without the exploded lower envelope,
2 – damaged diverter switch cylinder,
3 – electric arch traces on the lower electrostatic screen)

The transformer was regularly diagnostically tested in approximately four-year intervals. In the period between the last two measurements in the years 2002 and 2005, there was a relatively large increase of the bushing $\tan\delta$ amounting to 41 %, but its value was still relatively low (0,52 %). The bushing was treated as suspicious and more frequent testing was recommended. A detailed inspection of the bushing debris was performed several months after the failure. The condenser body was unwounded but no traces pointing to the cause of failure were found. The lower part of the condenser body was clean, with no traces of an electric arch. Traces of an electric arch were found only on the lower porcelain envelope fragments that were collected from the transformer tank, flange and lower electrostatic screen.

The following failure scenario can be presumed. Weakening of the sealing system leads to a gradual moistening of the bushing insulation system resulting in an increase of $\tan\delta$. Due to heavy rain and rapid cooling of the bushing, water can be sucked into it and this directly causes the lower envelope crepe breakdown (position 8 in Figure 1). Such a hydrodynamic shock breaks the OLTC diverter switch cylinder thus causing the loss of its axial support. Hence, the OLTC drops and moves to the side, deforming 123 kV line lead and on the tap winding leads in the process. Based on this case, it can be concluded that a forty percent increase of $\tan\delta$ is very significant, despite its relatively low value. The recommendation for more frequent measurement was not good enough. The failure could have been avoided by replacing the bushing or adding an intervention monitoring system.

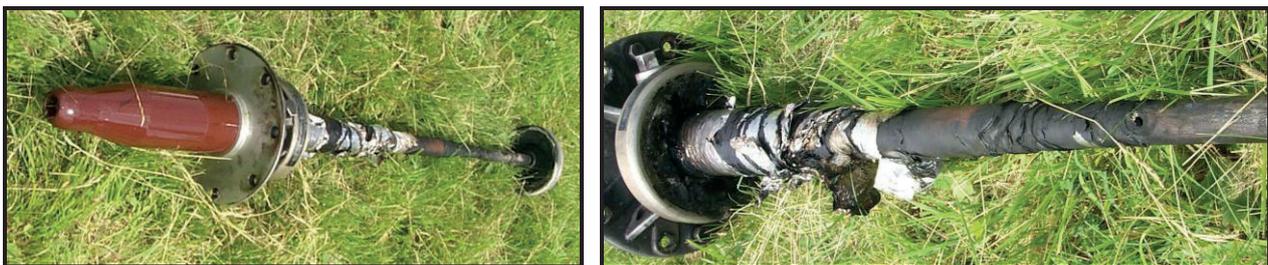
In the spring of 2005, the upper envelope of the 123 kV OIP type bushing on a 40 MVA, 110/10.5 kV transformer, 20 years old, exploded. The shock caused damage to the other bushings and equipment in the switchyard as well as a small fire. The failure occurred during a thunderstorm. Previous diagnostic investigation of the bushing had been undertaken in the years 1996 and 2000, approximately nine and five years previous to the failure, respectively. In that period, $\tan\delta$ increased by almost 50 % (from 0,17 % to 0,25 %), but the values were very low, even for new bushings. The bushing was connected by rope. All 123 kV bushing were replaced in a few days. Visual inspection of the bushing debris showed a longitudinal breakdown in the space between the condenser body and the upper envelope (space between positions 1 and 7 in Figure 1). This is implicated by the hole on the central tube caused by the electric arch during the breakdown, Figure 4. However, because of the great damage of the condenser body, most part of which was burnt, a possible cause of breakdown could also have been the condenser body breakdown, although in this case it is less likely. The lower envelope was not damaged; preventing oil leakage onto the fault site and thus it was not accompanied by a major fire or transformer active part pollution by bushing fragments. An inspection of the bushing head showed cracks that could have occurred prior to the failure and this fact could be considered as an initial sealing system defect.

Figure 4: Disassembled failed bushing; Figure left – the whole bushing; Figure right – upper part of the bushing (the hole on the right-hand side of the tube was caused by the electric arch)

The cause of this bushing failure is not completely clear. Possibly, it was caused by a defect in the sealing system or a defect of the bushing condenser body. This case also points out the importance of $\tan\delta$ change during service despite very small actual values.

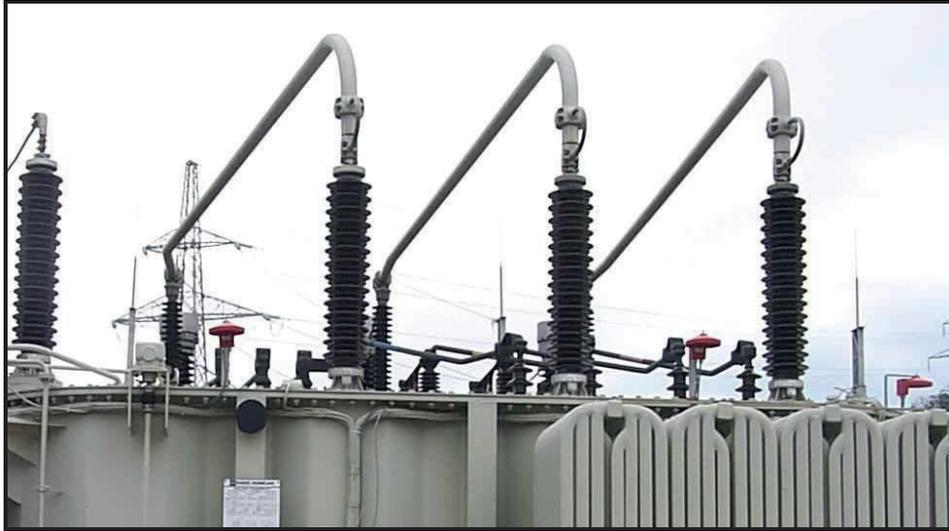
In the period of 1991 to 1998, three 123 kV OIP bushing explosions occurred on three GSU transformers 43 MVA, 115 kV in one hydro-power plant. Frequent on and off switching, just as service at full load is characteristic for this power plant (peak load power plant). In all three cases, the failure appearance was practically identical: HV bushing explosion, thus damaging the other HV and LV bushings, causing a fire that further damaged the entire transformer exterior. Each time, repairs lasted for several months and had to be conducted in the factory. The bushings were connected to the switchyard by tubes, as shown in Figure 5. The first failure occurred in 1991 on a transformer produced in 1981. No data on previous diagnostic investigations were available. According to the visual inspection, the burst progressed radially from the central bushing tube (pos. 6 in Fig. 1) to the flange in the test tap area (positions 9 and 11 in Figure 1). The second failure occurred in 1993 on a transformer also produced in 1981. The inspected breakdown traces were visually identical to the first case. Previous diagnostic investigation had been conducted 14 months prior to the failure, but the results did not show any problems. The third failure occurred in 1998 on a transformer produced in 1988. Breakdown traces progressed axially, from the upper endpoint of the bushing, through interspace between bushing condenser body (pos.1, Fig. 1) and porcelain (pos. 7, Fig. 1), to the flange in the test tap area (positions 9 and 11 in Figure 1). Previous measurement of $\tan\delta$, approximately 13 month before the failure, had shown a value of 1,52 %, but, unfortunately, despite this drastic increase in value, the bushing had not been replaced. The three exploded bushings were not produced by the same manufacturer. Traces of all the three breakdowns were in a way associated with the test tap.

Figure 5: Tubular connections between the switchyard and 123 kV bushings

Obviously, these three cases show that something causes bushing properties degradation. The assumption has been made that it is caused by the too rigid tubular connection between the bushing and the switchyard. In addition, the incorrect orientation of the bus dilatation compensator contributes to the degradation (see Fig. 5). It can compensate vertical but not horizontal dilatation, whereas the latter should be dominant. A replacement of the bushing – switchyard connection was recommended. Instead, a part of a tubular connection flexible cable (rope) was used. Switchyard reconstruction was performed approximately twelve years ago and since then there have not been any malfunctions of this type.

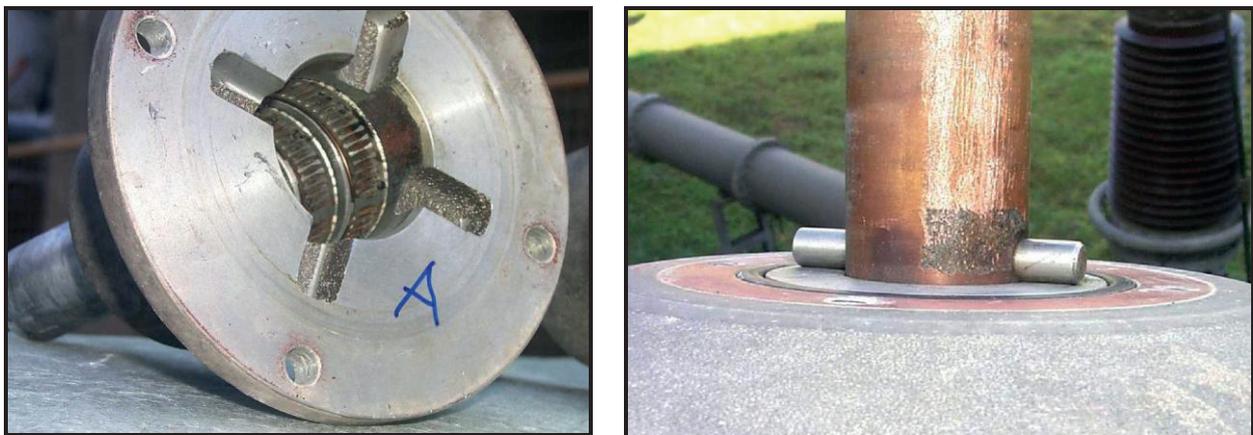
Thermal image scanning of the 250 MVA, 220 kV, 16 years old, GSU transformer in 2002 showed increased heating of the 245 kV bushing head and connection (positions 3 and 4, Figure 1) relative to a healthy bushing, approximately by 60 K. Measurement of the HV Winding resistance showed an increase of 0,87 % in the respective phase therefore indicating the cause of poor contact on the tulip contacts (pos. 3, Figure 1) between the connection and the bolt at the end of the copper cable, Figure 6. Inspection of the HV connection showed traces of metal melting on the tulip contacts and copper transfer from the bolt to the aluminum connection. This incipient failure was eliminated by replacing the tulip contacts spring part, since its weakening is the most probable cause of increased heating, and by cleaning contact surfaces. Owing to the availability of spare parts as well as to detection of the malfunction in the initial stage, repairs took only two days.

Figure 6: Left: Overheating traces on the HV connection and the tulip contact spring part; Right: Traces of overheating on the bolt

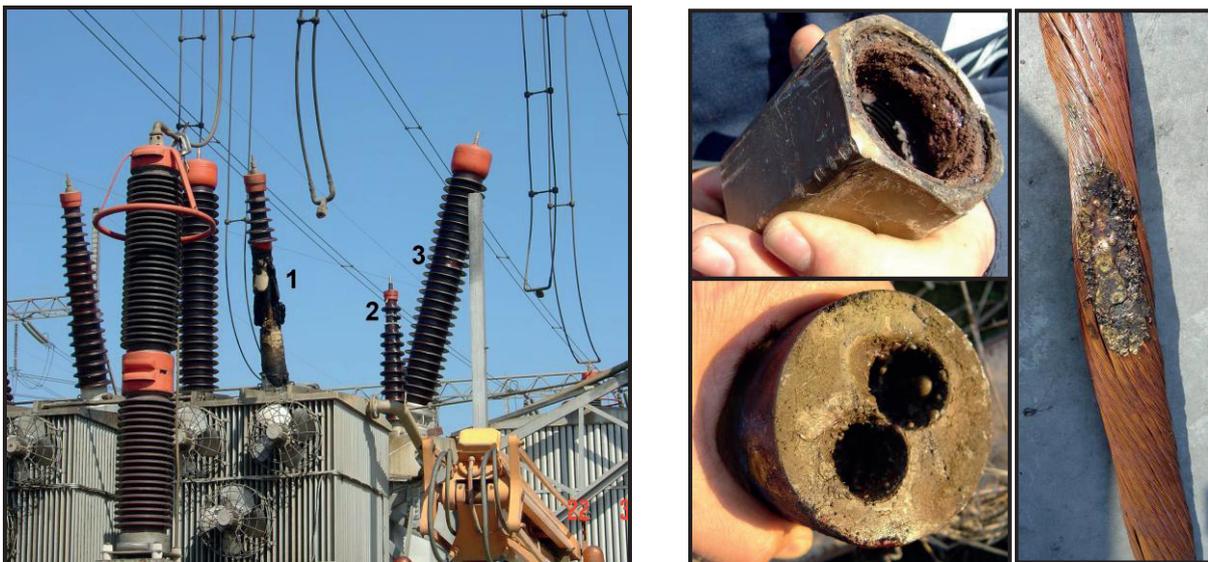
Figure 7: A 400 MVA, 400 kV transformer failure;

A very interesting 245 kV RBP bushing failure in the form of upper envelope and lower bushing part explosion occurred in 2005 on a 400 MVA, 400/220/30 kV, approximately 25 years old transformer. It was accompanied by a small scale fire on the transformer and pollution of the active part by the bushing fragments and other carbonized residues. Upper envelope fragments destroyed the neutral point bushing and one 420 kV bushing sustained damage, Figure 7. No information on diagnostic tests in the period of 5 years prior to the failure was available. Visual inspection of the bushing indicated a radial condenser body breakdown. Based on a detailed inspection of the bushing, the following probable failure scenario was established. Poor contact on the screw of the upper connection and the connector body (pos. 3, Figure 1) caused overheating which, enhanced during service, resulted in melting of the brazing by which copper cables were fixed to the connector body (Figure 7, in the middle top and bottom). Physical separation of the connector body and the cables occurred. Conduction of the current from the connector body was taken over by the central bushing tube. Electricity flowed from the tube onto the copper cables through several undefined locations, this being the only possible way to close the electric circle between the switchyard and the winding. Losses on undefined contacts heated the central tube (Figure 7, right) and bushing insulation, leading to condenser body thermal breakdown as a final consequence. Observed overheating traces suggested that the process took a relatively long time to develop and it is not clear why overheating was not detected by the thermal image scanning (generally performed once a year), which could have resulted in prevention of the bushing terminal failure, as it had been done in the previous case. Both failures were physically identical, but in the former case overheating was detected by thermal image scanning and fixed on time, with minimal costs and minimum down-time.

Figure left: 1 - burst 245 kV bushing, 2 - destroyed 170 kV neutral point bushing, 3 – damaged 420 kV bushing;

Figure middle top: traces of overheating on the top connection;

Figure middle bottom: connecting bolt body torn off cables;

Figure right: melting trace of brass central bushing tube on the copper rope

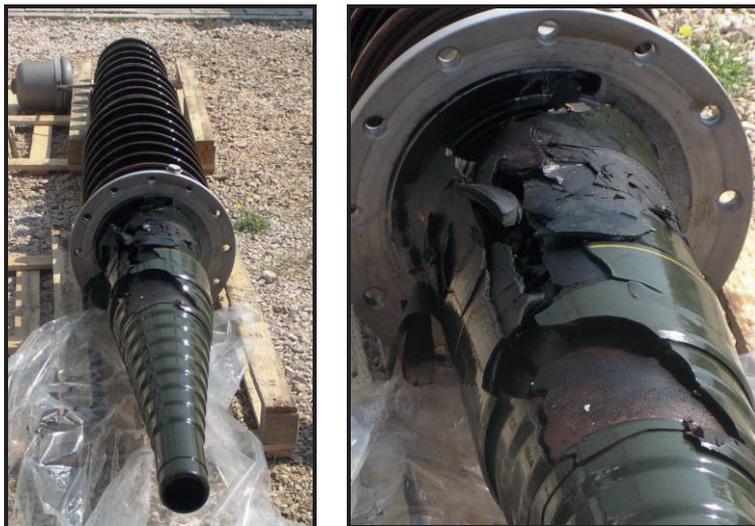
A failure of a 150 MVA autotransformer, approximately 30 years old, occurred in the spring of 2003. No special indications pointing to the failure mode were visible on the outside. Inspection of the disassembled RBP type bushing showed a burst of the bushing condenser body lower part (pos. 1 in Fig.1), approximately 0,5 m long, Figure 8. The transformer and, especially, the area around the 220 kV winding lead was intensely polluted by the bushing fragments, carbonized insulation and electrodes. Diagnostic tests of the bushing had been undertaken almost eighteen years prior to the failure but there had been no indication of the problem. The connection to the switchyard was flexible, by rope. The cause

of this breakdown is not known. However, breakdown traces indicate thermal breakdown with a wear out being a possible cause. According to the author's information, the transformer was scrapped.

Figure 8 Burst of a 245 kV, RBP type, bushing, the upper porcelain envelope remained intact (left), detail of the burst lower part (right)

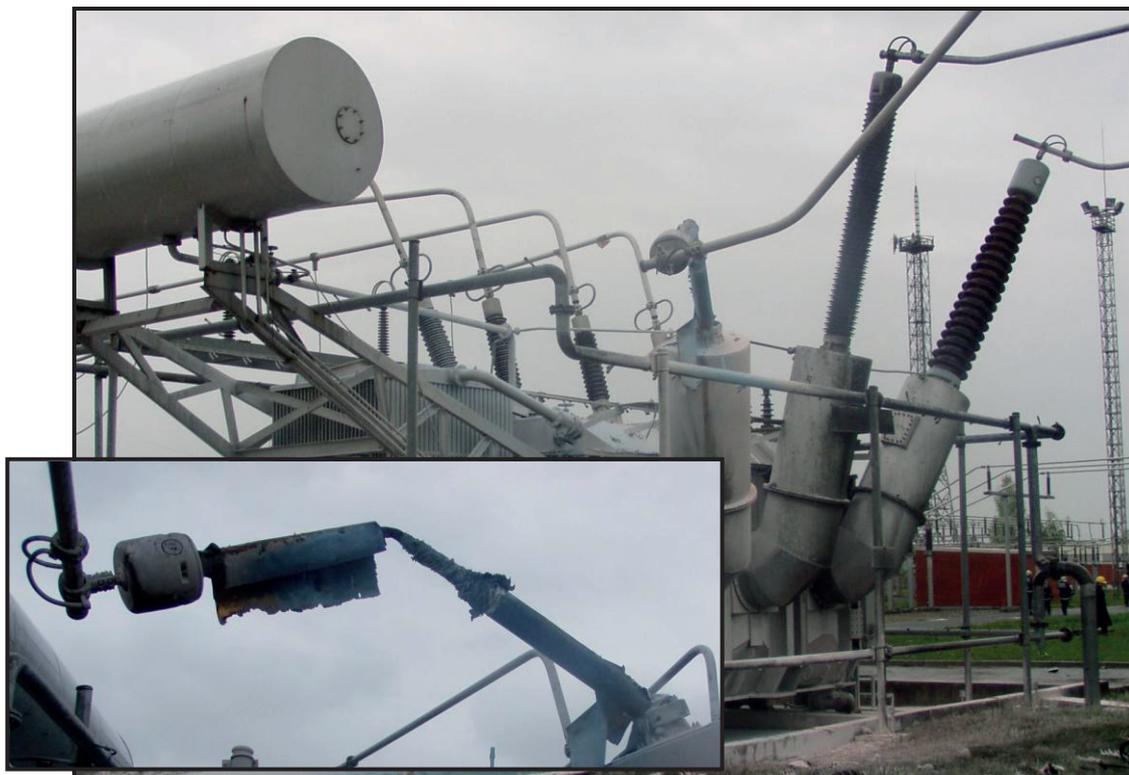
Two 400 kV bushing failures occurred on a 300 MVA, 400/110 kV autotransformer, one in 1994, the other in 2003, therefore after approximately 8 and 17 years of service, respectively. The bushings were of OIP type, connected to the switchyard by tubular connections, Figure 9. The first failure was of the incipient type – diagnostic tests showed a $\tan\delta$ of 2,2 % indicating a high degree of service unreliability. Visual inspection and DGA of oil confirmed the findings. Traces of carbonized oil and considerable concentration of gases resulting from the electric arch (or very strong PD) were detected. Previous diagnostic tests had been performed in 1989, when similar $\tan\delta$ of approximately 0,22 % had been found on all three bushings. The bushing was replaced with a spare one with down-time lasting a few days.

The second failure was terminal – an explosion followed by a fire, Figure 9, that could not be put out by the fire protection equipment (water spray system) because bushings are, because of large size, outside its action perimeter. Bushing fragments considerably polluted the transformer, but mostly remained inside the bushing turret. The dynamic shock damaged the 400 kV winding lead. The damages were, with a certain risk, fixed on site, with down-time lasting a few weeks. Traces of breakdown on the bushing condenser body indicated radial breakdown, most probably on the flange level. Diagnostic investigation had been conducted approximately three years prior to the burst, but did not indicate any defects ($\tan\delta$ was 0,23 %).

Figure 9: Bushing terminal failure in 2003 and traces of fire on the 300 MVA, 400 kV autotransformer; The right-hand bushing in the figure was replaced after an incipient failure in 1994. Detail shows the bushing debris and the tubular connection dilatation compensator

It can be presumed that the cause of accelerated bushing degradation could be the tubular connection, even with the applied dilatation compensator (in this case correctly oriented). Service experiences point to the possibility that the compensator can become blocked (seized) after long-term exposure to atmospheric influences, temperature variations etc, after years of service.

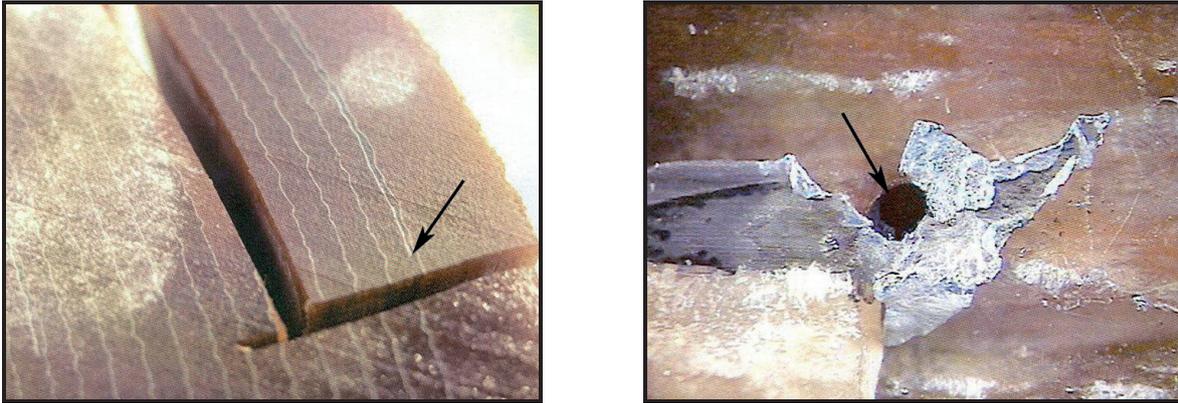
On the 350 MVA, 400/110 kV autotransformer, two almost identical incipient failures of the RIP type bushing occurred approximately one after another, the second one after three years service. The monitoring system registered a change of approximately 3 % in the 420 kV bushing capacitance, indicating a breakdown between neighboring condenser electrodes. It was confirmed by measurements on the site and on the dismantled bushing in a high-voltage laboratory. The $\tan\delta$ measured before and after the increase of capacitance, practically had not changed. The bushing was replaced with the down-time lasting several days. After dismantling, the bushings were examined in order to locate the breakdown. Results showed that it had occurred between the last condenser electrode (connected to the test tap) and adjacent electrode to it (breakdown across C_{1n} on Fig. 2), Figure 10. The exact puncture location was finally determined by microscope. Visually, the breakdown trace was a hole, around half a millimeter in diameter, stretching from the last electrode to the one before last, designated by the arrow.

In these two cases, the monitoring system proved reliable for fast detection of bushing capacitance changes. The observed traces matched with the measured capacitance values.

Figure 10: Breakdown position site; Figure left - the puncture is in the material at the depth about 1 cm from the point marked by the arrow; Figure right – the arrow designates the puncture between two electrodes (photo under microscope at magnification x15)
