Danijel Brezak  
Končar - Electrical Engineering Institute Inc.  
[dbrezak@koncar-institut.hr](mailto:dbrezak@koncar-institut.hr)

Dalibor Filipović-Grčić  
Končar - Electrical Engineering Institute Inc.  
[dfilipovic@koncar-institut.hr](mailto:dfilipovic@koncar-institut.hr)

## ULTRASONIC METHOD FOR TESTING OF POWER TRANSFORMERS

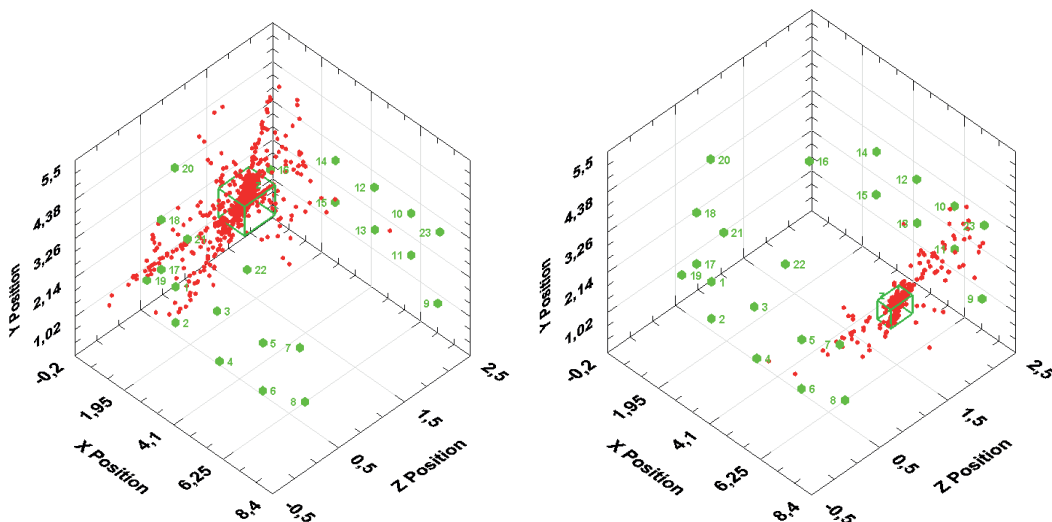
Figure 9. Obtained locations in region of returning core limb 1U (left) and 1W (right)

After analysis, two clusters (green box on figure 9), were obtained (areas were analyzed separately).

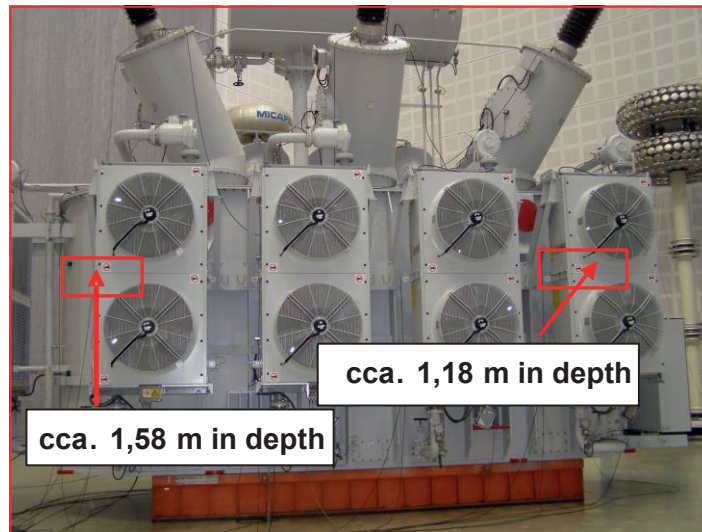
**Figure 10. Areas of high acoustic activities (based on 3D clusters)**

Areas of highest acoustic activity are shown on figure 10 (marked red). This result indicated that there are acoustic emission sources in the region of both returning core limbs.

The transformer was opened and inspected. It was determined that a part of electrostatic screen of returning limb did not have defined potential, i. e. they were not properly grounded and produced sparking.

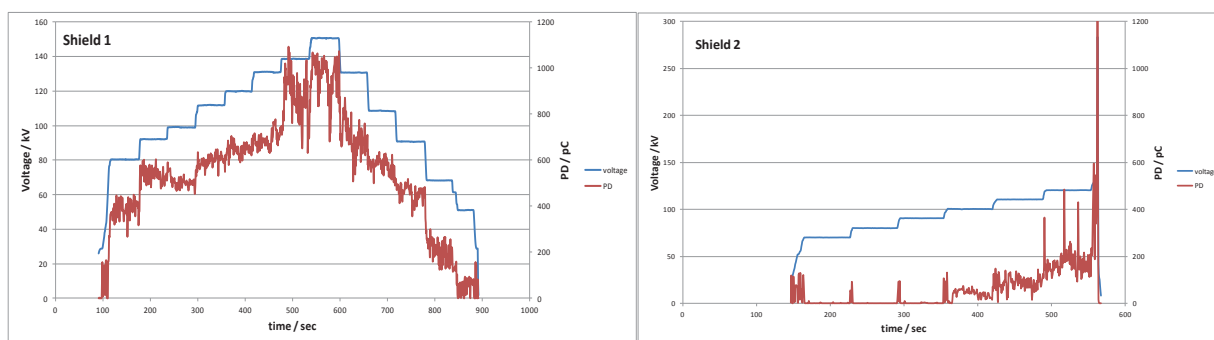
Figure 12. Plot of voltage and PD level vs. test time

Four sensors were placed at the bottom of the test tank. One of the end shields (screen 1, figure 12) showed high PD-s but with very low acoustic activity. This activity is within the range of surrounding noise of an on-site test.

As it is showed on figures 12 and 13, test of screen no. 1 showed very low acoustic activity even when PD levels were above 1000 pC.

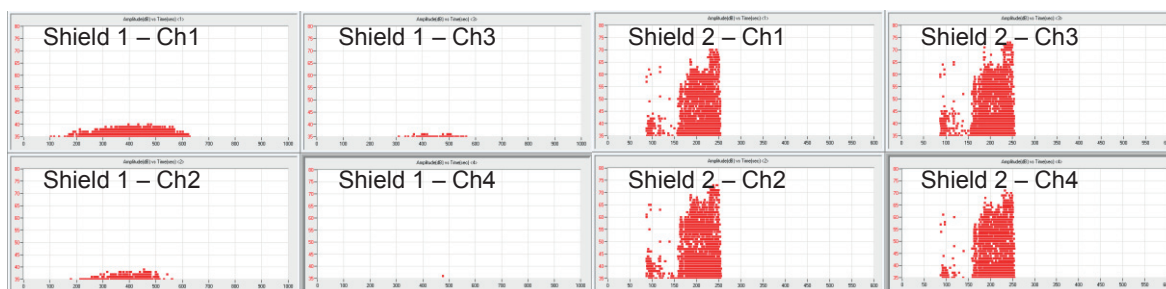
Figure 13. Plot of Acoustic activity vs. test time for both screens

To check the sensitivity of ultrasonic system in the existing test setup, a test of end shield no. 2 with damaged epoxy insulation (screen electrode in contact with oil) was performed. Ultrasonic system detected high acoustic activity even at PD levels lower than 10 pC. Since there was a risk of breakdown the ultrasonic system was shut off. Breakdown of shield 2 occurred at 130 kV.

Therefore it is very likely that the damping of acoustic waves generated in epoxy-resin insulation is too high and cannot be detected by the sensors placed on the tank of the transformer.
