AN ASPECT OF TRANSFORMER INRUSH CURRENT

SUMMARY

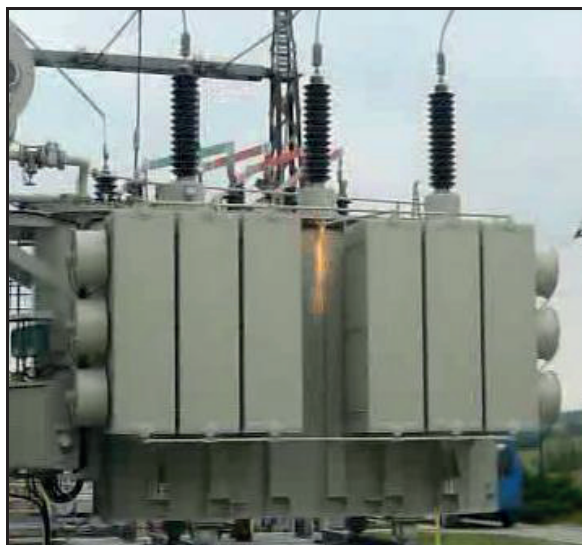
Figure 2: Sparks on tank during inrush current, transformer 40 MVA, 110 kV

Figure 1 and 2 show that the sparking may be fairly strong, astonishing the staff. Sparking does not appear on all new transformers. Moreover, it is a rare event observed only in several cases. In one case the phenomenon was observed on an about 30 years old but a completely refurbished transformer and it was also related to first energizing after refurbishment. No sparking striking events appeared on this transformer when it was new. In spite of this initial behavior, transformers operate perfectly without related complaints. Up to now there has been no evidence of any influence of the described phenomenon on dissolved gas analysis (DGA) results.
