Lessons Learned from Missing Flooding Barriers Operating Experience

Zdenko Šimić and Miguel Peinador Veira

European Commission Joint Research Centre

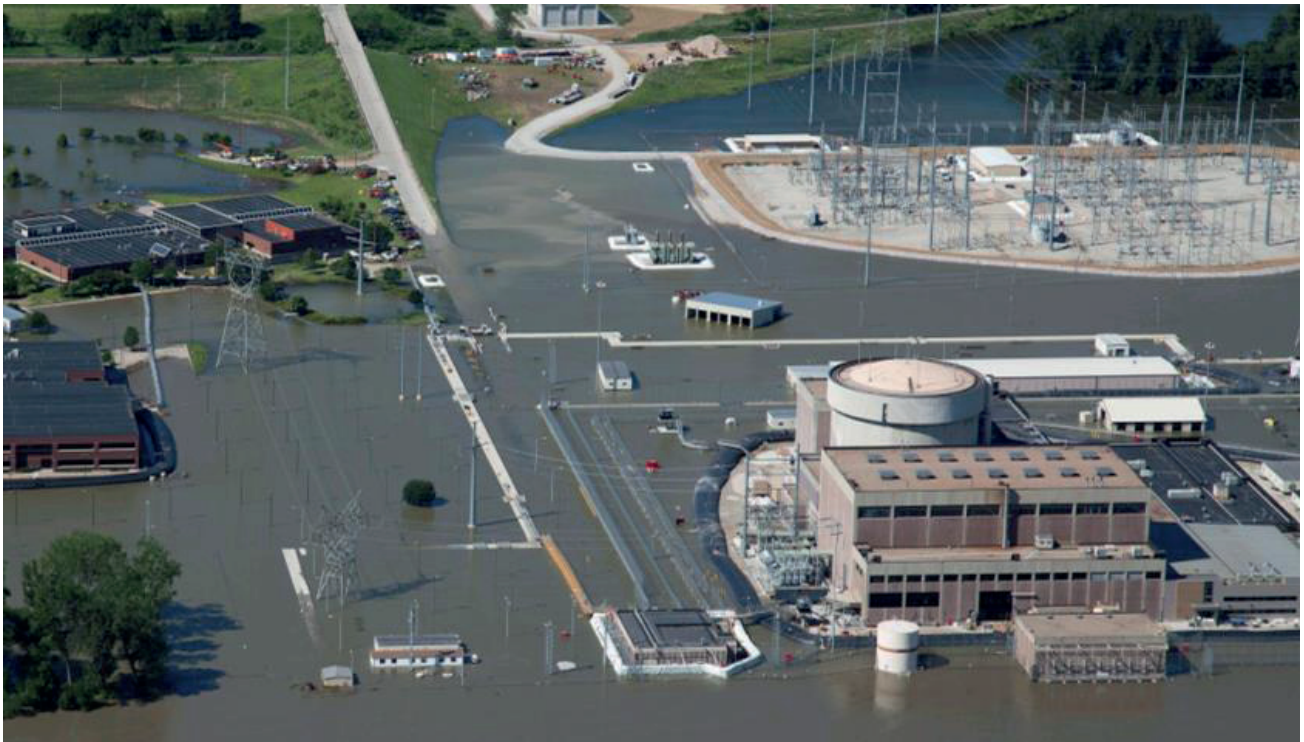
E14 Fort Calhoun Station, NRC identified inability to protect the intake structure and auxiliary building during external flooding. Demonstration in Sep 2009, revealed that sandbags could not retain 1.5 m static head of water. Licensee failed to implement appropriate corrective actions based on new flooding information. Licensee's ECR revealed unsealed penetrations below the licensing basis flood elevation that could cause intake structure vulnerability during external flood. Corrective actions were: redesign and installation of flood protection features without need for sandbags; sealing affected penetrations; revising procedures. This is yellow³ finding from NRC IR, [6].e. Even this is finding before Fukushima accident it is still included because it demonstrates appropriate preventive inspection regarding later licensee's findings and later demonstrated capability to withstand major external flood on June 6, 2011, Figure 2. Licensee's findings include unsealed penetrations through outside wall of the auxiliary and chemistry and radiation protection buildings (below the DBF elevation); unsealed conduits, 2 leading to the auxiliary feedwater pumps and 1 leading to safety related electrical switchgear; drain path from chemistry and radiation protection room to ECCS pumps rom; weak flood protection strategy for raw water pumps. Root causes include: weak procedure revision process; insufficient oversight of work activities; ineffective identification, evaluation and resolution of external flooding protection performance deficiencies; and related "safe as is" mind-set, [6].f.

Figure 2 Fort Calhoun plant on 16.06.2011 during the Missouri River Floods; vital buildings were protected using water-filled perimeter "flood berms" (Source: OPPD Public pres., 04.04.2012)
