## Possible accident scenarios related to the Spent Fuel Pool operating events

**Miodrag Stručić**

European Commission, Joint Research Centre (JRC), Institute for Energy and Transport (IET),  
Nuclear Reactor Safety Assessment Unit, Westerduinweg 3, 1755LE Petten, Netherlands  
E-mail: [miodrag.strucic@ec.europa.eu](mailto:miodrag.strucic@ec.europa.eu), phone + 31 224 56 5448, fax + 31 224 56 5637

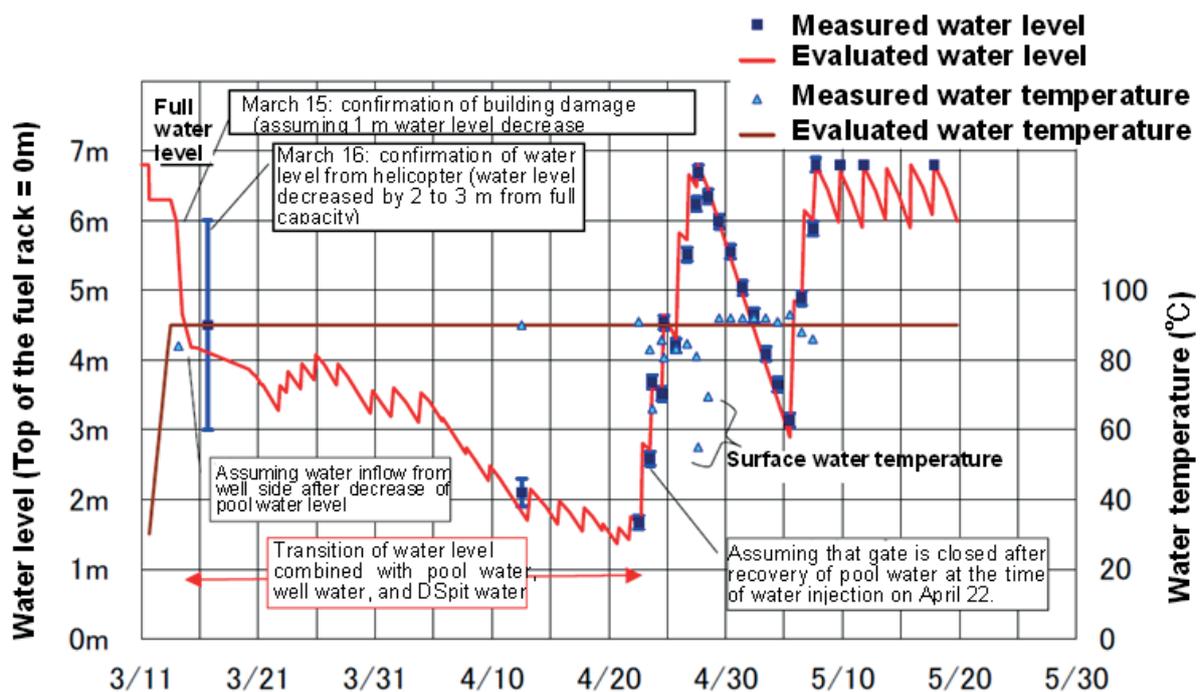
At first, the water inflow from the reactor well was not considered and it was estimated that the fuel would be uncovered by late March. Therefore, from 20 March, water was added via helicopter, fire truck, and concrete pump truck. Eventually, the water level reduced to 1.5 m above the top of the fuel racks as the amount of evaporation was larger than the water injection, including water inflow from the reactor well, until around 20 April, as shown in Figure 3[3].

Figure 3. Evaluated water level and water temperature in the SFP 4 by TEPCO

- The water level is assumed to have been reduced by 1.5 m as a result of sloshing by the earthquake and the explosion.
- Inflow from the reactor well occurred before 22 April. The water level was calculated by considering the water in the pool and the reactor well and dryer and separator pit collectively. After 22 April, the pool gate was closed, and no inflow from the reactor well was considered.

Later, intensive water injection conducted between 22 and 27 April succeeded in recovering the water level to the full capacity. The water injection was then suspended until 5 May to study the trend of the reducing water level. Subsequently, the water level recovered again to full capacity by intensive water injection, and then the water level is considered to be maintained at near full capacity by repeated reduction and recover due to evaporation and water injection.

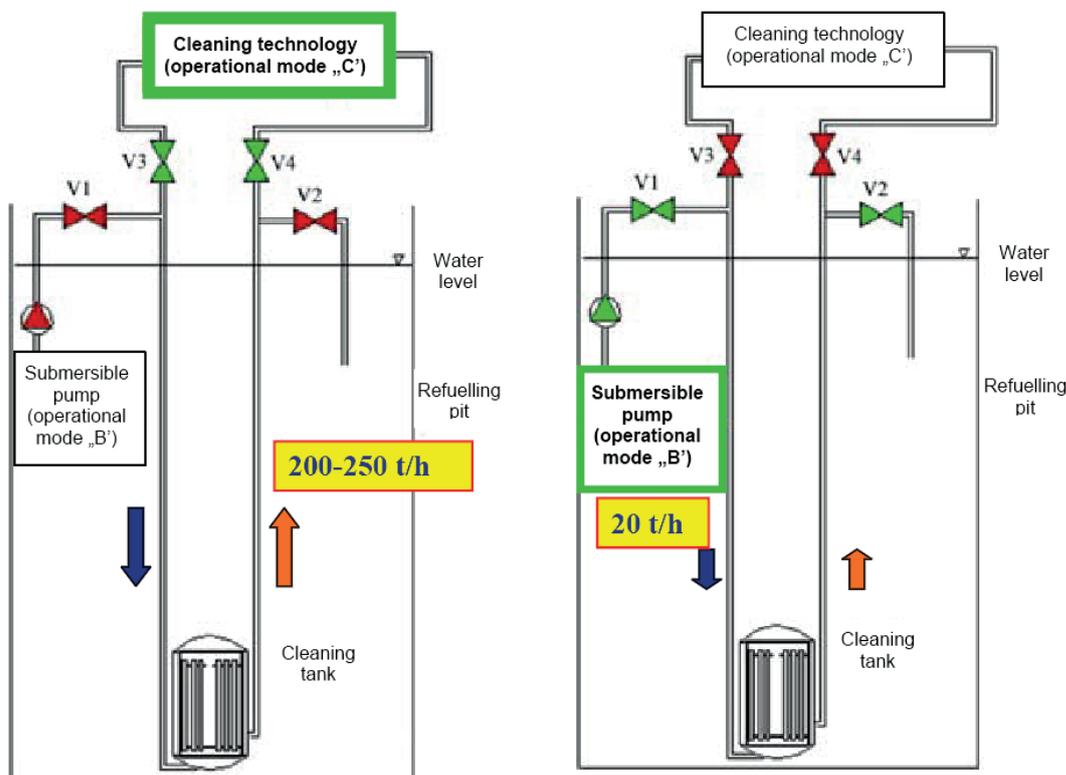
The cleaning programme for the sixth batch of FAs loaded into the cleaning tank was completed by 16:55 on April 10. The fuel was not removed from the cleaning tank immediately, since the crane was busy with other tasks. The coolant was circulated by a submersible pump with much lower mass flow rate than used in the cleaning process (Figure 4). Contracted specialists continuously maintained the cooling of the cleaning tank at 37 °C. At 21:53, activity was detected by the krypton measurement system installed in the cleaning circuit, and at the same time, the 'alarm' level was reached by the noble gas activity concentration monitors in the reactor hall, and then the operational dosimetry systems installed in the ventilation stack indicated abrupt increase of noble gas activity (max.  $0.2 \times 10^{13}$  Bq/10 min). The plant supervisor ordered to terminate the work carried out in the reactor building and to leave the area. An extraordinary maintenance committee was called, in order to evaluate the event and to take necessary actions. As highest priority, it was decided to open the cleaning tank, to carry out visual inspection, and if possible, to separate the nonhermetic FA and also to analyse the water quality.

Figure 4: Arrangement of the cleaning tank cooling during cleaning (left) and post-cleaning (right) [7].

Later inspection has revealed that, due to the special design of the cleaning tank and the characteristics of the fuel assemblies, the cooling by the submersible pump of lower mass flow was insufficient. The low flow rate pump was not capable of removing the decay heat (241 kW) due to a by-pass effect. The temperature stratification blocked the flow, and therefore, the coolant temperature reached saturation temperature in the upper part of the cleaning tank. Then, the steam-formation pushed the main volume of the coolant out of the cleaning tank vessel. This way, the FAs were left without proper cooling for hours and heated up to above 1000 °C, which resulted in severe damage and oxidation of the FAs. Oxidation in high temperature steam and hydrogen uptake resulted in embrittlement of the fuel assembly shrouds and the fuel rod cladding. When opening the cleaning tank, the injection of cold coolant caused the breaking up of the embrittled shrouds and fuel rod cladding.
