ABSTRACT

Condenser bushings condition monitoring

9. Case study of a 245 kV bushing failure at the 220 kV substation

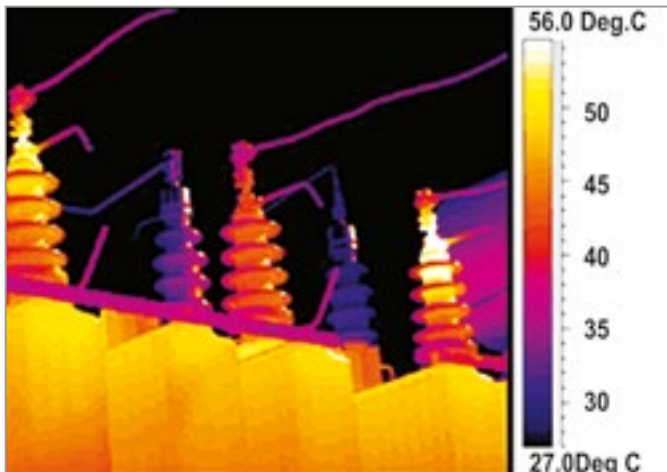
- loose terminal clamps
- improper fixing of draw lead at the adopter (also known as thimble) with top terminal
- improper soldering of lead with cable adopter (thimble)

Figure 4a. Hot spot at the top of the extreme right bushing

The specimen scanned images of hot spots are shown in Figures 4a and 4b [10], along with vertical temperature scales. The white colour on top of the far right bushing in Figure 4a indicates that its hot spot temperature is 54 °C to 55 °C, while the stud and the clamp of the middle-phase bushing indicated in white in Figure 4b show that the temperature at these points ranges from 46 °C to 48 °C.

Such hot spots are attended to by tightening the identified loose connections while the transformer is offline.

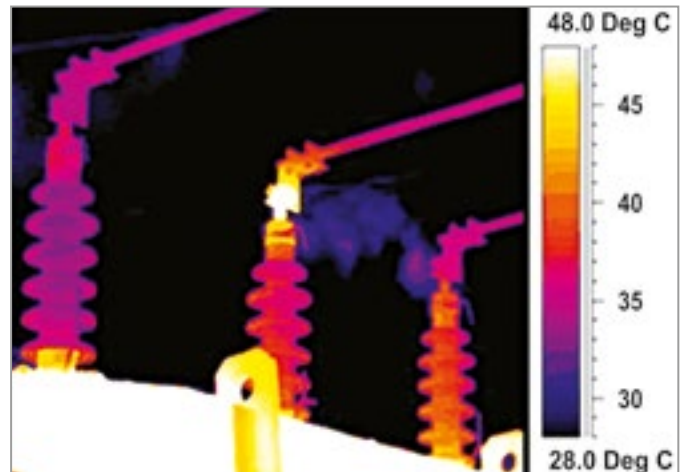
Figure 4b. Hot spot on the terminal clamp of the middle bushing

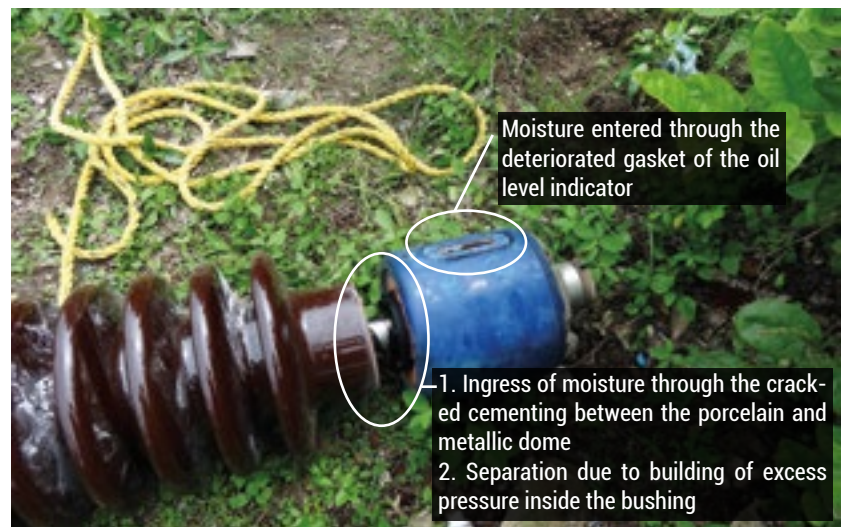
Based on the details presented in Table 3 and the photographs of the failed bushing, Fig. 5a and 5b, it can be inferred that the bushing failed between the successive periods of offline monitoring.

Figure 5a. The failed 245 kV, 1250 A OIP bushing showing cracked and separated oil expansion metallic chamber/dome from the porcelain insulator

Ingress of moisture must have taken place through:

- a. the cracked cementing which couples the porcelain portion of the bushing to the metallic dome, and/or
- b. the deteriorated gasket of the oil level indicator, Fig. 5a

the bushing core at low load periods and at cool night hours. Location of ingress of moisture is encircled in white, Fig. 5a. Non-bursting and non-shattering of the splinters of the outer porcelain of the OIP bushing at the air end indicate that the failure did not take place due to any violent conditions, such as heavy lightning impulse stroke/switching surges, etc., but resulted from the pressure that had developed inside it at a very slow pace – which is also confirmed by the bursting at the lower oil end side, Fig. 5b.

The development of excessive pressure inside the ill-fated bushing appears to have taken place due to a failure/shorting of

some of capacitances caused by ingress of moisture, increase in $\tan \delta$ value and also occurrence of low intensity partial discharge over the five-month period after the last offline $\tan \delta$ and capacitance measurements were performed.

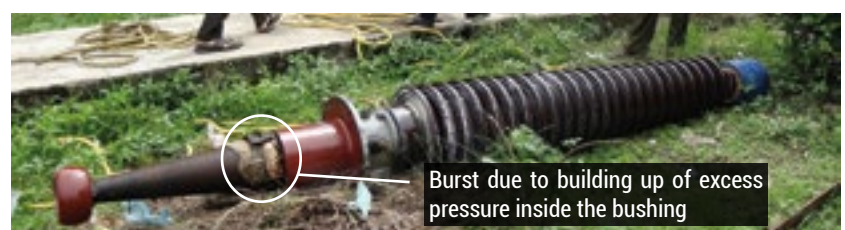
Figure 5b. The failed 245 kV, 1250 A, OIP bushing showing bursting of lower oil end insulator
