HRVOJE GLAVAŠ¹

Infrared Thermography in Maintenance of Building Applied Photovoltaics

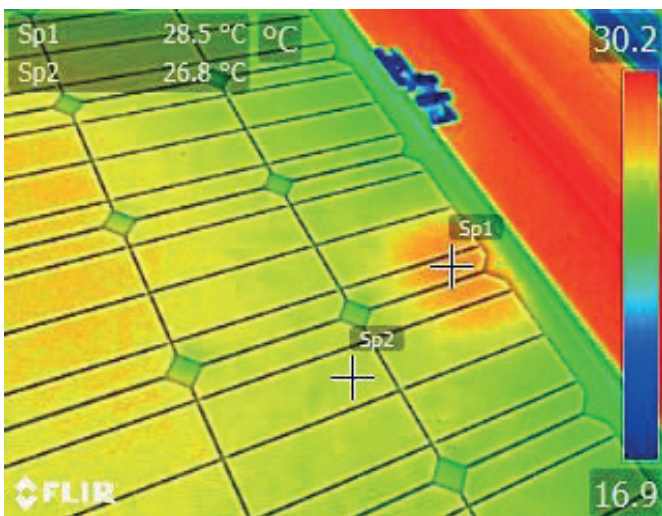
The PV panel cells are connected in the connection box by wires. The box is located at the bottom of the panel. Figure 11 shows the characteristic thermal pattern of the connection box. Because of the thermal resistance of the connection box, the place where the box is located is 1.7 °C warmer than the rest of the panel.

Figure 11. The thermal pattern of a PV panel connection terminal

The above examples (illustrated in Figures 9 and 11, with temperature differences of 2 and more °C) according to Table II require observation. In the case of a connection box, the pattern will not change, but in the case of the bird droppings pattern disappears with the appearance of the first rain or PV panel cleaning. In Fig. 12, the panel temperature can be read at 24.6 °C and at the point of hotspot 41.2 °C. This is a temperature difference of almost 20 °C, which leads to the conclusion that the panel will most likely be replaced (Figure is an example from the FLIR Tools software).

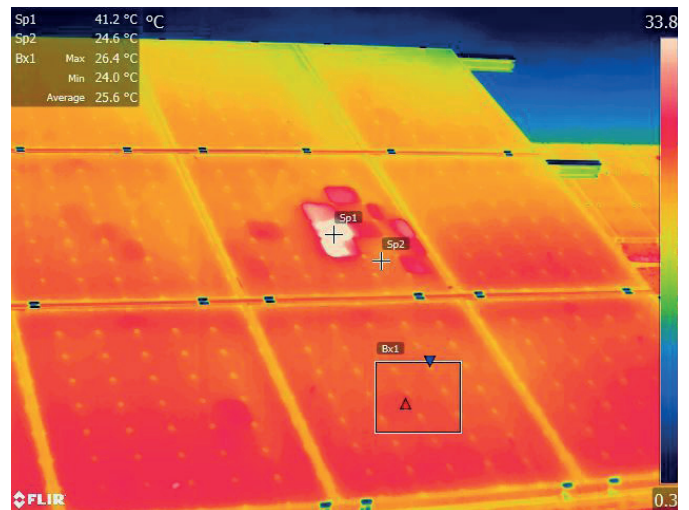
Figure 12. Thermal hot spot pattern, Source: FLIR Tools

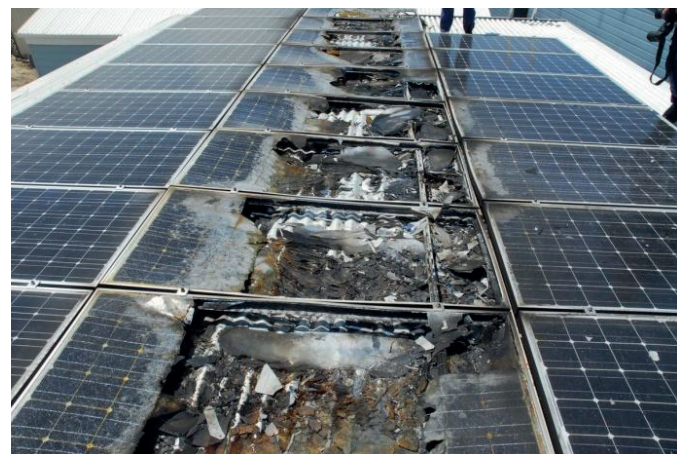
Monitoring the condition of the equipment is indispensable because defective equipment can lead to significant negative consequences. Figures 13 and 14 show the consequences of the defective PV system.

Figure 13. The consequence of fire on photovoltaic system, example [9]

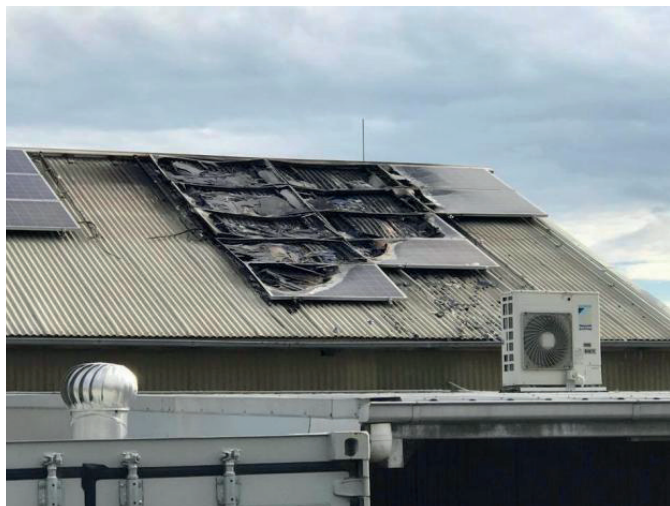
Figure 14. The consequence of fire on photovoltaic system, example, [10]
