Diagnosis of the Operational Gear Wheel Wear

Rafał GOŁĘBSKI, Arkadiusz SZAREK

Abstract: The article presents an analysis in the field of gear wheel testing method application. The results of tests of gear wheel teeth taken from a damaged gear rim are reposted. Tests were carried out on specimens to establish the causes of gear wheel tooth cracking. Macroscopic examination was made, which confirmed the occurrence of top layer spalling. An analysis to examine the damage to the surfaces of mating gear wheels is described. A destructive testing method was employed. The results of hardness and microhardness tests and metallographic analysis are presented.

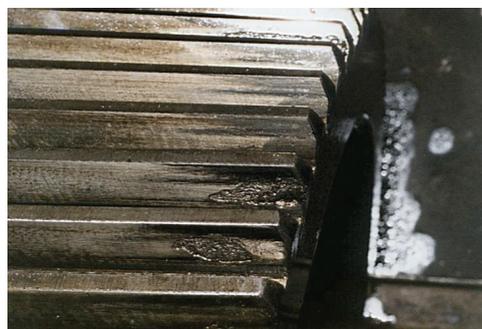
Figure 1 Tooth flank damage occurred due to pitting.

to the friction of tooth flanks in the presence of a lubricant, whose boundary layers are characterized by very high cohesion [6, 7]. Toothed gears are subject to cyclic loading that causes very high unit surface pressures [5]; because of this, the failures have the character of typical material fatigue failures. Top layer spalling arises on tooth flanks due to the occurrence of cyclic loads. Very often, this phenomenon is preceded by progressive pitting – Fig. 1.

Spur gears with visible failures in the form of mating surfaces spalling – Fig. 1, and tooth break-offs – Fig. 2, were subjected to investigation. The gears were put to prolonged operation. The operating conditions did not show that the gears might be operating under a load higher than standard. The machine included six pairs of gears that performed identical transmission jobs. Some top layer spalling, at a varying stage of advancement, could be observed on all the gears. Only two gears failed by breaking off. The material grade, of which the gears were made, was not known. On selected gears, the following examinations and tests were carried out:

Fig. 5 illustrates the microhardness test of tooth no. 1 damaged due to pitting – Fig. 1, and tooth no. 4 with no visible defects. When analyzing the microhardness distribution, it can be noticed that the hardness drop boundary coincides with the crack distance from the tooth

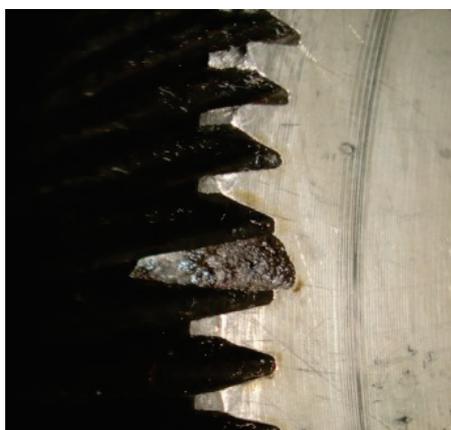
The photo in Fig. 2 shows a case of tooth wear by braking off. A tooth break is a consequence of the occurrence of pitting at an advanced degree, along with tooth top layer spalling.

Figure 2 Tooth flank damage by braking off

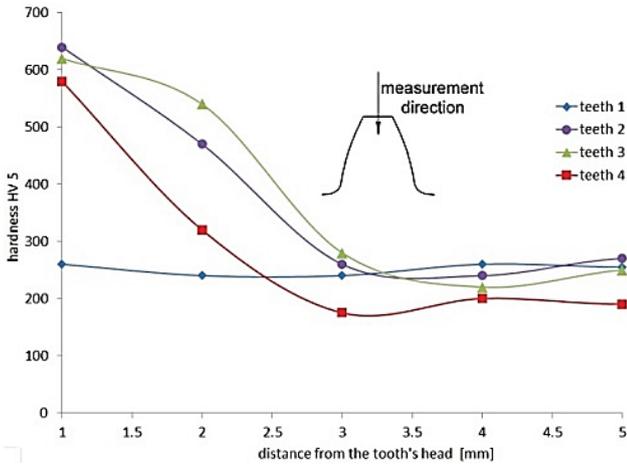
At the next stage, a hardness test was performed in the section normal in two directions: from the tooth point and from the tooth flank. Fig. 3 shows the results of the measurements of hardness distribution in the direction from the tooth point. The hardness of specimen no. 1 significantly deviates from that of the other specimens. A similar situation is for the hardness test in the direction from the tooth flank – Fig. 4.

In the case under consideration, for gear wheels subjected to induction hardening, the depth of the nominal hardened layer should not be less than 1.8 mm, while

retaining a hardness of 600-650 HV [18]. All tooth specimens do not show the correct hardness distribution. At the subsequent stage, the specimens of gear wheels nos. 1 and 4 were subjected to microhardness distribution measurement.

Figure 3 HV hardness distribution in the testing direction from the tooth point

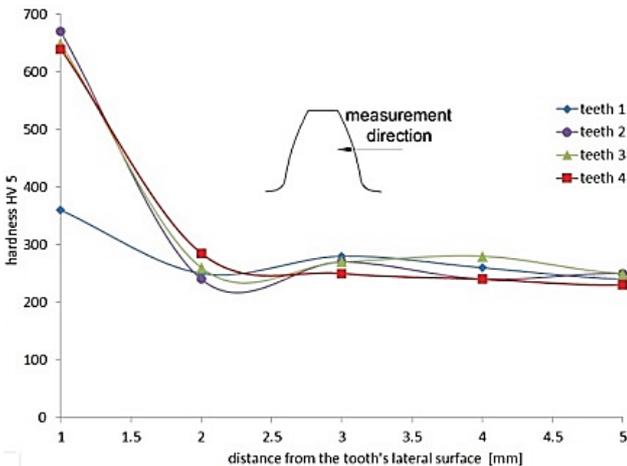
Figure 4 HV hardness distribution in the testing direction from the tooth flank

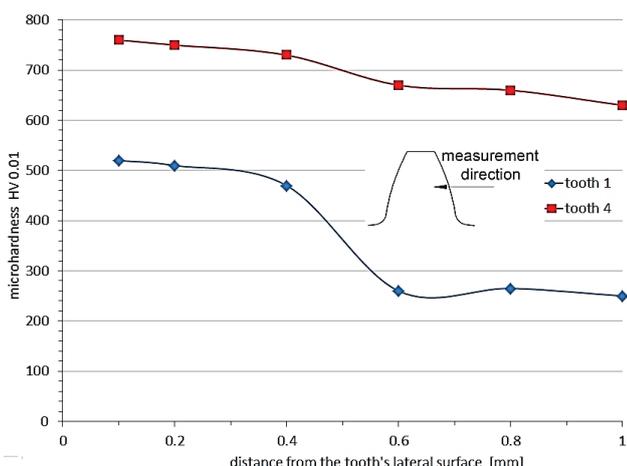
Figure 5 HV microhardness distribution in the testing direction from the tooth flank

flank, which is approx. 0.6 mm. It can be seen that the spalling thickness is approximately equal to the thickness of the hardened layer. The examination allowed us to infer that there was a non-uniform distribution of hardening depth for the whole gear wheel. At that stage of investigation, however, it was not possible to determine explicitly whether this had happened due to incorrect parameters in the hardening process or as a result of some technological errors made in finishing machining by grinding.

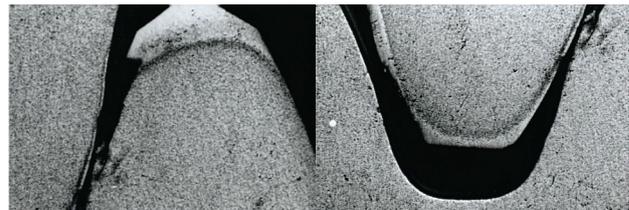
Fig. 6 represents teeth nos. 1 and 4 as Nital etched. At 6-times magnification, it was possible to observe non-uniform distributions of the hardened layer zone. In the case of tooth no. 1 (with visible defects), one can notice that on the tooth flanks, and especially within the useful region of mating surfaces, the hardening zone practically does not exist. For tooth no. 4 (with no visible defects), the distribution of hardening depth is also non-uniform. It was established conclusively that, as a result of the gear wheel grinding process, almost all hardened zone had been removed. This is a consequence of a wrongly performed induction hardening process, which had left an insufficient allowance for finishing gear wheel machining.

Figure 6 Fragments of tooth 4 and tooth 1 with visible microcracks and material losses

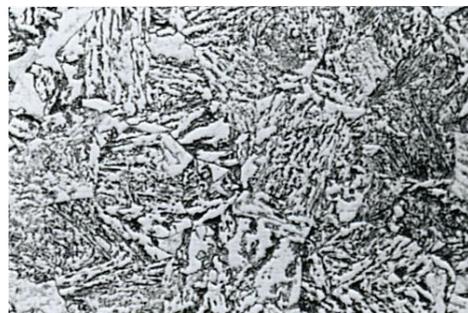
Photograph 7 shows a microstructure at the edge of tooth 1. This is a diphase structure of the bainitic type, which is characterized by the acicular structure of the bainitic ferrite matrix, and slender agglomerations of a second phase between the ferrite spines.

Figure 7 Microstructure of the hardened zone of tooth 1.

The precipitates of bainitic ferrite are closely related to the occurring decomposition temperature and with its drop, the orientation of the spines becomes slenderer. The presented structure may suggest too low an isothermal decomposition temperature. Fig. 8 shows microcracks on the tooth surface – specimen no. 1.

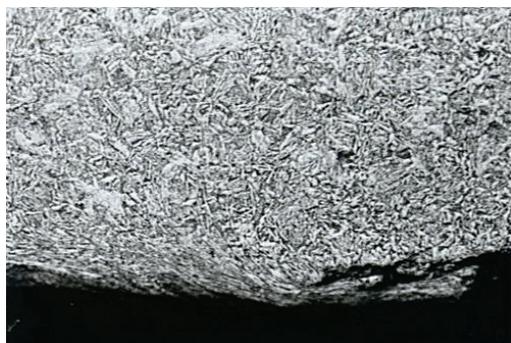
A plastic deformation of the top layer can be noticed on the edge. As the plastic deformation develops, slip band lines become visible. At the final stage, a shearing phenomenon occurs and, as its consequence, deformed zone delamination. A visible bainitic structure in the ferrite matrix.

Figure 8 Microstructure of the edge of tooth 1.
