## FAILURE ANALYSIS OF A DIESEL ENGINE CRANKSHAFT

Preliminary Note – Prethodno priopćenje

**Keywords:** 42CrMo; crankshaft; crack; metallography; hardness

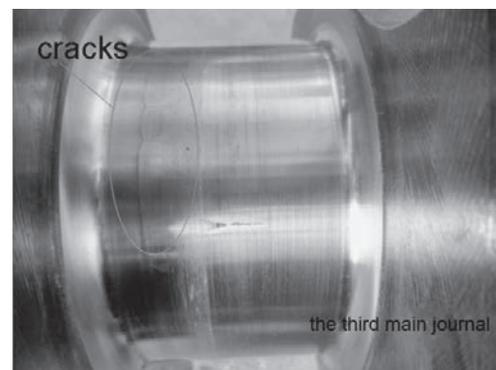
(a) The third crank journal

Many defects can be found in the third main journal of the crankshaft, as shown in Figure 1. Circumferential

scratches can be obviously noticed in the curved journal surface. The crank morphology on the curved journal is shown in Figure 1- (b).

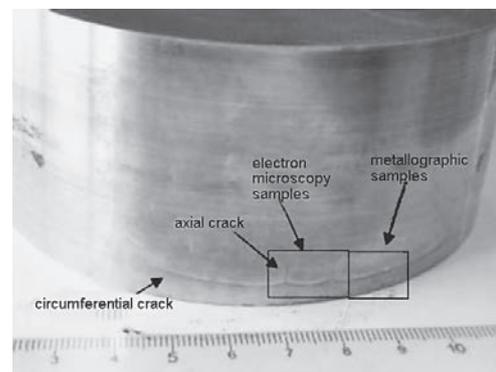
(b) Distribution of cracks

The main body of the crack is divided into three sections along the circumferential direction, but there are also branching cracks in the axial direction, and each axial branching crack is located at the section of the circumferential crack. On the other major diameters of the crankshaft, we have not found any abnormalities like cracks.

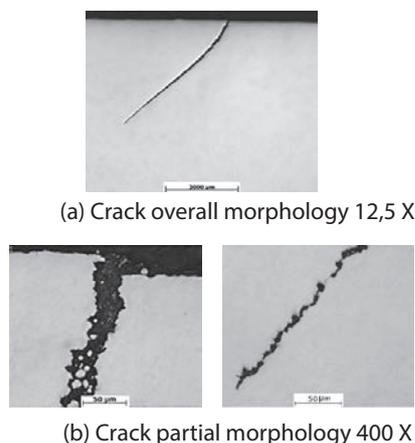
The metallographic sample was taken at the location of the shown crack and the cross-section of the metallographic sample was ground and polished. And the cross section was observed with a metallographic microscope. As shown in Figure 1- (b), the shape of the polished state of the circumferential crack is shown in Figure 2. The crack is narrow inside and wide outside. It was possible to judge that crack extends from the surface to the inside by the morphological features. The fact that ends of the crack is sharp and no oxide and other components are found inside can be learnt with further observation. The morphology of the inclusions near the crack is shown in Figure 3. According to the ASTM E45–2011A standard rating, inclusions level is D 0.5 which meets the technical requirements of Class D inclusions: the coarse system is less than grade 1, and the fine system is less than grade 3.

Figure 2 Circumferential crack's morphology

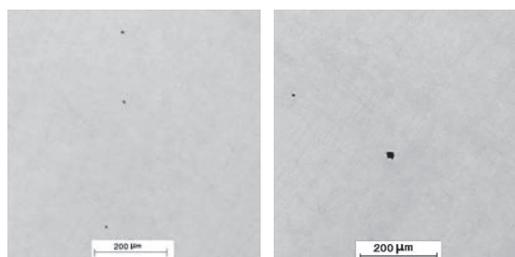
Figure 3 Inclusions near the crack 100 X

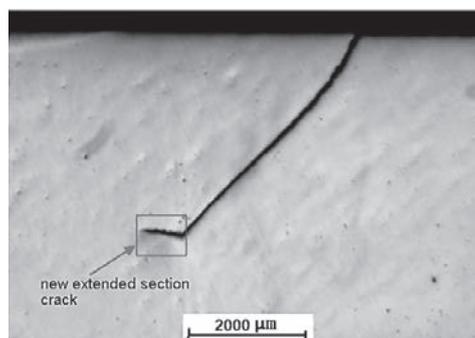
Figure 4 Extended crack morphology 12,5 X

crankshaft. The samples were placed at room temperature for two days, the crack continued to expand, crack morphology after the expansion was shown in Figure 4.

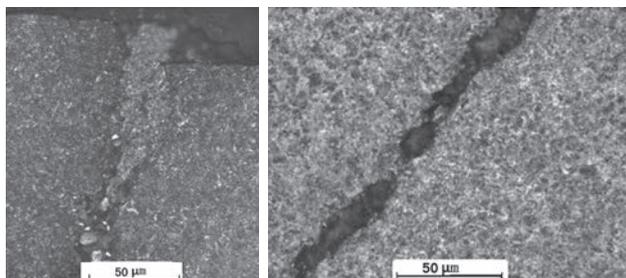
The metallographic samples were observed after being eroded with 4 % nitric acid alcohol and the erosion state morphology is shown in Figure 5. It can be seen from Figure 5 – (a) that it is a hardened layer on the surface of the crankshaft with a depth of 4,83 mm, which meets the technical requirements of the depth of the surface that hardened layer is no less than 2,29 mm, and has a depth of 3,36 mm. The crack was within the surface hardened layer and has a depth of 3,36 mm. A burn band was found on the surface of the crankshaft near the crack, the depth of the burn band was 0,47 mm, and the distance from the crack was 3,52 mm. Microhard Vickers hardness test of hardened layer, hardness value was 500HV0.3. According to GB/T 1172 - 1999, the hardness is converted to Rockwell hardness of 49,0 HRC which meets the technical requirements of 45 – 50 HRC surface hardness after quenching and tempering. It can also be found from the direction of the circumferential crack that the direction of the crack is consistent with the direction of the segregation band of the crankshaft journal.

**Figure 5** The shape of the crank's journal

not high and corresponds to the technical requirements. There is a hardened layer on the surface of crankshaft with the depth of 4,83 mm, which meets the technical requirements. The circumferential crack is completely in the surface hardened layer with a depth of 3,36 mm. A burn band is found on the surface of the crankshaft journal near the crack. The burn zone has a depth of 0,47 mm and a distance from the circumferential crack of 3,52 mm. The hardness of the hardened layer is 500H V0.3, 49,0 HRC in Rockwell hardness, which meets the technical requirements. It could be seen from the direction of the crack that direction of the crack is consistent with the direction of the segregation band of the crankshaft neck.

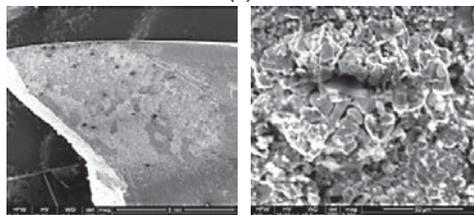
The electron microscope sample was opened along an axial crack. The macroscopic fracture surface morphology of the axial crack was shown in Figure 6. It can be seen that the crack starts from the shaft diameter surface and expands to the depth. The microstructure of the fracture surface was shown in Figure 7. It was seen that the surface of the fracture surface was attached with a layer of material which exhibits a molten state of solidi-

fication. It can be discovered by further observing on the surface morphology of the exposed original fracture that the original crack fracture is a brittle fracture along the crystal. The attachment of the fracture surface was analyzed by energy spectrum. The result is shown in Figure 8. Conspicuously, the attachment is mainly Pb metal elements.

**Figure 7** Axial crack fracture microscopic morphology (Note: a-c is marked directly in the Figure)

Scanning electron microscopy analysis of axial crack fracture: The crack is cracked from the surface of the crankshaft neck and expanded to the depth. A layer of material is attached to the surface of the crack, which material exhibits a molten solid state. Further observations reveal that bare original fracture exhibited brittle fracture characteristics along the crystal. The energy spectrum analysis of the attachment on the fracture surface was carried out, and the contents were mainly Pb metal elements.

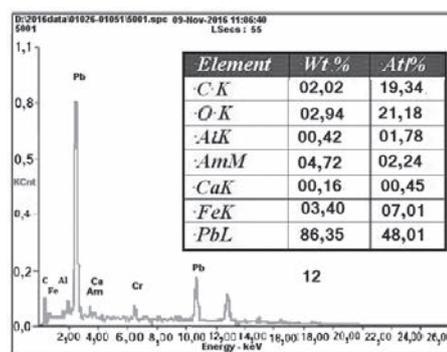
**Figure 8** Analysis of the energy spectrum of the surface of the axially crack fracture

burning band on the surface of the crankshaft. The crack fracture surface contains a molten material having a high content of Pb. This shows that the friction of the crankshaft with the bearing bush during use causes a high temperature phenomenon. The high temperature generated by the friction between the crankshaft and the bearing bush causes a large thermal stress in the surface area of the crankshaft neck. There is also a working stress on the surface of the crankshaft during operation. Thermal stress, residual stress and working stress interact with each other. When the tensile superimposed stress exceeds the bearing limit of the crankshaft material, it will first crack along the weak point of the crankshaft (ie, at the segregation band), causing the crankshaft to fail.
