FAILURE ANALYSIS OF EB03 CRANKSHAFT

Preliminary Note – Prethodno priopćenje

Study on the fracture specimen of EB03 crankshaft which produced by a crankshaft company. It is found that there is a phenomenon of high temperature oxidation on the surface of EB03 fractured crankshaft's journal by the macroscopic analysis of the fracture of the crankshaft. And there are a lot of sintered metal particles on the surface of the neck journal. These phenomena indicate that the axle diameter of the connecting rod is gradually locked in the process of operation, during this process, a lot of heat is generated with the holding of the tile and causes the phenomenon of burning and melting. It is found that the graphite has different degrees of deformation by observing the graphite morphology on the surface of the neck journal.

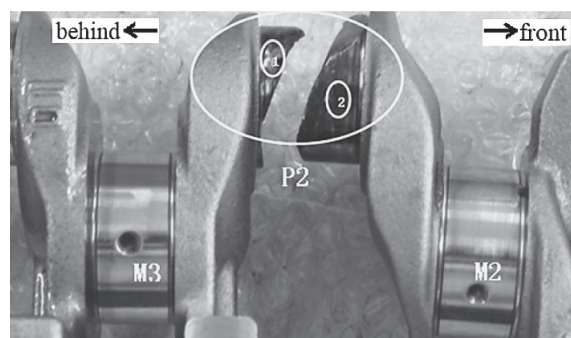
First, when the EBO3 crankshaft was put into bench test at full speed and under full load, the engine suddenly stopped after running for 65 hours. After disassembling the engine, a fracture was found at the back neck of the second connecting rod of the crankshaft. Then, analyzed the fractured crankshaft as follows.

Figure 1 The fracture diagram of EB03 crankshaft

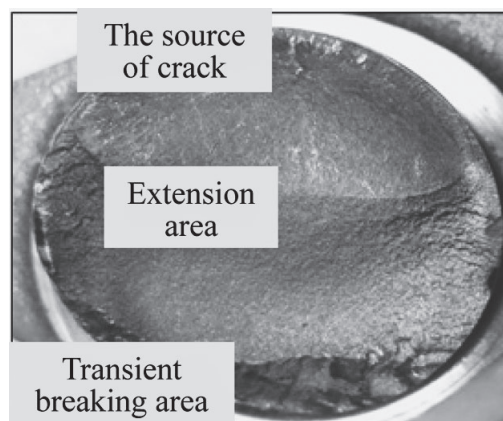
By observing the fracture area of crankshaft, it was found that the fracture source area, extension area and transient fracture area were obviously distributed. As the Figure 2 shows, the whole fracture had not obvious impact marks, which indicates that the crankshaft broke for a while. High temperature oxidation exists on the surface of the journal and there were a lot of sintered metal parti-

Figure 2 The fracture of the crankshaft

cles on the surface. The part of the visual observation presents white luster and suspected of iron filings. It indicates that the shaft diameter of the connecting rod was gradually locked in the process of operation.

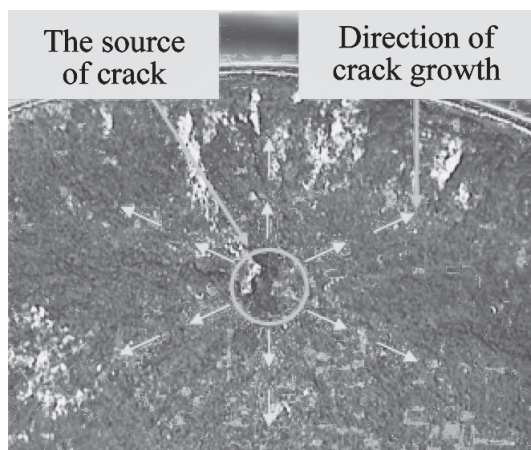
Figure 3 The source of crack

The vast quantities of heat generated when the bearing bush locked, and lead to the melting phenomenon. It was found that the crack source was in the sub-surface layer under the surface of the journal by low-power detection of the crack source area. The crack source which was about 4 mm away from the surface of the journal was obviously radial and extended around, as shown in Figure 3.

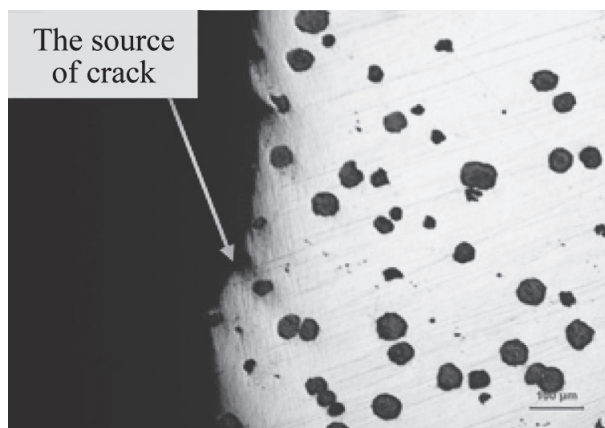
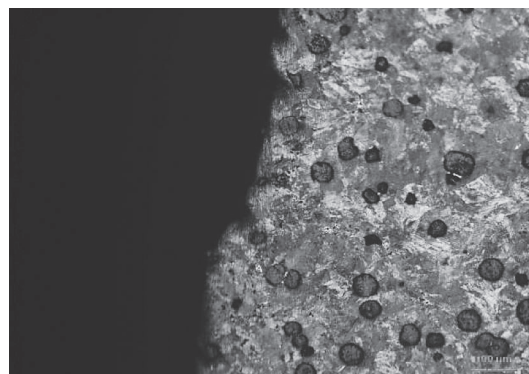
The results showed that the graphite spheroidization level near the fracture of the crankshaft was level 2. The diameter of graphite ball was 5 grades. The pearlite content was 95 %. There is no cementite phosphorus eutectic at the fracture location. The distribution and size of graphite were very uniform, no shrinkage porosity and other defects, so it meets the technical requirements. as shown in Figure 4, 5.

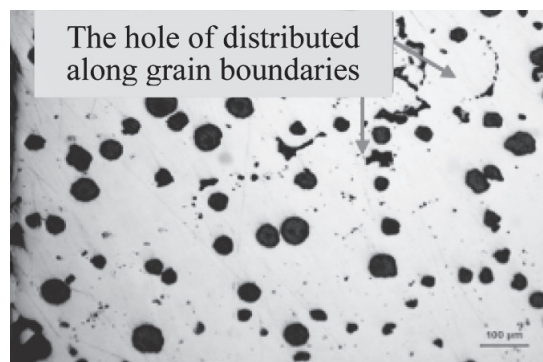
Figure 6 Graphite morphology of crack source

It is found that there were a lot of continuous voids and discontinuous point - like holes in the attachment by observing the crack source. The void was obviously distributed along the grain boundary of the eutectic cluster, and its regional range was $0,45 \text{ mm} \times 0,35 \text{ mm}$. Therefore, the location of the void can easily become a source of fatigue cracks. As shown in Figure 6.

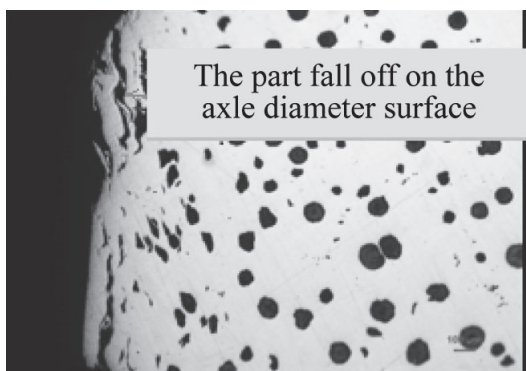
By observing the graphite morphology on the surface of the journal, we found that the graphite on the surface of the journal had varying degrees of deformation. Many cracks had been generated along the deformed graphite due to the acute angle effect of the deformed graphite. And part of the cracks had been rapidly extended to completely tear apart from the metal matrix. The graphite deformation area distributed from the surface of the journal to the axis, and the deepest part extended to about 0,5 mm. As shown in Figure 7.

The graphite is not vermicular or flake graphite produced by spheroidizing decay or inoculation failure during casting, but formed by deformation after extrusion. Extrusion may be caused by improper machining of the crankshaft.

Figure 7 Graphite morphology on the surface of the journal

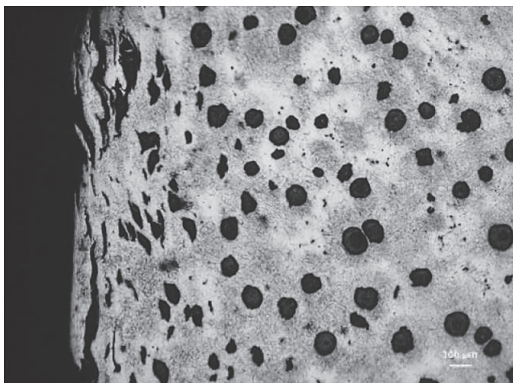
By analyzing the quenching structure, it is found that the tissue is severely overheated and the martensite is coarse martensite. There was a lot of bright white microstructure, which is suspected to be a secondary quenching microstructure, and the microstructure needs to be further confirmed by hardness testing. As

Figure 8 Structure of shaft neck quenching zone

shown in Figure 8. In addition, there is no obvious decarbonization in the structure near the crack, which indicates that the crack was generated after the quenching process. Otherwise, decarburization would occur in the quenching heating process. That is, the extrusion deformation of graphite was formed after quenching.

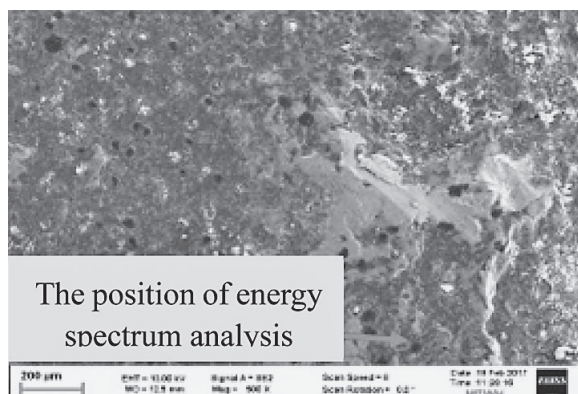
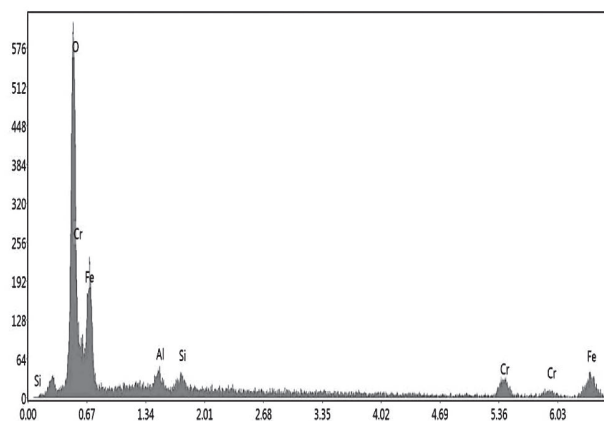
The crack source was analyzed by electron microscopy, as shown in Figure 9,10 and the results were shown in Table 1. It can be found from Table 1 that about 0,27 % of Cr and about 0,30 % of O were clustered around the crack source.

So, the high temperature oxidation of the shingles during the crankshaft operation leads to generate the detected oxygen element.

Cr element is easy to segregated near grain boundary and reduces the phase transition temperature here. The grain boundary strength of Cr element is the lowest, so it is easy to overheat or even overburn when heated. Simply put, it is easy to produce grain boundary melting phenomenon. First, form point-like holes are formed at the grain boundary, and then expand into cracks. The existence of oxygen element indicates that high temperature exists at the crack source. Many cracks have been generated along the deformed graphite due to the acute angle effect of the deformed graphite. It is found that Cr element tends to segregate around grain boundaries by electron microscope scanning and energy spectrum analysis. Because the grain boundary strength of Cr element is the lowest, the phenomenon of overheat or even overburn is caused during heating, so point-like holes are formed in the grain boundary, and cracks are formed along with the expansion of the holes. The cracks gradually expand with the imbrication and eventually fracture occurs.
