Željko Domazet¹, Lovre Krstulović-Opara¹, Francisko Lukša¹

Fatigue Failures in Industry and Their Repairs – Case Studies

¹Faculty of Electrical Engineering, Mechanical Engineering and Naval Architecture, University of Split, Split, Croatia

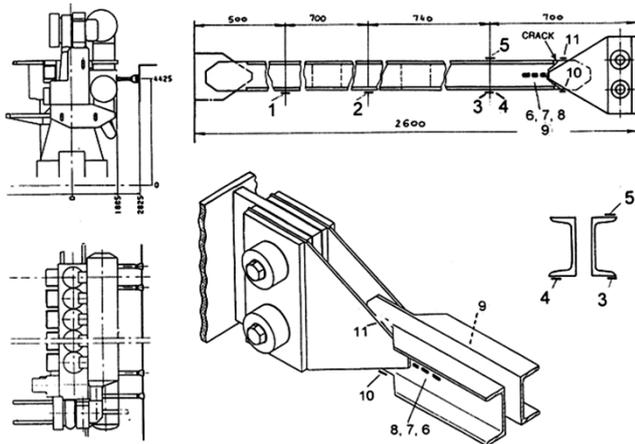
Fig. 2. Lateral engine support with observed failures and setup of the measurements for stress determination

of the joint. In order to obtain maximum stress, three strain gages were applied (15-17), Fig. 2. As all four supports were not manufactured geometrically identically, on the other side of support 3, strain gage 18 was applied as well as gages 21, 22, 23 on supports 1, 2, 4, respectively. A significant difference of the measured axial forces between the supports was detected. One of the beams was loaded with approx. 50% lower load. However, maximum axial force $F = 20$ kN (calculated from the nominal stresses) was within the range of design load values. Measurements gave no significant bending moments. The results of nominal stresses ($\sigma = 10, 15$ MPa) could not be the reason for fatigue cracks, in spite of observed differences from one support to others. Stresses at the crack initiation points were measured to evaluate the quality of design. Three strain gages (15, 16 and 17) were used for extrapolation of maximal stresses. Maximum stresses at the welds toe are extrapolated. Their amplitudes vary depending on the weld design, but the measured values of 70 or even 80 MPa could easily cause the initiation and propagation of fatigue cracks.

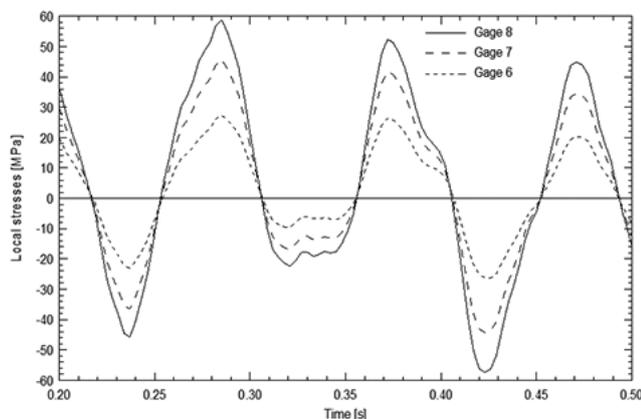
Fig. 3. Local stress determination

According to the existing S-N curves for such weldments and determined maximum stresses, it is possible to predict the fatigue life of approx. 5×10^6 cycles, or a few

weeks of service. This service life is too short, compared with expected 20 years. This prediction had good agreement with the time to failure observed on the former ships. Failures are mainly caused by the inadequate joint design, the support and ship (hull) structure from one side, and insufficient weld quality. Namely, stress concentration factor in the critical area $s_{loc}/s_{nom} \sim 5$ was quite unacceptable. It should be not more than 2 – 2.5, and a complete reconstruction of this important detail was necessary.

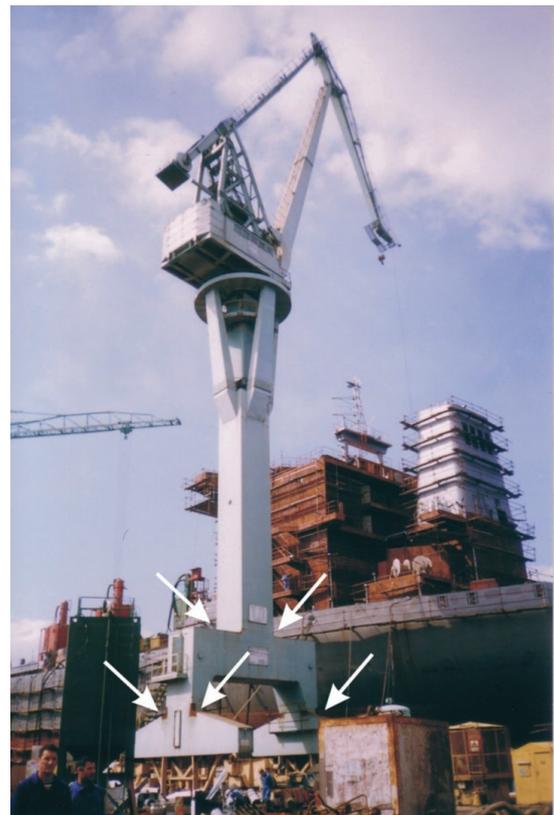
Fig. 4. Portal crane in Shipyard Split

Cracks occurred at transition areas from vertical to horizontal supports on both legs, growing from the corners and bringing into danger the whole construction, Fig. 4. The first cracks were detected soon after the crane was

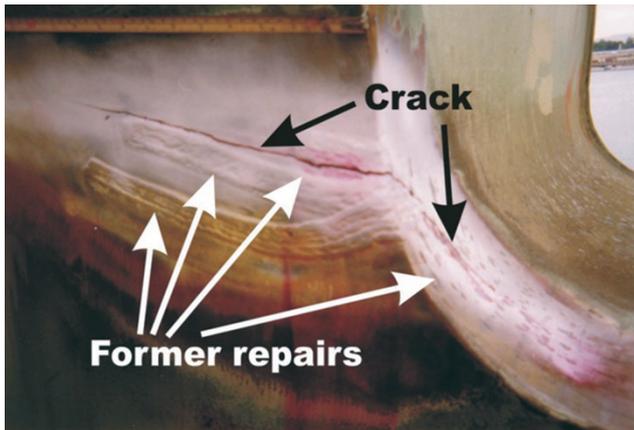
placed in the shipyard, so the allowed carrying capacity was reduced from 250 kN to 50 kN, figure 4, but the cracks continued to grow. In order to find the source of crack initiation and growth, the complete documentation and calculations were checked. It was found that calculations were performed by using simple beam elements, without taking into account stress concentration, and influences of inertial forces and wind were underestimated. Those facts led us to perform complete static and fatigue analysis, to measure real stresses during typical manoeuvres and to redesign the critical places of the crane.

Fig. 5. Detected cracks

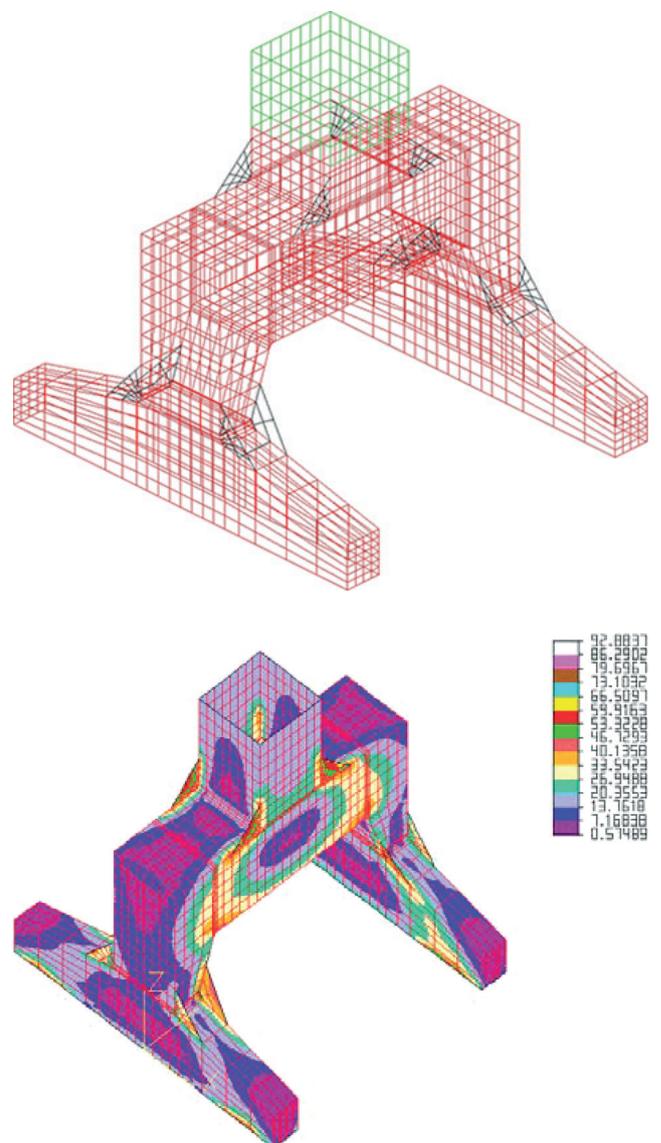
Fig. 6. FEM mesh and some results

Strain gauge measurement and FEM analysis showed the source of the crack initiation – high stress concentration in the transition areas from the vertical to horizontal

part of the supports. At critical points those stresses exceeded the fatigue strength of the material and caused the crack initiation and growth. Variable loads cannot be avoided, so the only solution was to redesign the critical areas in order to redistribute local stresses. FEM analysis also showed the best way for redistribution of high stresses: application of triangle stiffeners that fit the existing construction (Fig. 7). Those stiffeners were welded by using the MAG process. Heat treatment was used to minimize residual stresses, and fatigue limit of welds increased by grinding the weld toes and roots. After the repair was completed, stresses at critical points were measured once again and compared to the values predicted by FEM. According to the data obtained from FEM and strain gauges measurements, it is clear that stresses at critical points were significantly lowered, especially in critical areas. All the stresses were under the fatigue limit, so the main source of crack growth was removed.

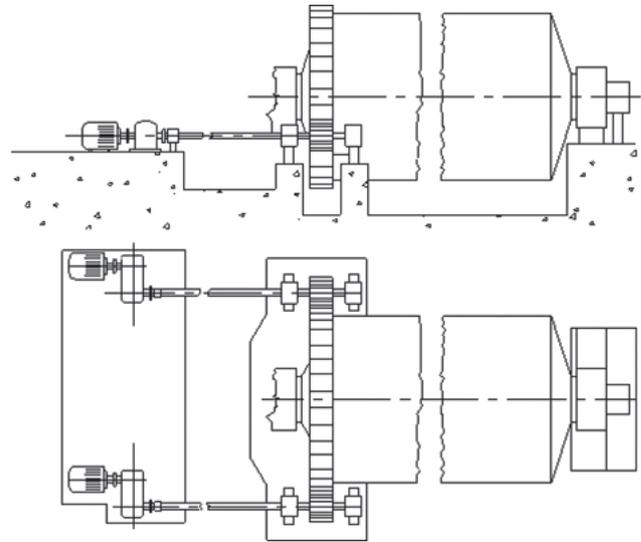
After 20 years in service, the great gear wheel of cement mill, Fig. 7, failed due to fatigue. When the whole mill plant was stopped and inspected, additional seventeen fatigue cracks were found at the tooth fillets. The gear wheel was fabricated of cast steel and mounted in two ring parts at the front side of the cement mill, Fig. 8.

Fig. 8. Cement mill and its characteristics

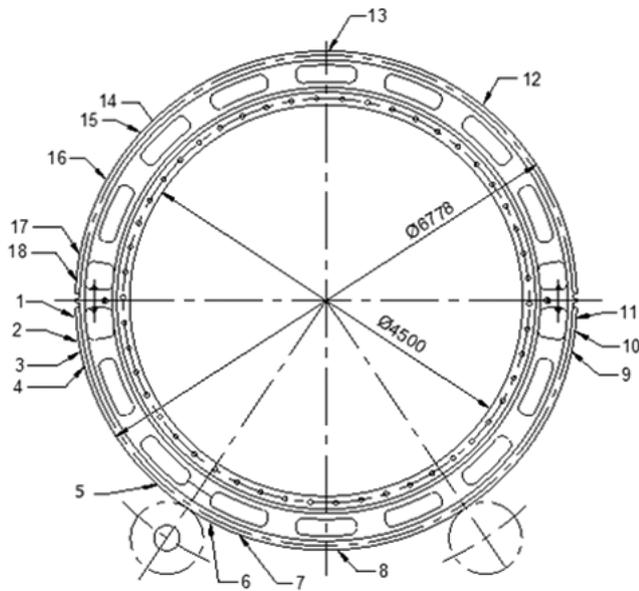
At several positions, very close to the surface, a lot of casting errors (pores, slag inclusions, etc.) were found, Fig. 8. Joint efforts of alternating stresses, casting errors (sized several millimeters to several centimeters) and most likely existence of residual tensile stresses caused fatigue cracks initiation and propagation at the critical positions. The cross section of the gear rim, where complete fatigue failure occurred (fatigue crack No. 2), was additionally weakened by decreasing the rim thickness due to connecting bolts. The position of the cracks is shown in Fig. 7. The surface crack length varied from 20 mm to 600 mm (total failure). The position and size (surface length) of each discovered crack were estimated by means of non-destructive testing (magneto-flux method). In order to determine the complete data on crack shape and size (depth), and to perform repair welding, voluminous work (cracks removal by arc-air grooving) was undertaken.

Fatigue crack number	Crack position (teeth number)	Crack surface length (mm)
1	2-3	200
2	3-4	600, failure
3	16-17	290
4	19-20	330
5	24-25	20
6	26-27	315
7	32-33	50
8	63-64	320
9	112-113	250
10	113-114	180
11	114-115	200
12	158-159	100
13	168-169	400
14	209-210	160
15	210-211	60
16	216-217	120
17	229-230	200
18	230-231	90

Fig. 9. Detected cracks on the cement mill

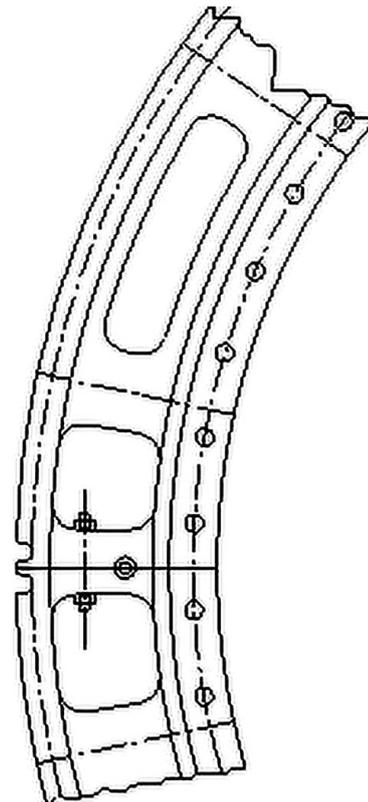
Fig. 10. Additionally weakened gear by decreasing the rim thickness due to connecting bolts (position 2 from Fig. 7)

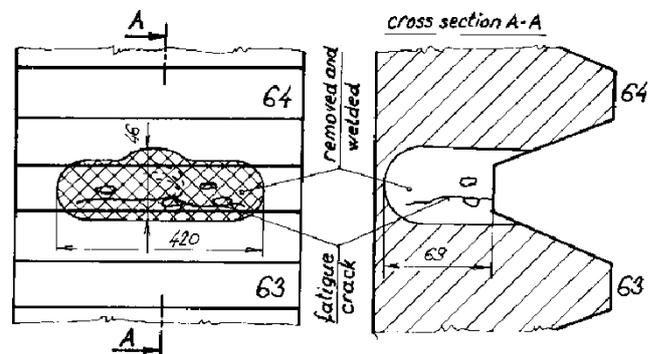
Fig. 11. Typical fatigue crack on the cement mill

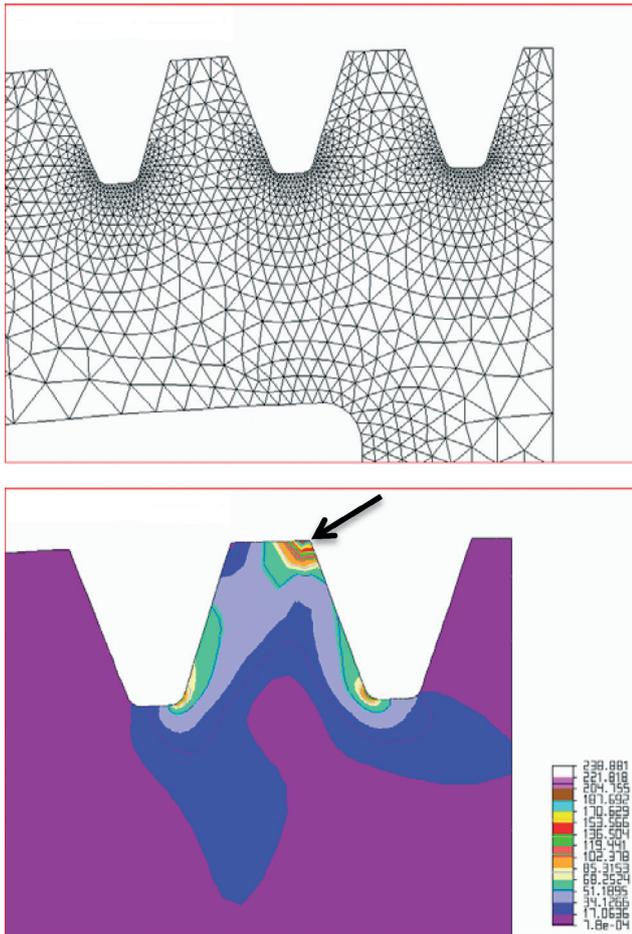
During each revolution of the cement mill and large gear, every tooth was loaded twice (two small gears) by tooth force alternating from zero to the maximum value. Numerical method (FEM) was used to determine the stress distribution at the gear rim. Calculated maximum stress amplitudes were found at the tooth fillet, approximately 50–115 MPa, depending on their positions on the surface. Stress intensity decreased very fast in the depth of the gear rim.

Fig. 12. Stress distribution and stress concentration
