FRACTURE ANALYSIS OF NODULAR CAST IRON CRANKSHAFT

Based on the analysis of the fracture of a certain type of QT800-2 nodular cast iron crankshaft, the cause analysis of the fracture crankshaft is discussed based on macroscopic inspection, metallographic analysis and mechanical properties test. The results show that the shrinkage and surface cracks in the casting process are the main factors leading to the fracture of the crankshaft, and the process improvement measures for the manufacturing process of QT800-2 nodular cast iron crankshaft are put forward.

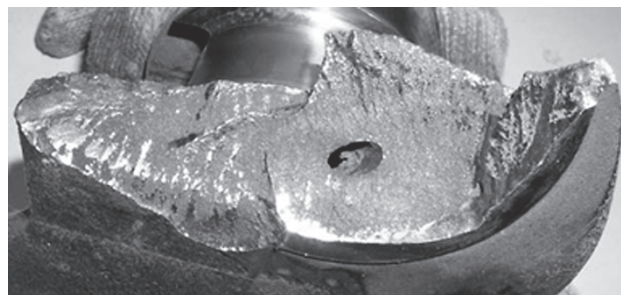
Figure 1 Macroscopic morphology of fracture

The macroscopic appearance of the fracture is shown in Figure 1. The whole fracture has no fatigue crack, and it is instantaneous brittle fracture, and some areas around the fracture are worn. The crack initiation is located at the transition part of the 4th connecting rod

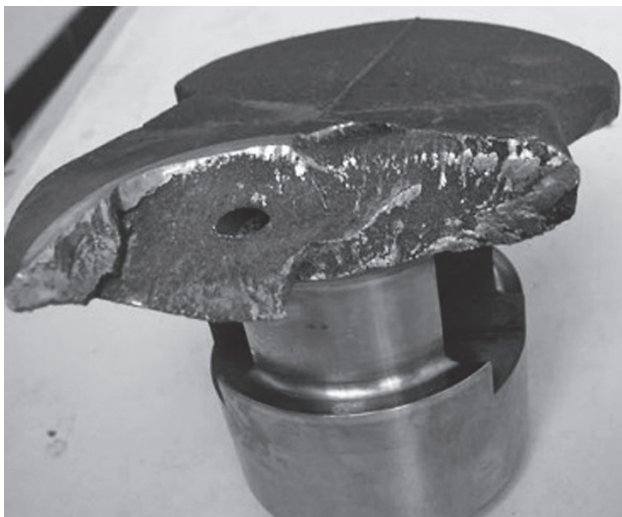
Figure 3 Macroscopic morphology of fracture

and the 8th crank. From Figure 3, it is at the bottom of the convex plate of the crank. The crack initiation is relatively flush and narrow and long. It is speculated that there may be a long micro-crack in advance, leading to flush fracture at this place.

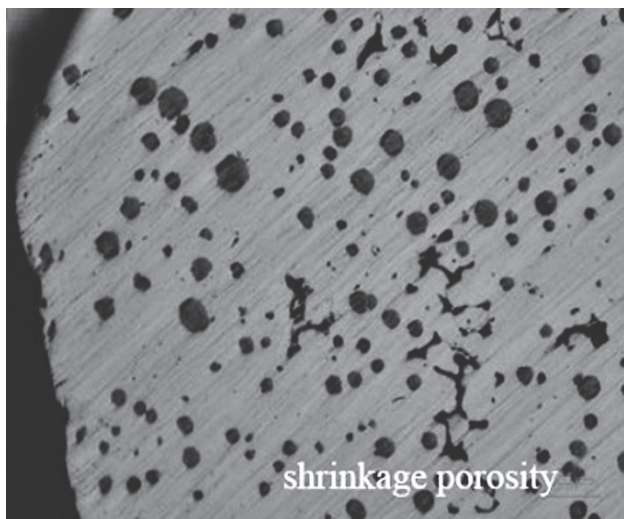
Figure 4 Surface morphology near oblique oil hole (100 ×)

According to the metallographic examination of GB/T9441-2009 ductile iron, Figure 4 - Figure 7 shows the metallographic photos near the fracture. Figures 4 and 5 show that a large number of shrinkage porosity has been found in different areas of the matrix, with a maximum length of about $170\mu\text{m}$ and a maximum width of about $130\mu\text{m}$. The spheroidization rate is 2-3 (requirement 1-4), and the ball diameter is 5-6 (requirement 5-8). Figure 6 shows that the pearlite content is 85% - 95% (requirement $\geq 85\%$). A part of cementite in the matrix can be observed in Figure 7.

The shrinkage hole generally appears in the place where the molten iron finally solidifies, which is the branch shrinkage caused by the volume shrinkage of the molten iron when it is solidified without the timely replenishment of the molten metal. Shrinkage is divided into concentrated shrinkage and porosity. The influencing factors of shrinkage include chemical composition of molten iron, carbon equivalent, inoculation and spheroidizing treatment, mold stiffness, pouring temperature, casting modulus, gating system, riser and so on.

At present, the general solutions at home and abroad are: application of subsidy and cold iron; pressure shrinkage method; adjustment of pouring conditions; hot metal composition and nodularizer control method; reasonable gating system design and riser application and so on. Combined with this case, it is feasible to add pure lanthanum nodularizer and replace sand riser with PB riser. In addition, the computer numerical simulation technology is used to assist the study of the relevant factors affecting the crankshaft shrinkage, which can further improve the problem-solving efficiency.
