## FRACTURE ANALYSIS OF CRANKSHAFT OF HEAVY TRUCK ENGINE

The crankshaft of diesel engine of a heavy duty vehicle broke during running. By means of macroscopic and microscopic observation of the fracture, chemical composition and metallographic structure analysis, and mechanical property test, the cause of the fracture of the crankshaft was studied. The results showed that the surface hardness of the journal was not up to standard, the wear and tear were serious, and local burns were suffered. The fatigue brittle fracture of crankshaft shaft journal and connecting rod was caused by abnormal external force. It is suggested to control the heat treatment and manufacturing process of crankshaft, optimize the structural design, improve the assembly precision and improve the lubrication system.

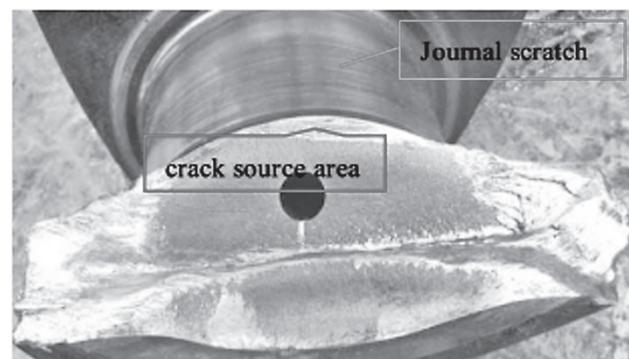
The crankshaft material is 42CrMo, the main heat treatment process is: normal-temperature-surface nitriding. The shaft is broken at the second crank, as shown in Figure 1.

From Figure 1, the crankshaft shows a short time fatigue brittle fracture. No.1 connecting rod journal is seriously scratched due to wear and tear, the tiles are burned locally until the surface is black, and there are

(a) Fracture region

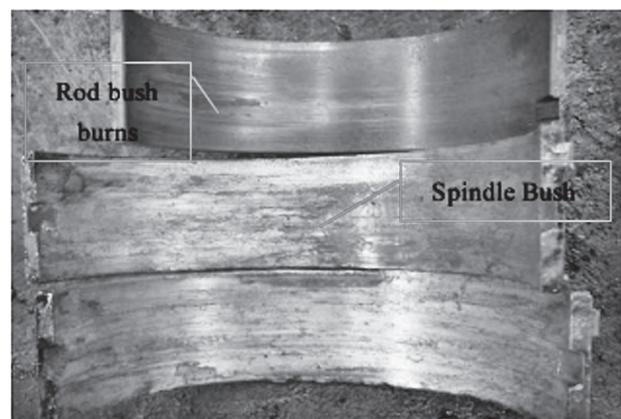
small concave holes in the tiles, which should be caused by sundries in the lubrication system during failure and wear. The first, second and third main shaft journal were all scratched by wear, and the flange was scratched the most seriously, as shown in Figure 2. Between the flange and the gear, a gap of about 6mm was found between the two. According to this, it can be inferred that when the accident happened, the shaft journal, especial-

(b) Abrasion burn of bearing bush

4 From the macroscopic and microscopic point of view, the crack develops rapidly and the brittle fracture features are clear. Each journal is seriously scratched by wear, and the tiles are burned locally and blackened, which indicates that the friction between the crankshaft and the axle bush produces high temperature, which causes the surface of the journal to produce greater thermal stress, and the crankshaft material has the tendency of brittleness of overheating. The appearance of small concave holes in the tile indicates that the lubricating system has sundries. The gap between flange and gear is about 6 mm, which indicates that the abnormal forces on the journal, especially the forces at the fillet and the connecting rod are the main reason for the short-time fatigue brittle fracture of the crankshaft. It is suggested to optimize the crankshaft structure design, control the crankshaft manufacturing process, especially improve the surface quality of the transition rounded corners, improve the assembly precision, and improve the lubrication system, so as to prevent similar accidents.

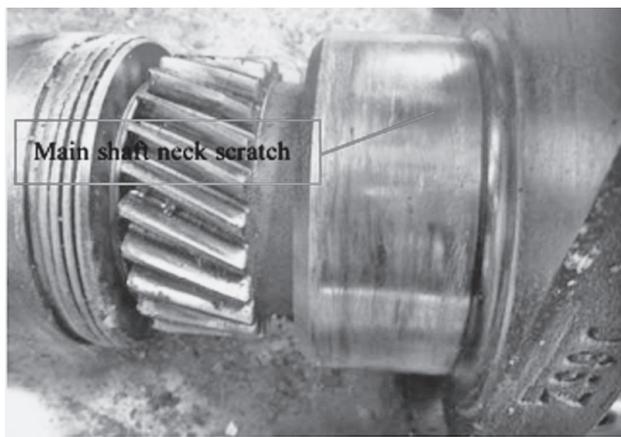
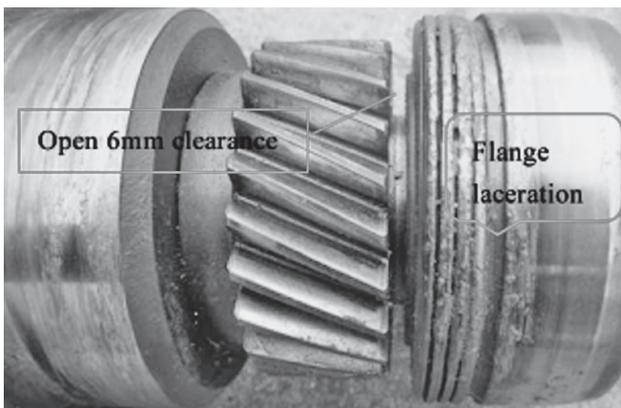
**Figure 2** Scratch and wear of spindle journal Chemical composition analysis

ly the round corner and the connecting rod were under abnormal stress, resulting in serious grinding and failure of all the accessories of the cylinder block [5,6].

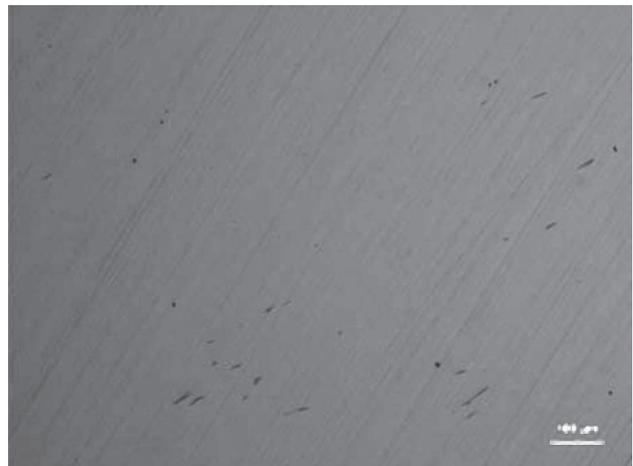
According to GB/t10561-2005, nonmetallic inclusions were inspected and evaluated. As can be seen from Figure 3, there is a grade A1,5 sulfide inclusion near the lower rounded corner. The 42CrMo is mainly composed of endogenous inclusions of MnS t-type. The content, spacing, size and shape of inclusions are direct-

**Figure 3** Surface topography near the fracture 100 X

ly related to the fracture toughness of 42CrMo steel. The fracture toughness can be improved by controlling the content of sulfur or spheroidizing treatment of sulfide [8].

1 The chemical composition of the crankshaft meets the requirements. The matrix structure is qualified pearlite reticular ferrite, and there is no obvious defect in the fracture. The rounded corners are relatively smooth, and the radius of the rounded corners is within the required range. There are grade A1,5 sulfide inclusions near the lower fillet. It is suggested to pay attention to spheroidization of sulfide inclusions to improve fracture toughness of 42CrMo steel

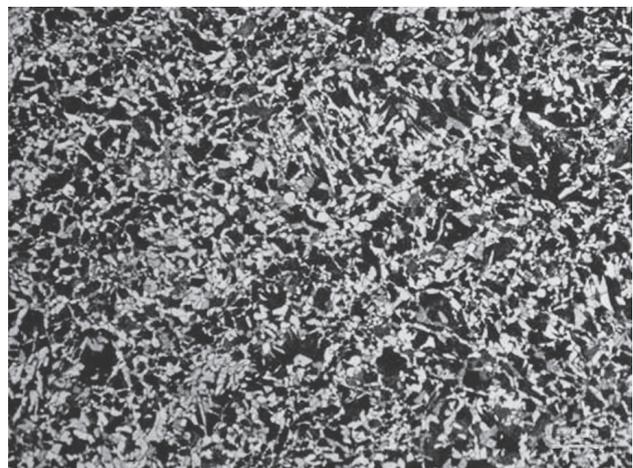
**Figure 4** Tissue near fracture 100 X

As can be seen from Figure 4, the matrix structure of the crankshaft is qualified pearlite + reticular ferrite. The grain size is determined to be grade 8 according to GB/ t6394-2017 (requirements). Grade (5-8), band 1 ( $\leq 1$ ). The requirements are met.
