## CRACK ANALYSIS OF CRANKSHAFT FOR DIESEL ENGINE

The cause of crankshaft fracture crack of a certain vehicle has been analyzed through macroscopic inspection, chemical composition analysis, microstructure analysis, hardness test, mechanical properties test and dimension inspection. The analysis results show that: All of its chemical composition, microstructure, hardness, mechanical properties and dimensions accord with the technical specifications. However, due to the bearing score of the seventh main journal and the wear of fillet, the crankshaft cracked at multi-points from the fillet. The reason is that the fracture of crankshaft is finally caused by large cyclic external force.

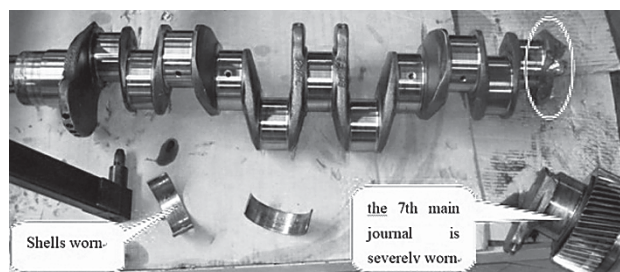
From the broken crankshaft and its accessories, it occurs for the bearing score of the seventh main journal, a little serious wear of the journal and bearing shells (Figure 1), serious wear of the boss on the broken side of the seventh main journal (Figure 2). However, the journals are in good condition, and there is no bearing score.

Figure 1 Broken shaft morphology

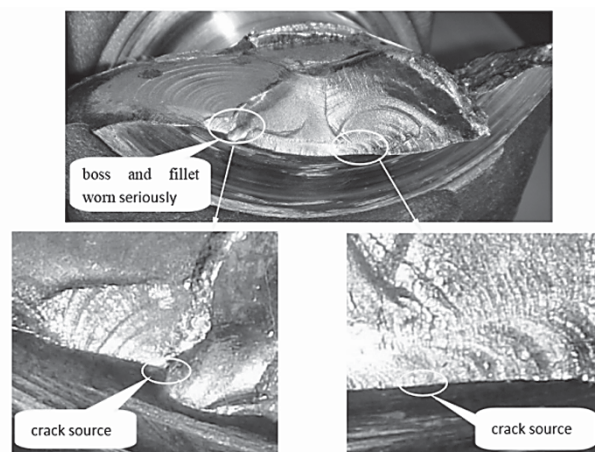
From the macro fracture, there are two crack sources that both are in fillet on the side of the main journal at the fracture of the crankshaft. And the boss and fillet are worn seriously. It will easily cause the crank of the crankshaft from here and ultimately led to fracture. There is a larger area of crack break, which accounts for more than a half of the whole fracture. It can be determined that the crankshaft is subjected to large external force during use.

Figure 2 Macroscopic fracture morphology

In conclusion, the chemical element composition, microstructure, hardness, mechanical properties and dimensions of the crankshaft are all qualified. However, from the macroscopic observation of the fracture, the fillet on the side of the 7th main journal is severely worn, and there are two original cracks here, which crack and eventually cause the crankshaft to fracture.

After the engine was disassembled, it was found that the 6th cylinder of the engine next to the seventh main shaft diameter had more carbon deposits than other cylinders, indicating that the cylinder is prone to rough work during operation, which brings additional load to the crankshaft, which causes the seventh main shaft diameter. The fillet is excessively worn, and the two crack sources at the crankshaft's fillet wear will accelerate the propagation of cracks under the action of a large cyclic external force. This further verifies that the long-term rough work of the sixth cylinder of the engine is the main reason for the fracture and failure of the crankshaft.

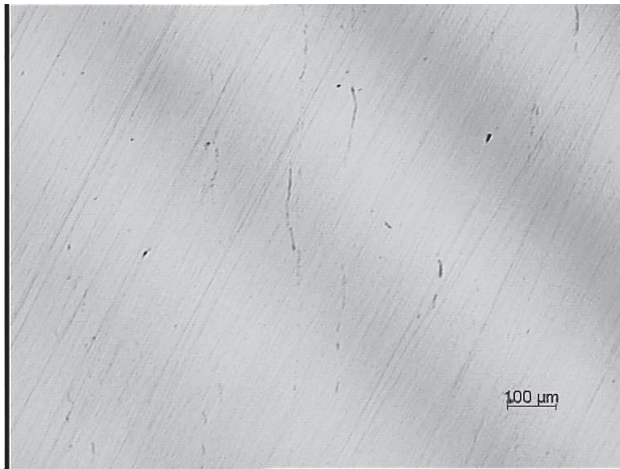
From the microstructure (Figure 3), Observation of the microstructure near the crack revealed that there is a slight amount of sulfide in it. According to the test results of microstructure, as shown in Table 2, they are all within

Figure 3 Matrix at the fracture

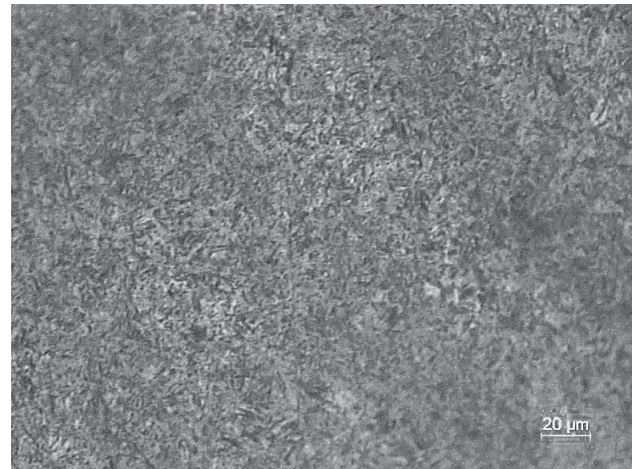
Figure 5 Quenched martensite at fracture (500 ×)

the range of technical requirements. After pickling and electrolytic etching, the morphology as shown in Figure 4, that the grain size of the matrix whose grade is Grade 7 is relatively uniform, is finally formed. The grain size of the matrix is relatively uniform, and the grade is Grade 7. After eroding the sample of the crack source of crankshaft, the metallographic structure obtained under microscope by 500 times of the material is quenched martensite (Figure 5). Its grade is Grade 5 (As shown in Table 2).

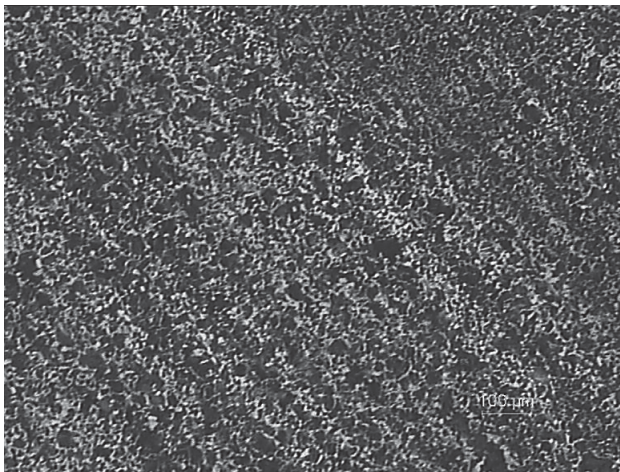
Figure 4 Matrix after fracture corrosion
