CAUSE ANALYSIS OF CRACKS IN DIESEL ENGINE CRANKSHAFT BLANK

Received – Priljeno: 2020-08-29
Accepted – Prihvaćeno: 2020-10-30
Preliminary Note – Prethodno priopćenje

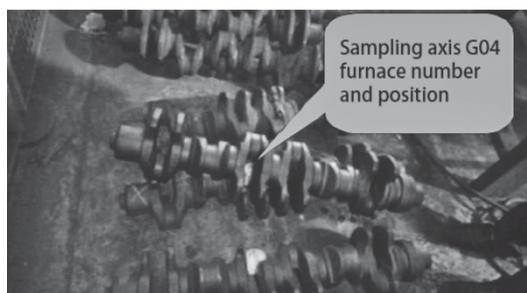
Figure 1 Crack location of scrapped crankshaft blank

Crack location of scrapped crankshaft: connecting rod journal, Figure 1.

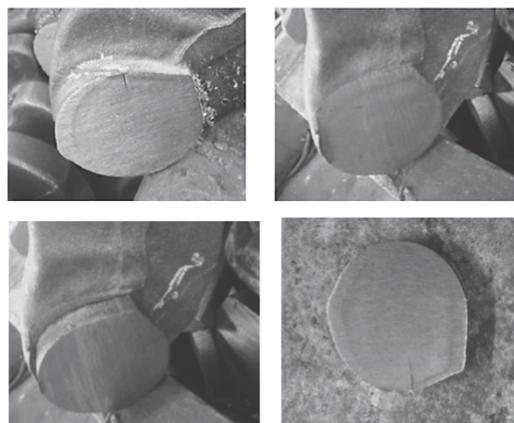
Figure 2 Group diagram

After sampling the fractured crankshaft journal on the saw machine, it was found that the crack originated from the position near the parting surface, and the inclusions at this position would be concentrated. The crack is relatively thick and appears to be one at first sight.

However, after careful observation, the crack is not continuous, and multiple cracks expand at the same time, and finally converge and tear into one. One end of the crack extends to the transition position between the journal and the fillet, which is close to the hot spot of induction hardening. Due to the skin effect, overheating is easy to occur near the hot spot. See Figure 2.

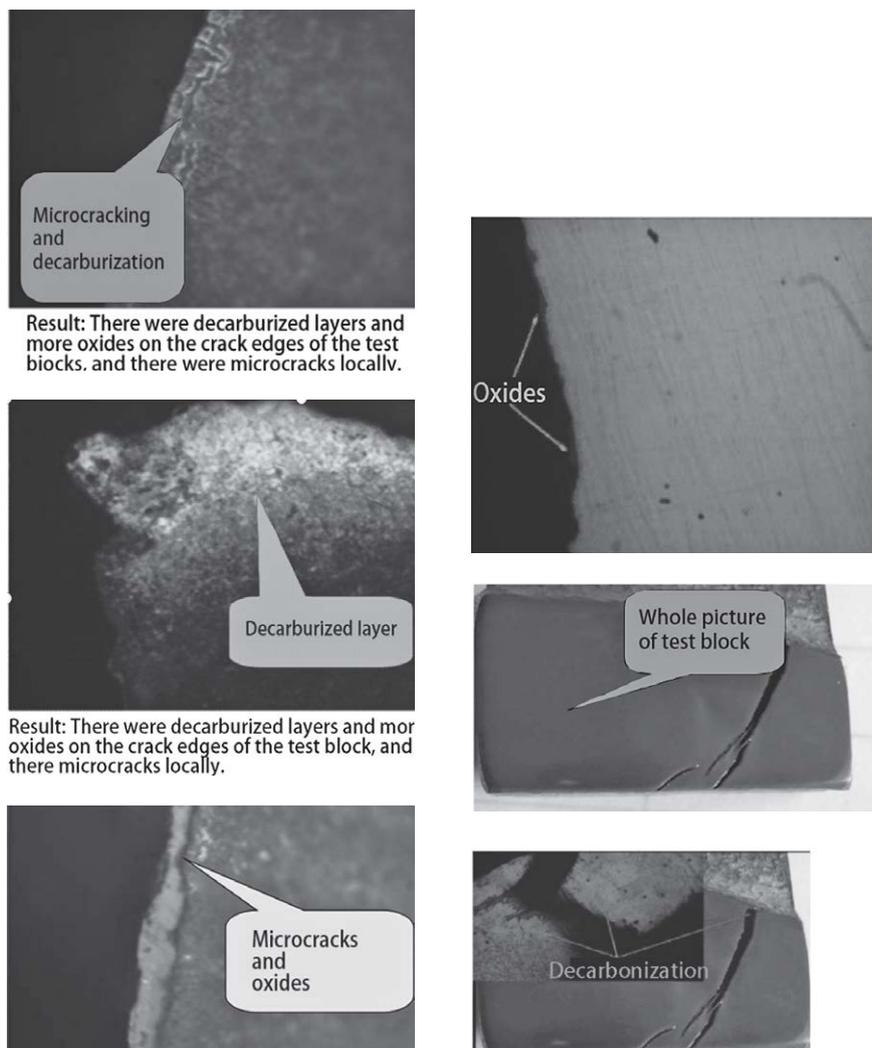
Figure 3 Group diagram

The microstructure of the fractured crankshaft was analyzed, and it was found that the matrix structure was lamellar pearlite + reticular ferrite, without other abnormal structure and overheating phenomenon. The microstructure is obviously normalized with grain size of 6-8. Near the crack, there is obvious oxidation decarburization phenomenon around the crack, as shown in Figure 3.

A large number of nitride inclusions were observed near the crack, Harm of nitrides: nitride inclusions are characterized by high hardness, not easy to deform and

distributed in groups. With the increase of nitrides, the brittleness of steel will increase obviously, and the geometric nitrides will form the crack source of brittle transgranular fracture of steel. The most obvious physical characteristics of nitrides: when the heating temperature is lower than 1 200 °C, the morphology of nitrides does not change.

ing steelmaking, and there are many inclusions in the steel, such as silicate, calcium carbonate and spherical oxide. These inclusions gather on the grain boundary, weaken the grain boundary, and cause intergranular cracking of crankshaft under stress. There are deep decarburized layer on both sides of the crack, and the crack line is soft and thick, which conforms to the characteristics of non quenching crack. The fracture is caused by the overheating or burning after the heating temperature is too high before forging.

The heating temperature of billet before forging should be strictly controlled, and the holding time under high temperature should be shortened as far as possible to prevent the steel from overheating and burning.
