Krško NPP Experience with RTD Bypass Elimination

Gordan Janković

Nuclear Power Plant Krško
Vrbina 12, 8270 Krško, Slovenia
gordan.jankovic@nek.si

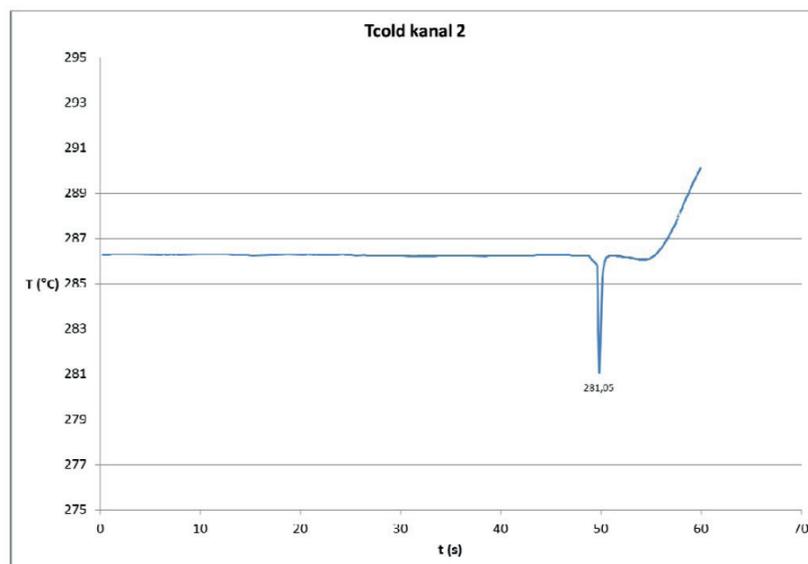
Figure 9: Plant computer trend for protection channel 2 Tcold

As the plant was performing an initial power increase after the outage, at about 90% power, the reactor tripped on OPΔT protection signal. By looking at the trends on the plant computer (as shown on Figure 9 and Figure 10), it could be seen that all temperature signals coming from the field had downward spike. Lag filters filtered out these spikes for the Thot signal, but strong lead/lag filters amplified the spike on Tcold signal, which resulted in large spikes on ΔT signal, so that it went above the OPΔT trip setpoint on 2 out of 4 channels. Reactor operator on shift noted that the trip coincided with reactor makeup water selector switch operation, which was known to sometimes cause irregularities on control equipment, but plant did not have any record of spikes or any irregularities in reactor protection instrumentation. With reactor tripped, the troubleshooting team was able to reconstruct the spikes of varying amplitude on resistance-to-voltage cards (NRA cards) whenever the reactor makeup water selector switch was operated. The cause for that was determined to be operation of up to 12 auxiliary relays that are located in auxiliary relay racks nearby temperature channels. The relays are powered by 118 VAC power source. Since relays did not have any surge protection, whenever a relay was energized or de-energized, voltage spikes of sometimes more than 1000 volts occurred (see Figure 11), which emitted electro-magnetic (EM) pulse. EM pulse is believed to be picked-up by the interconnecting cables and transferred from auxiliary relay racks to reactor protection cabinets, where temperature channel cards were located. Since NRA cards operate with relatively small field signals of about 300 mV, which is then amplified with large gains, they were most susceptible to picking up the EM pulse.

The EM pulse generation was greatly reduced by installation of the surge protectors on all affected relays, which limit the voltage spikes on the relay coils to 200 volts. These are passive metal oxide varistors, which do not require any maintenance.

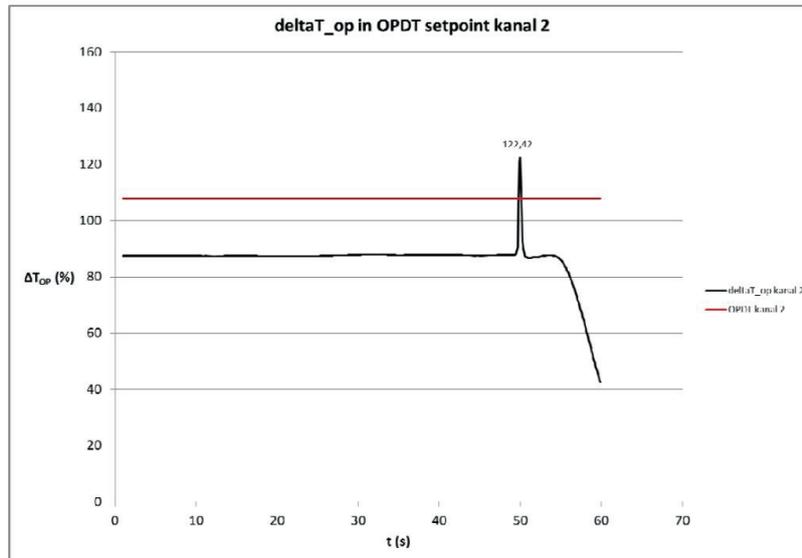
Figure 10: Plant computer trend for ΔT signal for OP ΔT reactor trip (black) and OP ΔT setpoint (red) for protection channel 2

The root cause analysis was performed which identified four contributing causes for the trip: the EM pulse generation by the auxiliary relays, the transfer path for the pulses, the NRA cards input stage susceptibility to EM noise, and OP ΔT protection reconfiguration that made the channel vulnerable to short-term spikes in field signal. In order to prevent such events in the future, three contributing causes were addressed and resolved or mitigated. It was judged that resolution of EM noise transfer to protection cabinets would require significant effort without further improvement to temperature channels noise immunity, and possibly creating new problems.

The most complex contributing cause to address was OPΔT protection change that would remain efficient for the mitigation of design accidents and not be over-sensitive to short-term signal disturbances. A sensitivity study [10] was performed where a series of Tcold lead/lag or lag-only filters were compared with magnitude of the Tcold signal disturbance they can filter out without generating a trip signal, and compared with the departure from nucleate boiling ration (DNBR) they still attain (as a measure of reactor protection efficiency). This showed that the implemented aggressive Tcold lead/lag filtering was very conservative and that DNBR margin remains with lag filter on the Tcold signal, while it offered maximum disturbance rejection. Based on this conclusion, Tcold lead/lag filter was replaced with lag-only filter.

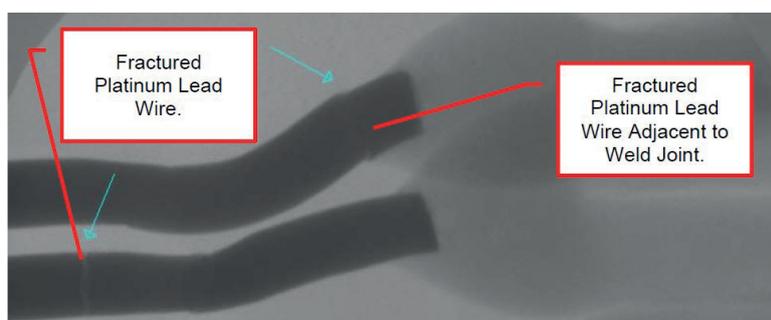
Figure 13: X-ray of RTD platinum lead wire fractures

which were also measured on and believed to originate from reactor coolant pumps (RCP). Failed RTD was removed from the thermowell and significant rub marks were observed on several places on RTD sheath (see Figure 14), which supported the assumptions about vibratory environment. The plant conservatively decided to replace all four cold leg RTDs in outage 2015 with spares. The failed RTD unit was shipped to the manufacturer for examination and determination of root cause for the failure. After one cycle of operation in a neutron flux environment the RTD was slightly activated so the manufacturer was only able to perform visual and x-ray examination, because he did not have means to contain radioactive debris that would form with destructive examination. Nevertheless, the cause for the RTD failure was clearly visible as platinum lead wire breaks on the x-ray shots (see Figure 13). The causes for the break however could only be assumed.

- failed RTD units had insufficient powder potting in the RTD tip region, which resulted in excessive platinum lead wire mechanical loading and failure
- the cross-section of the most of the failed wires showed typical signs of metal fatigue.

- Instead of pure platinum, a higher strength platinum-rhodium alloy material shall be used for RTD lead wires
- The RTD manufacturing process was revised so that better potting was assured
- RTD tip was slightly redesigned to support better potting.

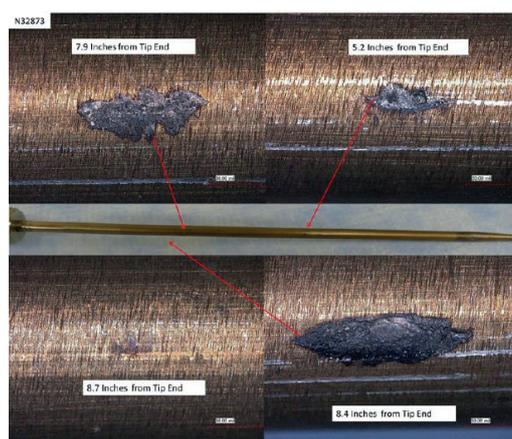
Figure 14: Rub marks on the RTD sheath

- the RTD sheath has higher resonant modes in 3-5 kHz region
- the measured vibrations in the RTD tip spectre had peaks in the same 3-5 kHz region
- comparison between RTD tip and RCP vibrations proved RCP to be the source of the vibrations
- the vibration data indicates that excitation by flow turbulence is not a large contributor to RTD tip vibrations.

- redesign of the internals of the RTDs, so that vibratory loading on the critical RTD components would be as low as achievable
- qualification programme for plant-specific high frequency vibration operating environment
- to order the high frequency vibration root cause study from RCP OEM, in order to suggest methods to reduce or eliminate vibrations generation from the pump.
