The preliminary inventory of coseismic ground failures related to December 2020 – January 2021 Petrinja earthquake series

The most recent major earthquake series struck near Petrinja (December 29th 2020 M 6.2), and triggered extensive ground failures in the wider area of Petrinja, Sisak and Glina. Coseismic ground failures including subsidence dolines, liquefaction and landslides have been documented over a large area by various experts and teams. These data are stored in the newly created inventory, which is openly presented in this paper. This inventory is administered and updated by the Croatian Geological Survey, and will be available online via a Web Map Service (WMS) (www.hgi-cgs.hr). The aim of the inventory is to not only provide data for the development of susceptibility maps and more detailed exploration for possible remediation measures, but also to define the priorities for immediate action. The earthquake triggered the rapid development of dropout dolines which endanger the local populations of the villages of Mečenčani and Borojevići. This is still an ongoing process in the vicinity of the houses and therefore in-situ exploration started immediately. Liquefaction rel

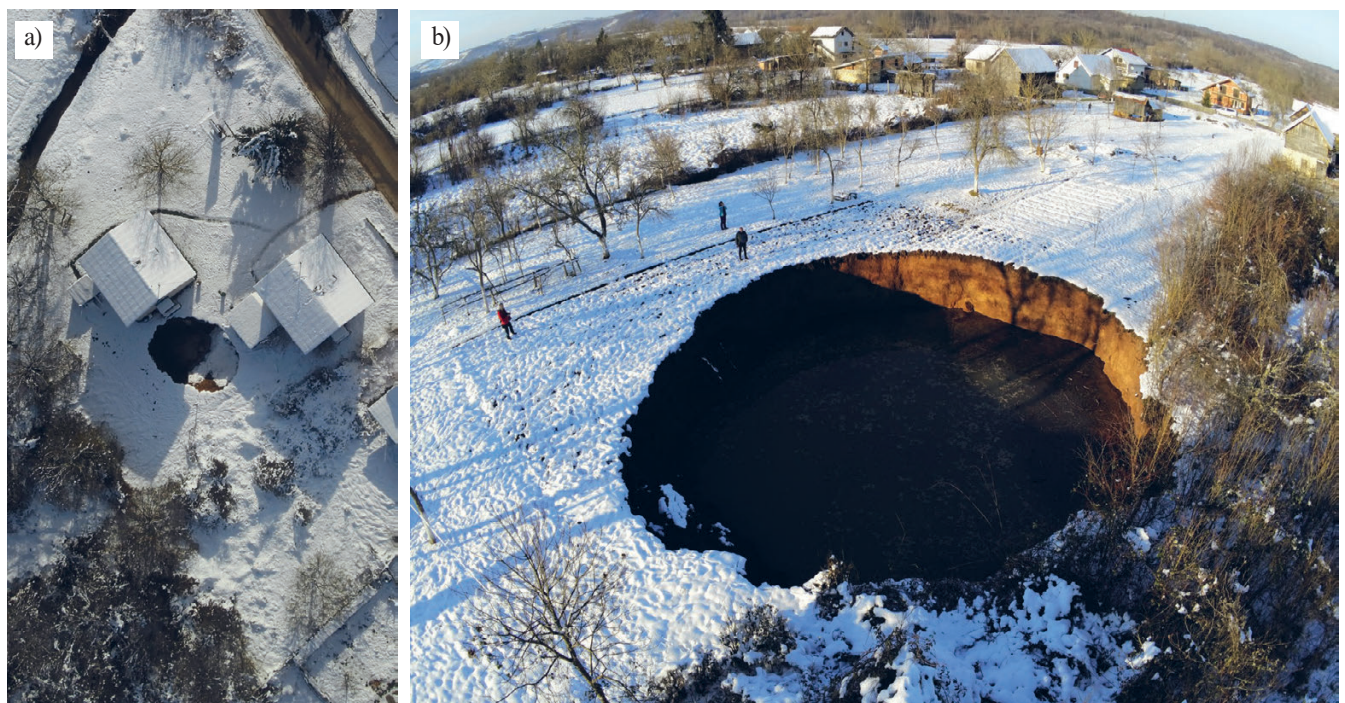
At the time of writing this manuscript, 35 records were entered in the inventory (Figure 4, Table 1), but up to February 15th 2021, more than ninety (90) subsidence dolines were registered in the area between Borojevići and Mečenčani in the Donji Kukuruzari municipality. The great majority of these are classified as dropout dolines formed by the sudden (or over a few hours) collapse of cover sediments into the underground voids, forming steep-sided cylindrical depressions. The majority of the dolines are between 1 and 10 m in diameter, but the largest one is more

Figure 4. Dropout dolines in Mečenčani village: a) endangering adjacent houses (observation point IK31), b) the biggest doline, more than 20m in diameter and about 12 m deep (observation point IK4).

than 20 m in diameter, and is still enlarging. Therefore, their final dimensions are not yet known. New dolines are still forming, almost twenty days after the main earthquake event.

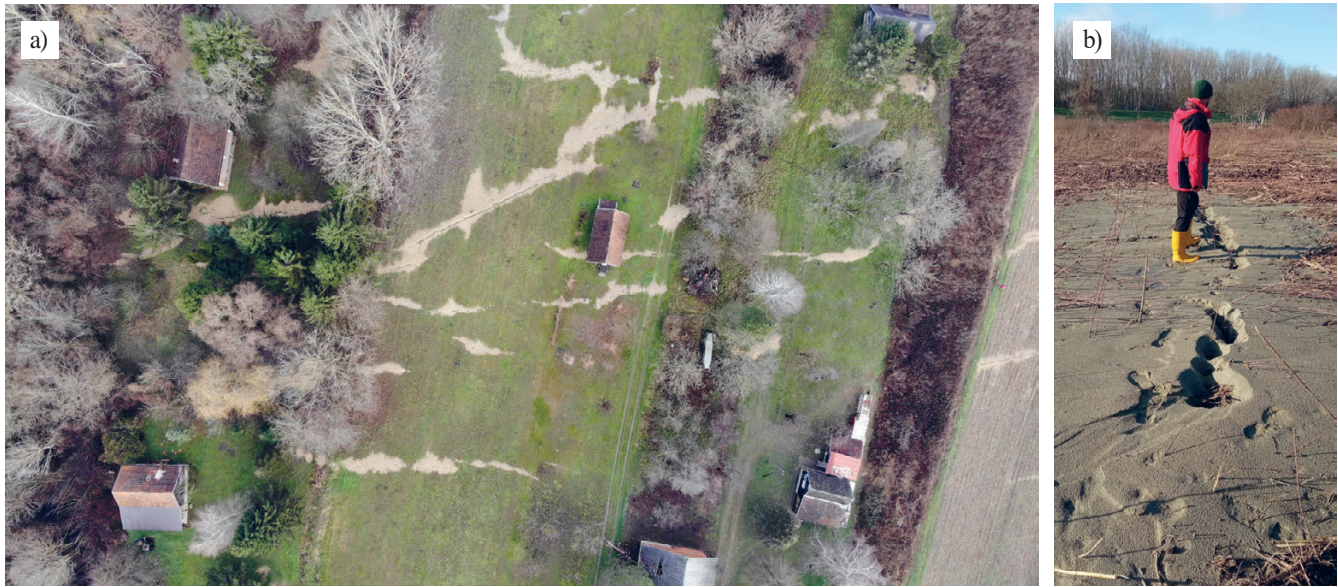
Figure 5. The sand boiling features along linear fractures: a) in Letovanić (aerial photo); b) in Sisak (observation point Si-04).

quake Glossary, 2021). The research area exhibited many locations with such features, eighty-five are in the database at present (Table 2). Most of the sand boils are aligned in a row along a linear fracture exposed at the surface (Figure 5). Locations of sand boil phenomena are found in several areas adjacent to the rivers Sava, Kupa and Glina and are clear indications of liquefied zones.

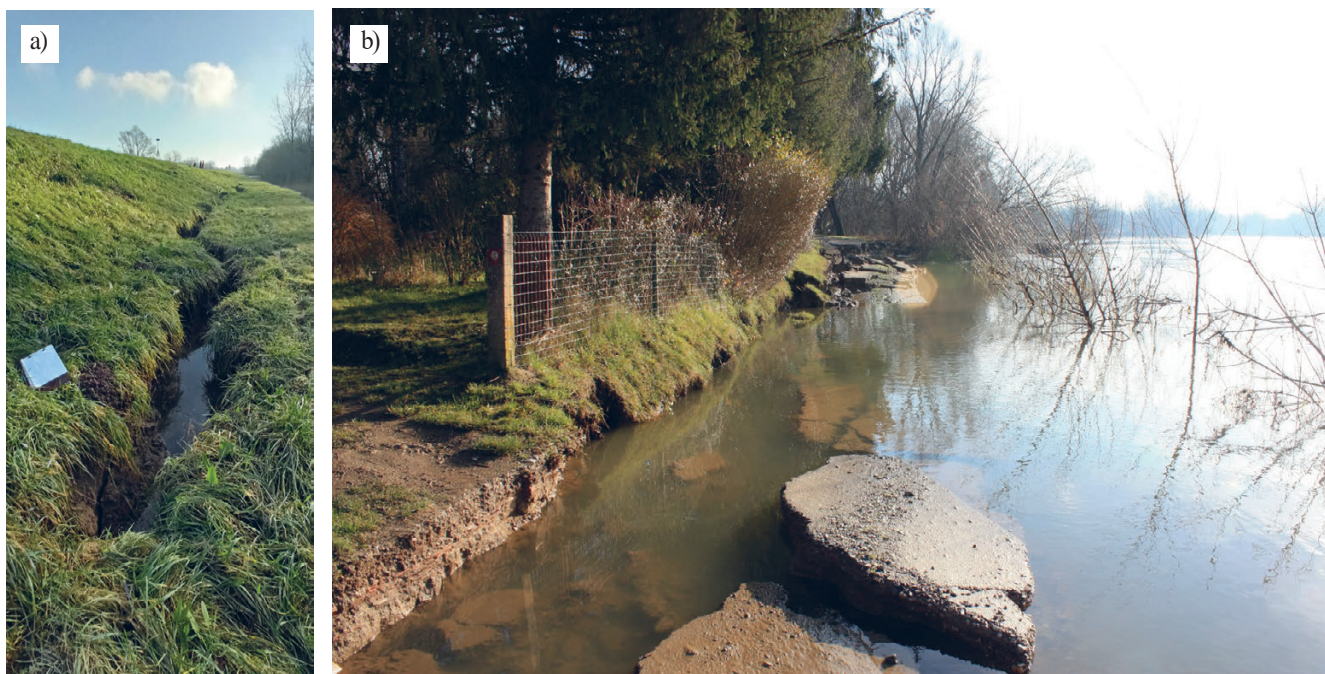
Here, the lateral spreading is the result of liquefaction of the saturated and loose sandy layers, and occurred on the flood embankments of the river Sava but also on the natural Kupa and Petrinjčica river banks (Figure 6). Horizontal displacements in most of the cases are from a few centimetres to several decimetres.

Figure 6. Lateral spreading and associated processes: a) failure of the flood embankment in Sisak (observation point Si-03); b) road failure in Letovanić (observation point RMT-35).

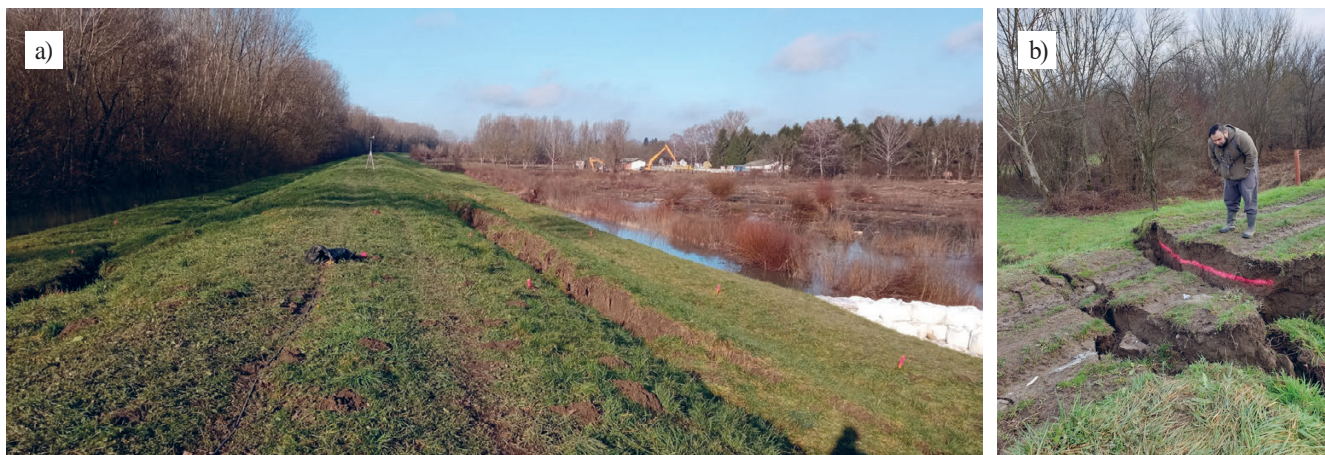
Figure 7. Subsidence and lateral spreading of the embankments near the Sava river: a) in Sisak (observation point Si-03); b) in Palanjek (observation point NP-21).

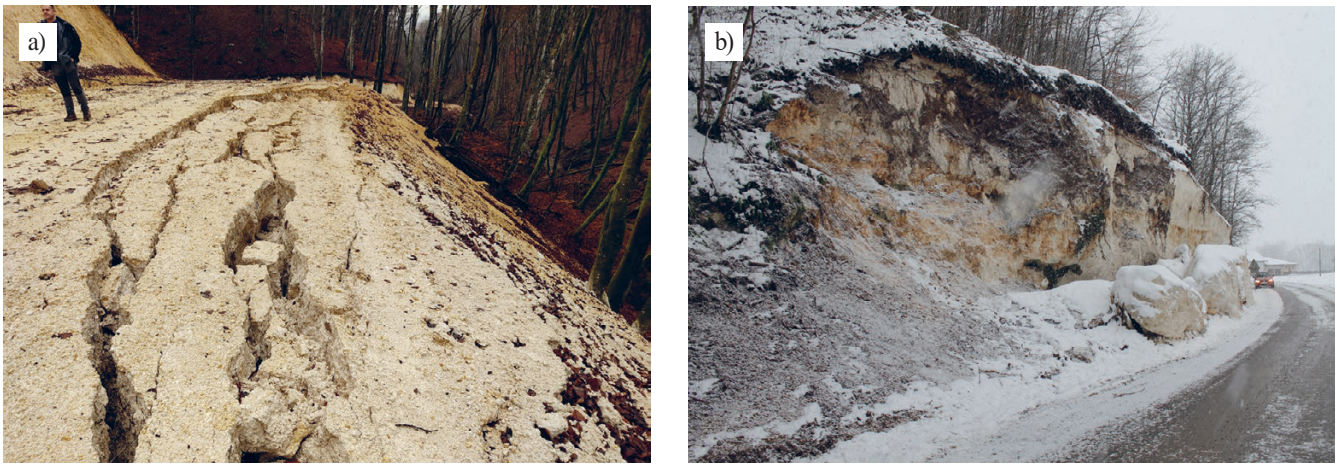
Figure 8. Coseismic landslide activation: a) slide in forest road embankment (near Strašnik, observation point ŠP-3); b) rockfall near Pecki that blocked the local road (observation point IK-ODR).

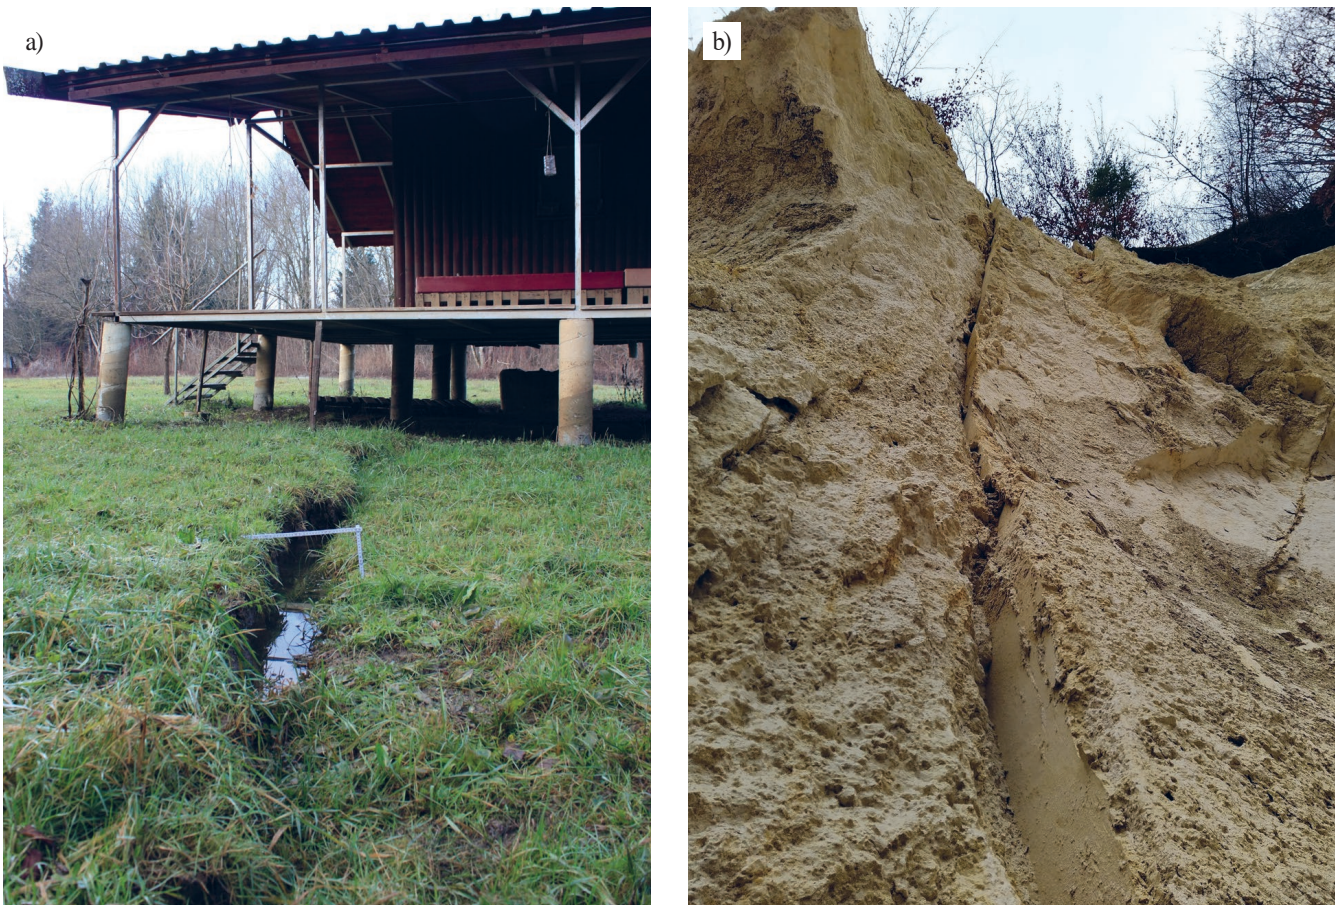
Figure 9. Soil rupture: a) near Letovanić (observation point RMT-38); b) near Župić village (observation point MV-11).

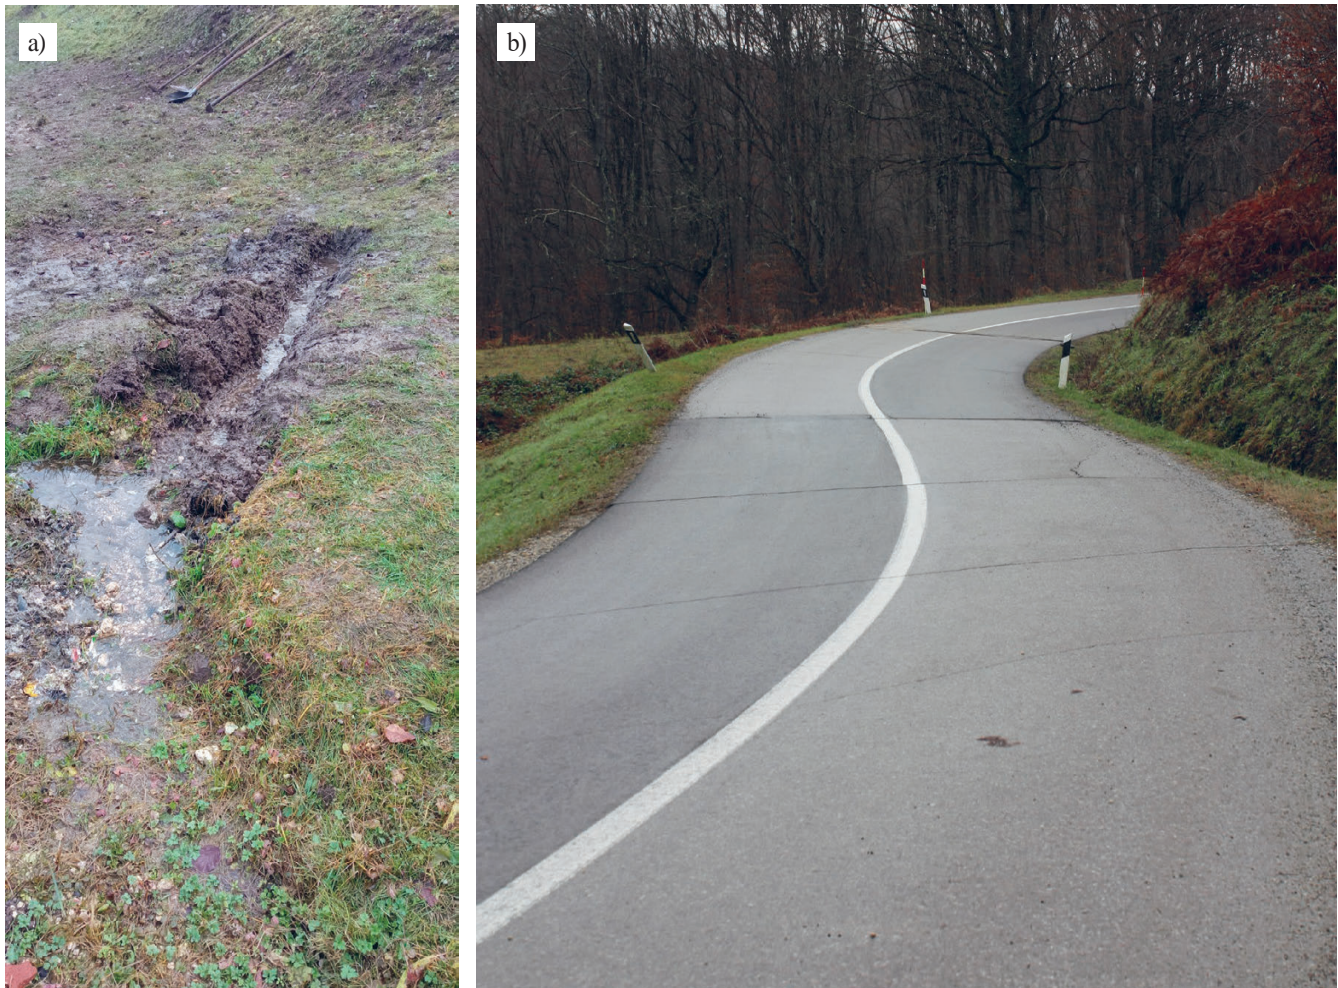
At a single location in Hrastovica, the displacement or clouding of springwater is registered. Here, before the main earthquake, the groundwater catchment collected all waters above the family house, but after intensive ground shaking, the groundwater emergence was scattered in a wider zone causing groundwater eruption inside and around the family house (Figure 10a).

Numerous road ruptures are also registered (Figure 10b). The great majority of these fractures are in the wider zone of the activated seismogenic fault (Figure 2). Other road ruptures follow minor, local faults, or are related to liquefaction-induced subsidence.

Figure 10. a) clouding of springwater in Hrastovica (observation point HR-DN-01); b) road ruptures near Pokupsko Vratečko (observation point RMT-43).

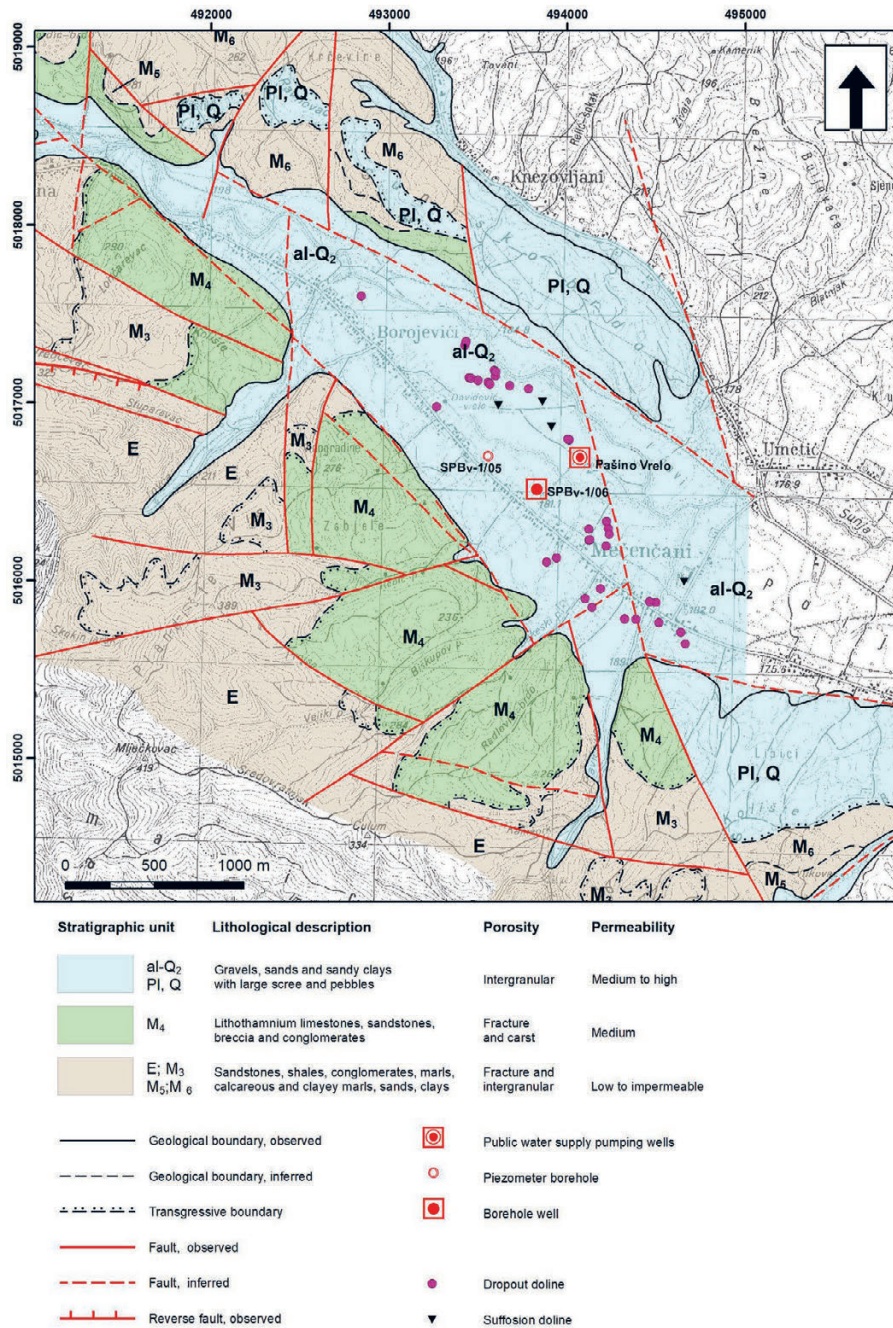
The subsidence dolines are exclusively found in the area around the villages of Mečenčani and Borojevići. This area was surveyed in detail during the hydrogeological investigations for Pašino

Figure 11. The distribution of subsidence dolines in the wider Mečenčani and Borojevići area on the geological map (originally in the scale 1:5 000; MRAZ, 2005).

possible detection of newly formed surface depressions can govern the positioning of geophysical profiling and core drilling in order to define the depth of soil cover on top of the limestones, detect existing underground cavities and define their size, interrelationships and provide sampling from deeper horizons. Borehole in situ tests, installation of piezometer and laboratory analysis of the soil samples may also be needed in order to provide data for the detection of failure mechanisms, and the influence of seismic waves and ground water interaction causing rapid development of dolines in this area. It was suggested that site exploration covers the wider area in order to enable the production of a detailed subsidence susceptibility map.

In addition, monitoring of the area should be established. Monitoring should include periodic remote sensing, groundwater level monitoring and monitoring of ground shaking intensity. These data, with the results of the other aforementioned investi-

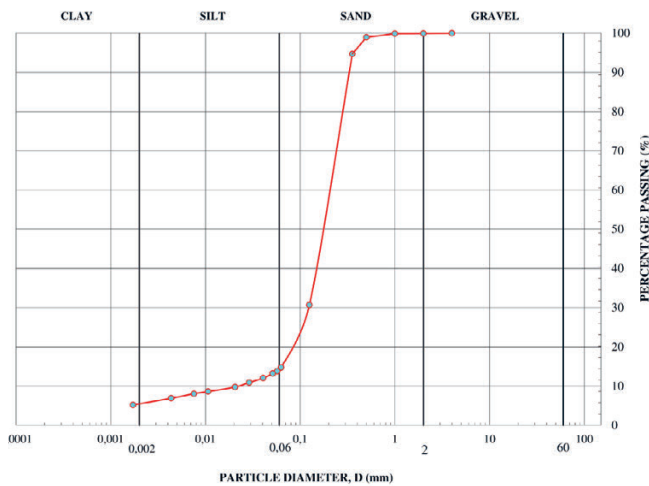
Figure 12. Granulometric diagram of sand boil material sampled at the surface in Brest Pokupski. The analysis is done in accordance with HRN EN ISO 17892-4:2016 norm.
