Retrofitting of a 420 kV draw-lead type bushing with a draw-rod type - Part II

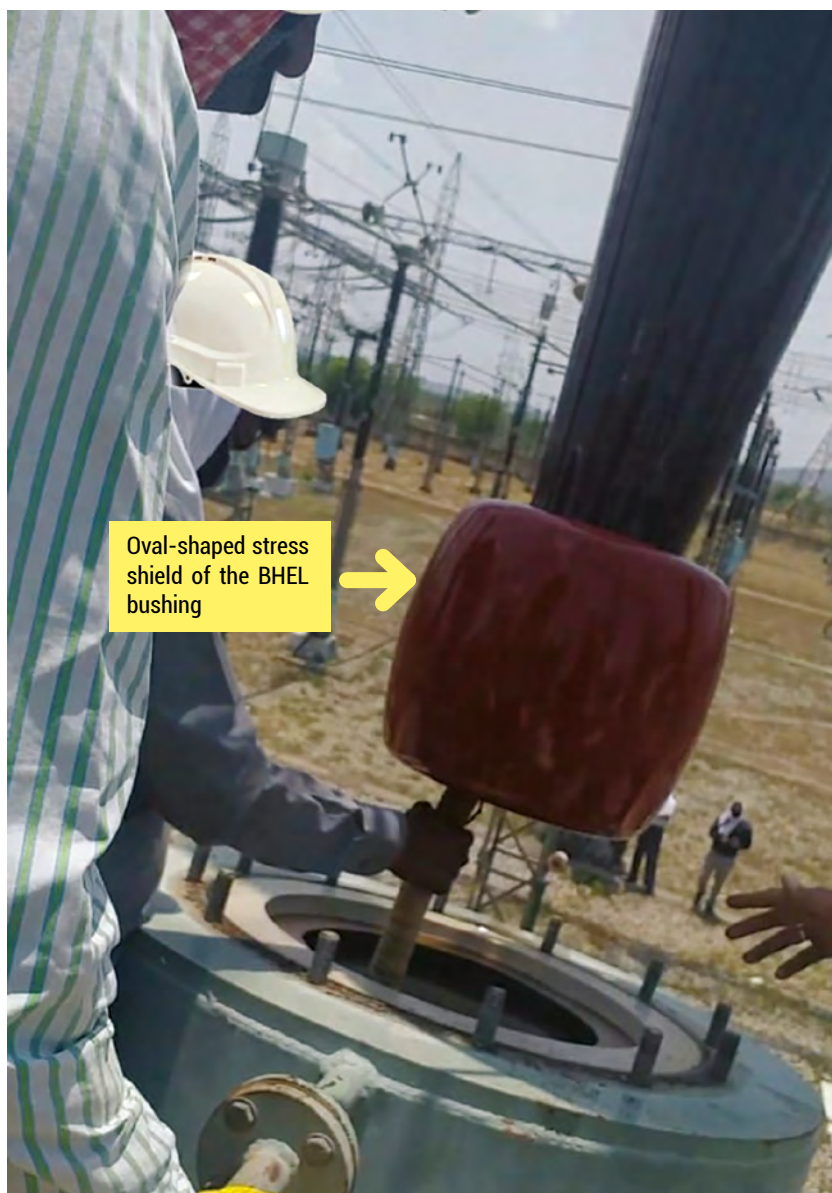
Fig. 1 shows the removal of the 420 kV BHEL bushing with the help of a Hydra crane.

Figure 1. The process of removing the 420 kV BHEL bushing with the Hydra crane.

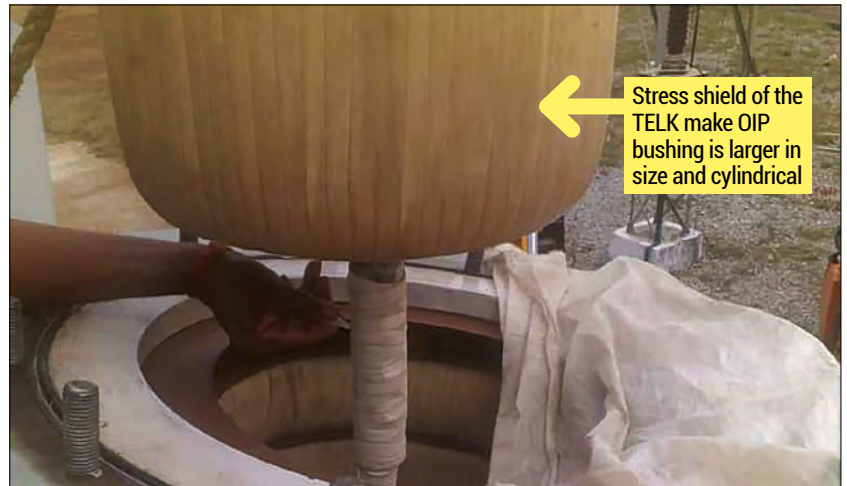
Figure 8. A 420 kV OIP TELK's design bushing being inserted through the turret with a stress shield

ix. Since the 1 V turret is tilted towards the outer side by about 15 degrees, an appropriate angle of the bushing was established with the second Hydra crane such that the TELK bushing (Fig. 10) assumed a tilted position of about 15 degrees to the vertical plane and then it was gradually lowered down through the turret CT (bushing CT), keeping all precautions since that the portion of the bushing CT area diameter of the TELK bushing was 10.0 mm larger than that of the BHEL bushing. There was hardly any play between the inner diameter of the turret CT (installed in the groove of the turret) and the diameter of the metallic portion of the bushing (diameter D2 in Fig. 5), which was encircled by the bushing CTs. The bushing was lowered down through the turret with utmost precision, maintaining an accurate angle with the successfully fitted stress shield, with the help of two Hydra cranes (Fig. 10).

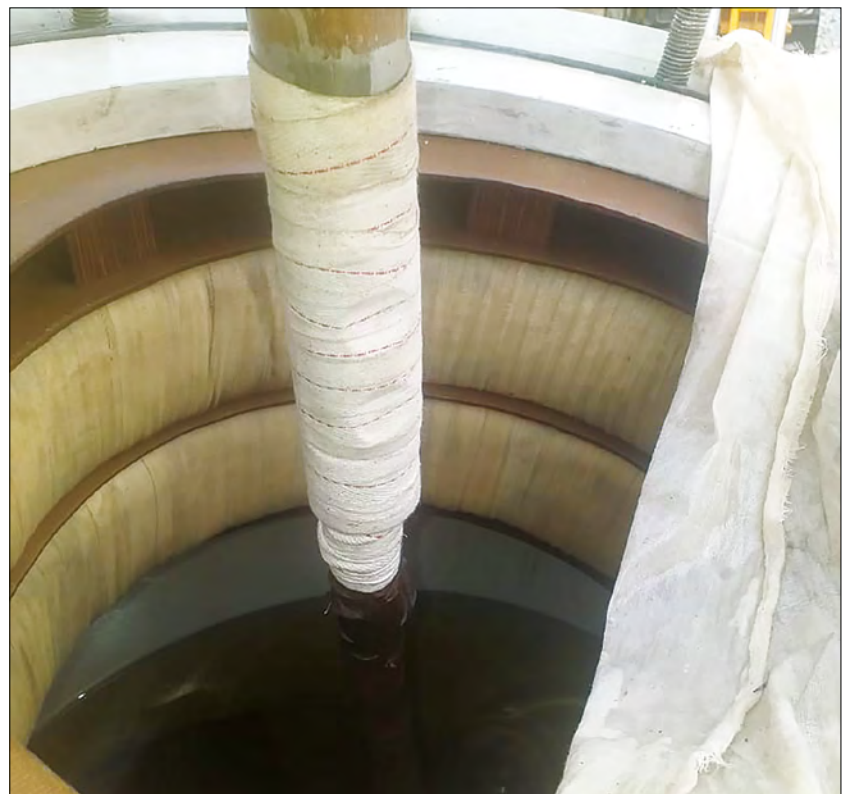
Figure 9. Cotton tape wrapped over the half-lap joints of 1 V phase winding lead and the draw-rod type bushing, tightened

vii. After properly tightening the half-lap joint of the winding lead connector with the half-lap joint of the 420 kV draw-rod end and grinding the larger portion of the draw-rod half-lap connector to size, the whole exposed winding lead and the terminal connector (two halves of half-lap joint connector) were wrapped with a crape tape and then with a cotton tape over that (Fig. 9).

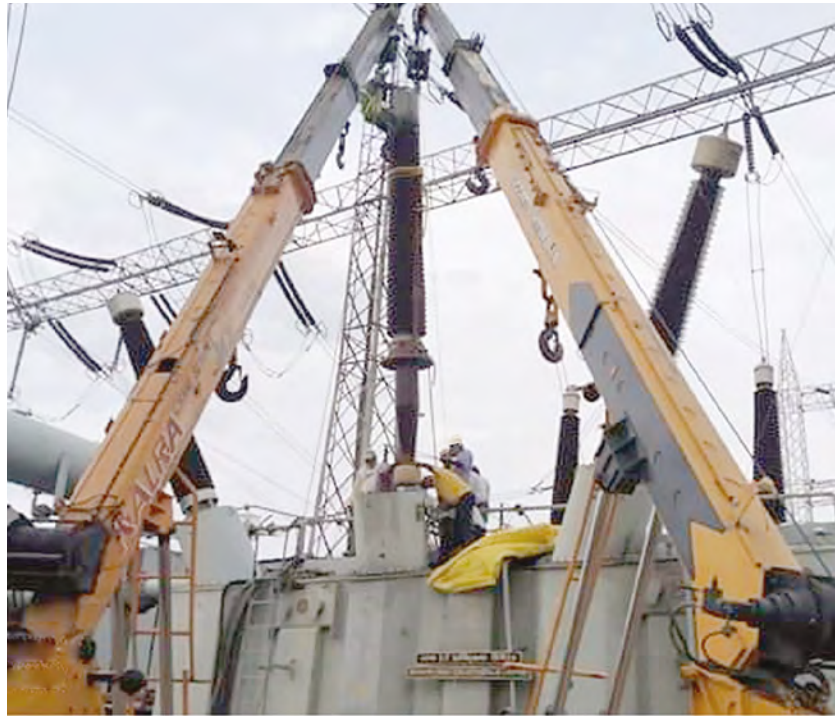
Figure 10. Manoeuvring and lowering down of the TELK’s design 420 kV OIP bushing through 1 V turret of the BHEL’s design 315 MVA transformer with utmost care and precision using two long boom Hydra cranes.
