Evaluation of masonry buildings and mosques after Sivrice earthquake

Research Paper

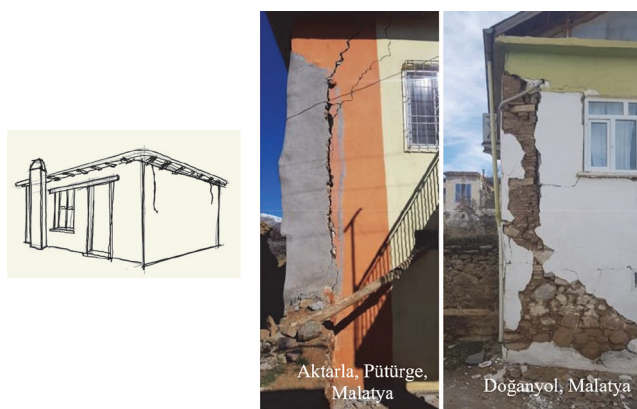
This type of damage occurs due to insufficient interlocking between connecting bearing walls at corners. Examples of this type of damage in the region were seen in two buildings, as shown in Figure 15. It was discovered that the building in Aktarla village was constructed in the 1960s. There is no date of construction for the building in Doğanyol.

Figure 15. Vertical cracks and splitting at corners

These types of damage can be repaired, in various ways, by local strengthening of damaged wall sections. Stone stitching is a method that consists of removing parts of intersecting walls and replacing them with a new, single large stone, which is used for both walls. This strengthening can be performed at different heights along the separated wall intersection. The introduction of new tie rods/beams (wood, reinforced concrete, or steel) is another method to repair the separated wall sections. Moreover, by tightening these tie rods, the gap between the separated walls can be reduced or even closed [15].

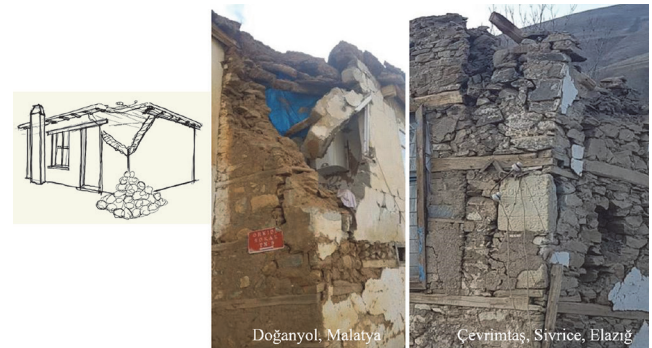
Cases of wedge-shaped corner failure were observed during the site evaluations. This type of failure occurs due to inadequate connection details of wooden tie beams used at the corners along the building height and at roof levels. Examples of this type of damage in the region are shown in Figure 16.

Figure 16. Wedge shaped corner failure

This type of failure requires reconstruction of the corner region, and provision for adequate bonding of the newly-added wall element to the existing walls. New ties can also be added to compensate for the loss of monolithic behaviour of the damaged section. Another strengthening method is to introduce

a reinforced concrete column at the damaged corner along the height of the wall. In this method, the remaining portion of the wall is reconstructed using similar stone masonry [15].

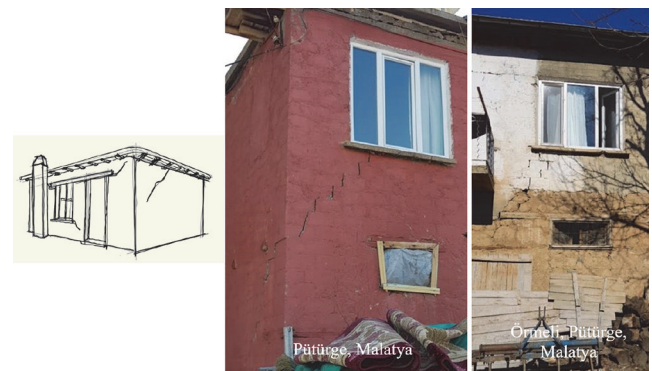
Diagonal cracking due to excessive shear and tensile forces was also commonly observed during the field investigations. The width of these diagonal cracks was very small in some of the masonry buildings; however, the increased width resulted in failure of some of the investigated buildings. Examples of this type of damage in the region are shown in Figure 17.

Figure 17. Diagonal cracking on walls

These cracks can be repaired by injecting fluid cement mortar, cement grout or epoxy-based materials into cracks up to 10 mm wide. The reinforced concrete jacketing of walls from both sides is another method that can be deployed to strengthen heavily-damaged walls having crack widths of more than 10 mm. The partial or complete removal and reconstruction of wall sections can also be performed if the damage is extensive and the integrity of the whole system is in danger [15].

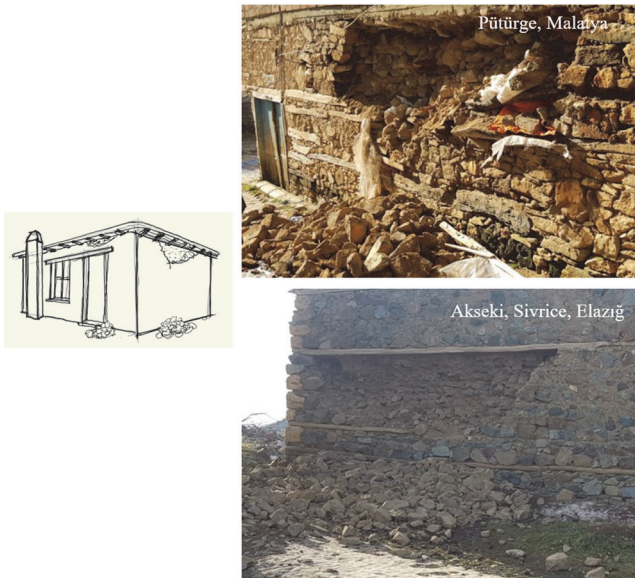
This type of damage occurs when out-of-plane wooden ties do not sufficiently resist the motion of a wall in its out-of-plane direction. Some parts of the wall tumble towards either the outside or the inside of the building. Examples of this type

of damage in the region are shown in Figure 18. The partial or complete removal and reconstruction of wall sections should be performed to repair this type of damage. During the repair process, the damaged section should be supported by temporary shoring [15].

Figure 18. Out-of-plane wall splitting

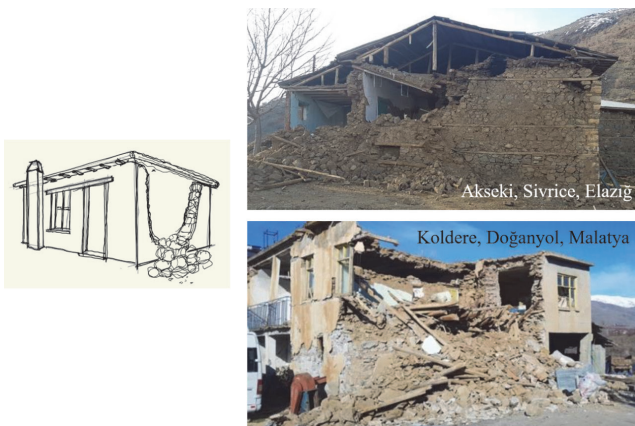
During the site visit, it was observed that collapsed or heavily damaged buildings mainly suffered from the separation of bearing walls and floor/roof systems. This was due to the lack of proper connections between bearing walls and flooring/roofing systems. Another reason for this type of damage might be the insufficient strength and stiffness of the flooring/roofing systems (flexible diaphragm). Examples of this type of damage in the region are shown in Figure 19.

Figure 19. Failure due to wall separation

Repair of this type of damage begins with the reconstruction of damaged walls. The flooring/roofing system must then be

repaired appropriately to enable uniform motion of the wall and flooring/roofing system during earthquakes. This connection can be provided through provision of new tie beams (wood, reinforced concrete, or steel) at the top of a bearing wall. In this repair method, the existing flooring/roofing system should be tied adequately to the newly-installed tie beams [15].

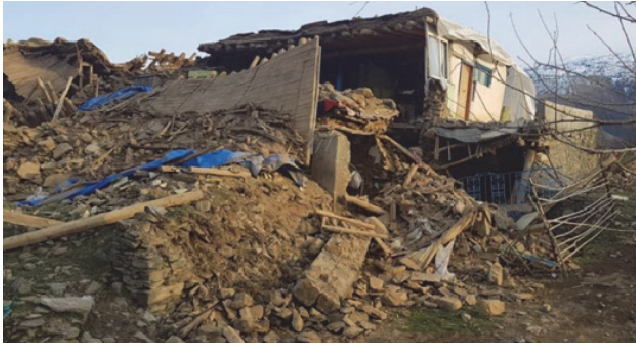
Figure 22. Collapsed masonry building in lower Cevrimtaş village (building 1)

TBEC [12] is used to evaluate the effects of earthquake forces on masonry structures in Turkey. As discussed above, the buildings were constructed on two types of soil: strong and soft soil. The horizontal elastic design response spectrums of these two soil types, which are obtained using TBEC [12], by paying attention to the soil amplification factor, are plotted in Figure 12. The figure indicates the fact that the structures located on soft soil (local site class ZC) are subjected to greater accelerations over a longer period compared to those on strong soil (local site class ZA). Therefore, greater earthquake loads would be exerted on masonry structures constructed on soft soil. This fact related to local site class was believed to be the main reason of collapse of the masonry structures in the lower Çevrimtaş village.

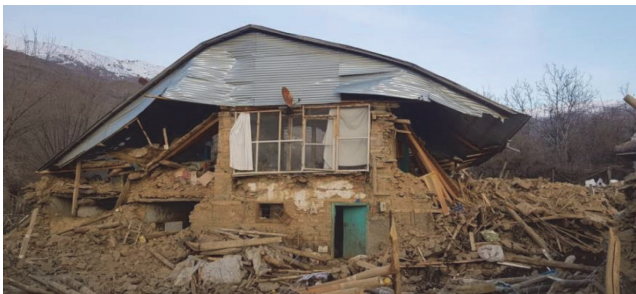
Figure 23. Collapsed masonry building in lower Cevrimtaş village (building 2)

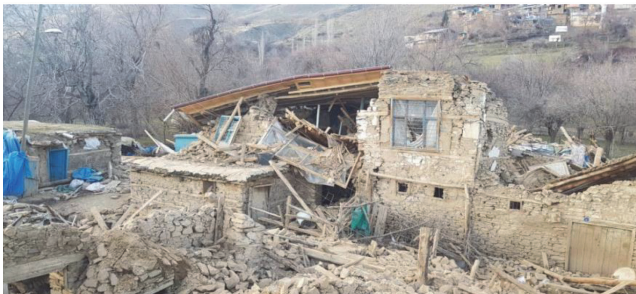
Figure 24. Collapsed masonry building in lower Cevrimtaş village (building 3)

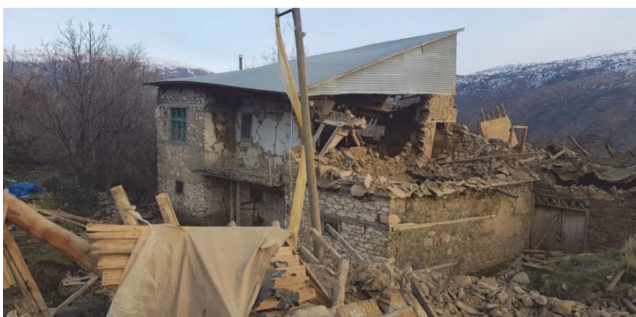
Figure 25. Collapsed masonry building in lower Cevrimtaş village (building 4)

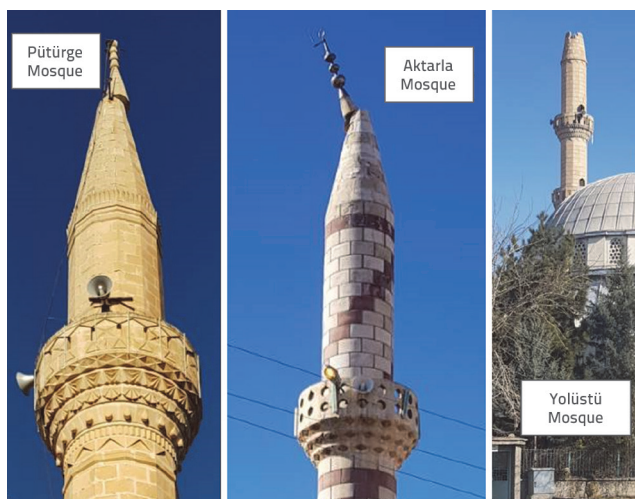
During site investigations, minarets with similar cap damage were observed. During the earthquake, the tapered section of the cap could not resist lateral loads produced by the motion of the flag. As a result, the flag and some parts of the cap detached from the remaining part of the cap. The failure plane usually passed through the mortar interface between the bricks where the weakest plane was located. The photographs related to this type of damage are shown in Figure 27.

Figure 27. Damage to minarets due to separation of flag from cap

These types of damage and failure of minarets will be observed in future earthquakes unless they are strengthened. Fibre reinforced polymers can be used to repair and strengthen masonry minaret structures against shear and bending stresses [18, 19]. In new constructions, these damages may be prevented using reinforced masonry along the minaret height.

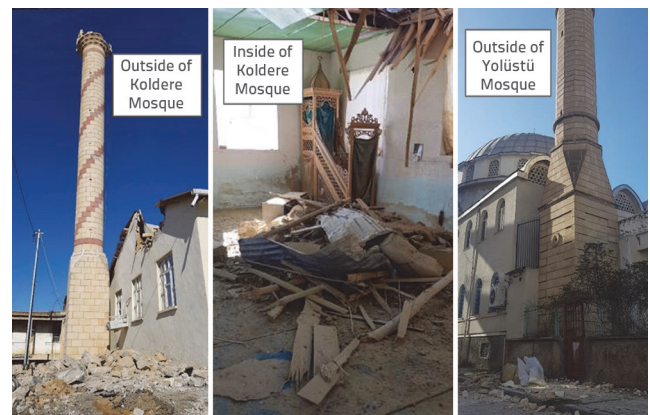
This type of failure does not produce any damage to the surrounding area when the flag is not fully detached from the cap and does not fall off. However, when they are detached, significant damage can be observed due to the debris falling from the minaret. This type of damage was observed in some of the mosques in the region, as shown in Figure 28. In Koldere village, the earthquake resulted in the collapse of the flag, cap, and upper shaft of the minaret, and the debris fell down into the main prayer hall of the mosque. The roof of the mosque was punched through due to the falling debris and the mosque suffered severe damage. This type of failure may be experienced due to the discontinuity in stiffness since the upper shaft is usually constructed with a smaller area compared to the area of the lower shaft. Another reason may be the effect of the second vibration mode since the upper shaft is exposed to lower compressive stress compared to that of the lower shaft. The flag and some parts of the cap of Yolüstü and Furkan Mosques also collapsed and fell down. The cars parked on the street were damaged due to the falling debris of Yolüstü Mosque; however, the debris did not result in any other damage to the Furkan Mosque.

Figure 28. Damage due to falling debris

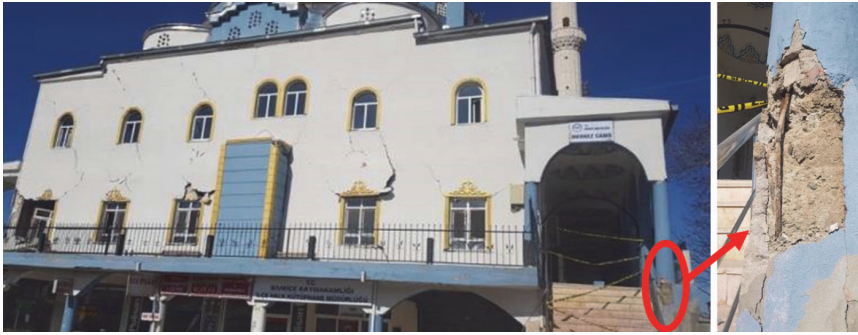
The Sivrice Mosque was built in 2000 using reinforced concrete and it experienced heavy damage during the earthquake. There were shops at the ground floor level of the structure; the mosque was located on the first storey. There was little or no damage at the shop level; however, the mosque section of the building experienced severe damage. Photographs of the damaged mosque are shown in Figure 29. A closer view of a damaged column is also shown in this figure. Based on visual

Figure 29. Sivrice Mosque after the Earthquake

observations made at the site, the reasons for damage were associated with poor quality of concrete, use of undeformed (plain) reinforcing bars, and insufficient use of transverse reinforcements. These deficiencies were believed to be a result of inadequate inspection of the construction process, since structural design of the building was based on a very detailed and comprehensive code, Turkish Earthquake Code (TEC) [20], which was in effect at that time. TEC [20] prohibited the use of any concrete having compressive strength of less than 20 MPa; it required the use of deformed reinforcing bars, and enforced the use of adequate transverse reinforcements, especially in the confinement zones of column and beam ends. The minaret of this mosque was not damaged. However, due to structural damage observed in the mosque, it had to be demolished one week after the earthquake.
