EVALUATION OF CAST DEFECTS IN SHIP PROPELLER OF RECYCLED ALUMINUM ALLOY

Original Scientific Paper – Izvorni znanstveni rad

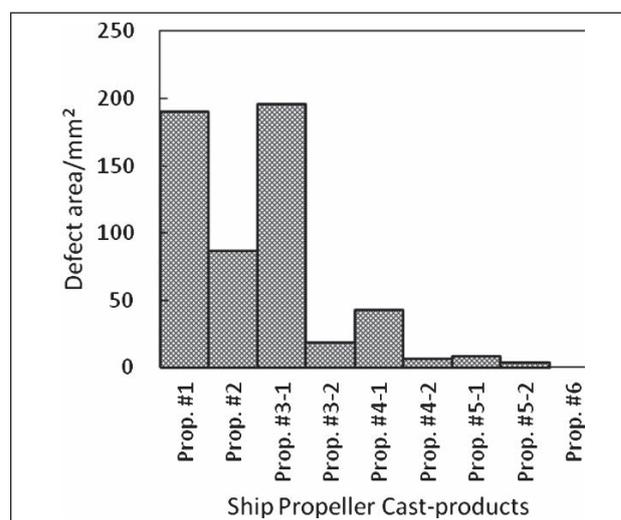
Figure 4 Defect area in cast propeller products

Figure 4 shows the area of defects formed on one or both blades of the ship's propeller. The mold temperature for propeller 1 (Prop.#1) to propeller 5 (Prop.#5) is the mold condition at room temperature (no preheated). Thus, the product is observed to have defects in one or both blades. However, propeller 6 (Prop.#6) was preheated to the mold at 250 °C. As a result, there is no visible defect in the blade. Similarly, for the next propeller products produced, there is no indication of defects when heated in a metal mold (250 °C).

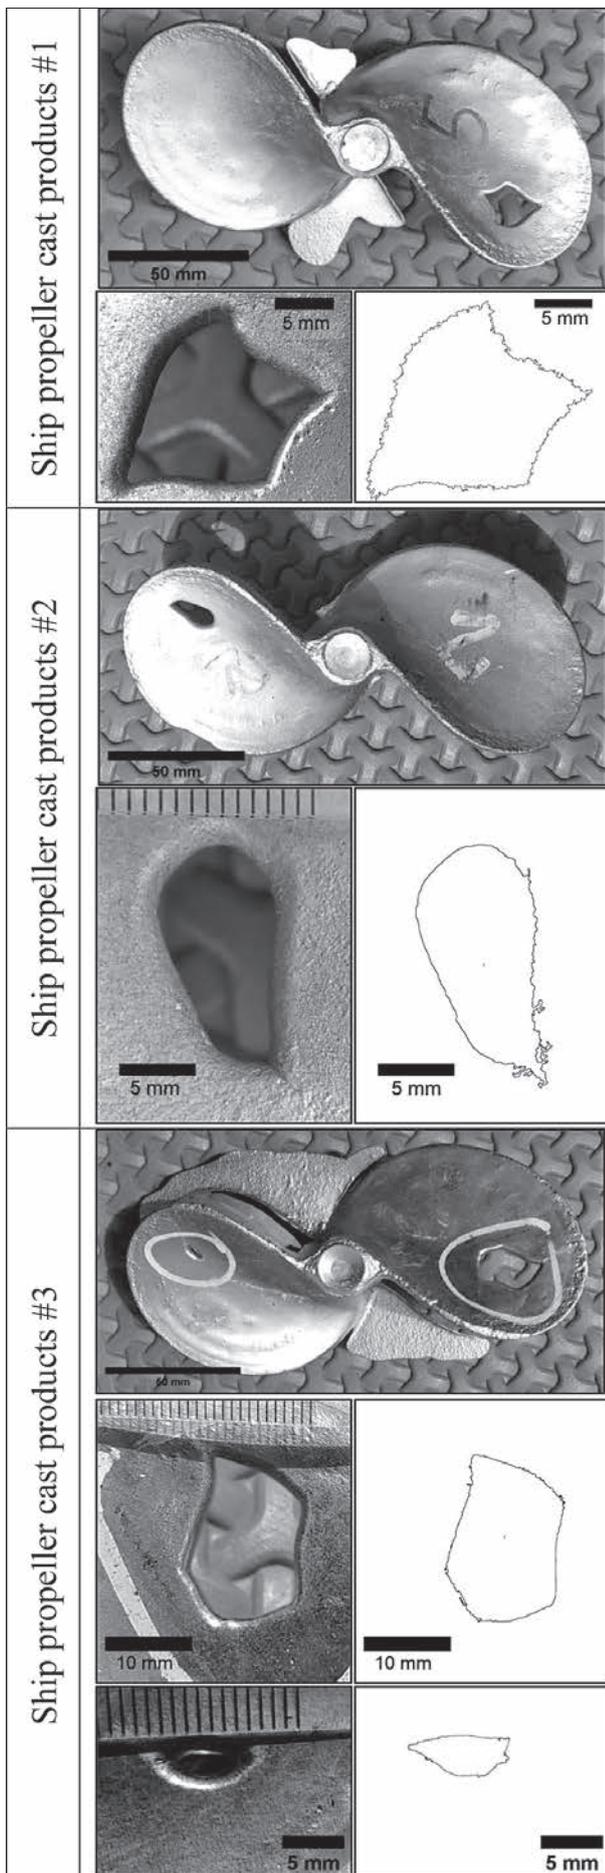
Macroporosity defects were seen in propeller 1 (Prop.#1), propeller 2 (Prop.#2), and propeller 3 (Prop.#3-1 and (Prop.#3-2), respectively, as shown in Figure 5. At propeller 1, a macroporosity defect is seen on one side of the blade with a geometry that is almost like an irregular rectangle. The defect area measured through image processing application is 160,62 mm². Propeller 2, the geometry of the porosity macro defect looks like an irregular oval with one sharp edge. The size is half smaller than the propeller defect 1, the measured area is 86.5631 mm². Propeller 3, macroporosity defects formed on both sides of the blade (Prop.#3-1 and (Prop.#3-2) with an area of 196,118 and 19,144 mm², respectively.

Figure 5 Macroporosity defects formed in the cast products numbers 1-3

In product numbers 1-3, macroporosity defects are seen with various shapes but are generally in square or irregular circles. Porosity defects are caused by extreme temperature differences between the molten and the die. Other causes are low pouring temperature, metal liquid contaminated with the dirt during the melting and casting process, lack of air ventilation, too much lubricant in the cast cavity [10].

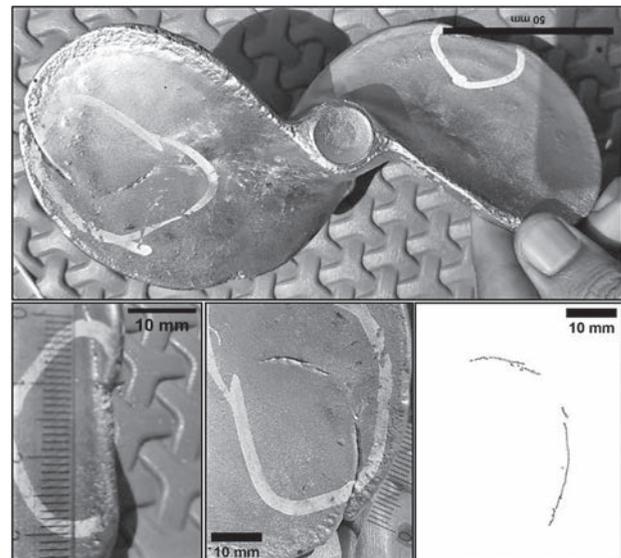
Figure 6 shows the shape and geometry of the misrun defects seen on one of the blades of the propeller 4 product (Prop.#4-1), so the dimensions of the blade are not perfect. On the other hand, cold shut defects were also seen on blade 2 (Prop.#4-2) of the same product (propeller number 4). The area of each defect is 43,293 mm² for misrun defects and 6,341 mm² for cold shut.

Cold shut causes discontinuity in the propeller blade product. The cause of the cold shut defect in the formation of two flows of molten alloy that do not join properly is when the liquid fills the cast cavity.

Figure 6 Misrun and cold shut defects on ship propeller cast products #4

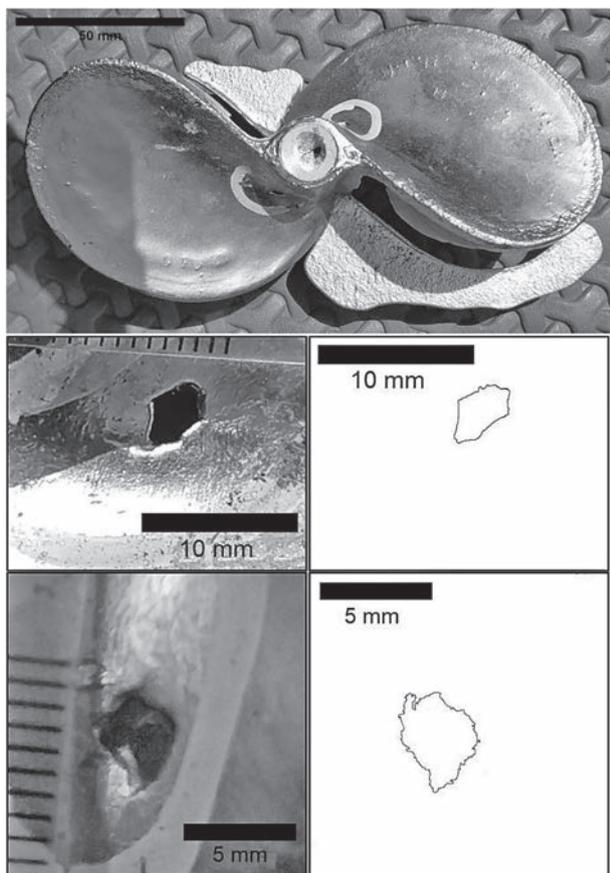
Figure 7 shows the shape and geometry of the shrinkage cavity defects formed in the two-blade base areas (near the sprue). The measurement of the defect area is

8,67 and 3,921 mm², respectively (Prop.#5-1 and Prop.#5-2). Meanwhile, propeller product number 6 (Prop.#6) and so on did not find any defects on the surface or holes in the propeller blade area or tip (Figure 8). This shrinkage cavity defect is caused by a lack of liquid metal when solidifying the metal. The decrease in temperature of the metal during solidification causes shrinkage. Some parts lack liquid metal in the mold cavity, which will cause a shrinkage cavity. Holes are formed on the upper surface while the lower surface of the blade appears to be filled with solidified molten metal, this is due to gravity.

Figure 7 Defect of shrinkage cavity on ship propeller cast products #5

Several defects were seen in propeller products number 1 to 6, caused by no-preheating to the mold (at room temperature/ 26 °C). Meanwhile, after preheating the molds it succeeded in reducing defects such as macroporosity defects, misrun defects, cold shuts, and shrinkage cavities. The extreme drop in temperature occurs in the condition of the mold without preheating. When the molten metal touches the metal mold, thermal shock occurs and makes the liquid metal that is directly in contact with the mold cavities freeze quickly. Such rapid freezing produces defects in the tip area of the ship's propeller, as shown in products 1 to 4. The formation of defects is influenced by the cooling curve which is dramatically dropping due to heat transfer conduction from the molten metal to the metal mold and then transferred to the ambient air. A drastic drop of temperature from 760 (pour temperature) to 300 °C is recorded in the first 10 seconds when the molten metal touches the metal mold. Quick solidification is not only causing defects but also affects the properties of metal alloys [9].

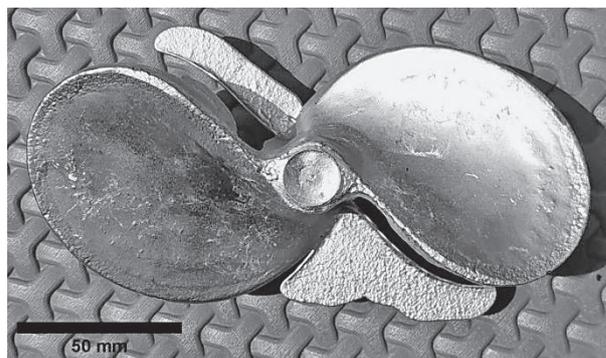
Figure 8 Products without defects in ship propeller cast products #6
